PRELIMINARY ACCIDENT REPORT

Accident and Incident Investigations Division

Accident
- Preliminary Report -
AIID Ref No: CA18/2/3/10471

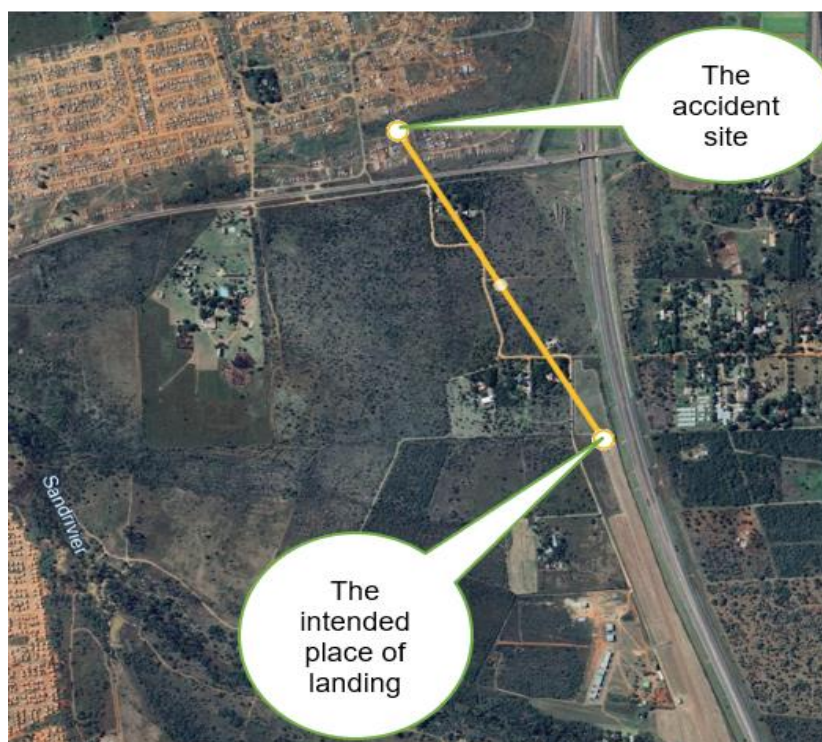
- 1.1.3. The accident occurred approximately 0.6 nautical miles (nm) west of Bundu Fly Inn Estate Airfield at Global Positioning System (GPS) co-ordinates determined to be 25°39'02.9" South 028°02' 48.7" East, at an elevation of 4 265 ft.

Figure 2: The accident site and the threshold of Runway 27. (Source: Google Earth)

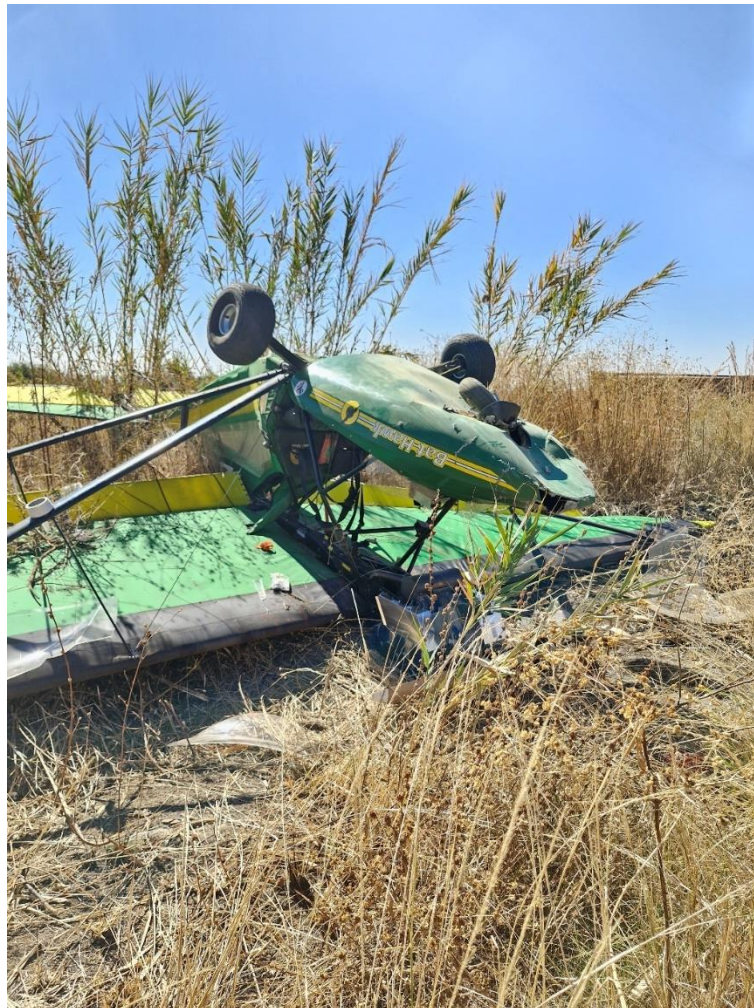
1.3.1. The aircraft was substantially damaged.

Figure 3: The aircraft post-accident. (Source: Pilot)

1.12.1 During the forced landing, the aircraft's nose wheel impacted a rock and, consequently, flipped over and skidded before it came to a stop. Both wings and the wing support struts sustained substantial damage. The aircraft's windshield shattered during the accident sequence and pieces of it were found near the nose section. The nose gear was found bent backwards. The fuel tank was damaged which caused the fuel to spill to the ground. There was no visible damage to the engine.

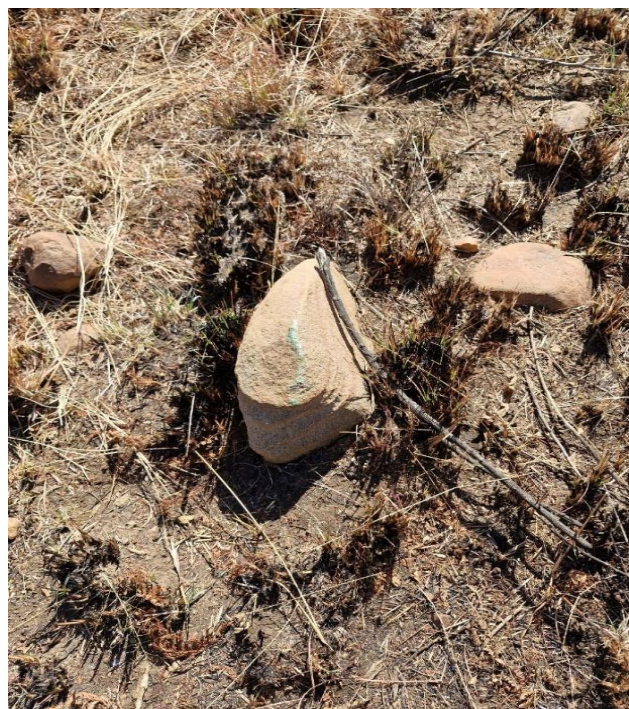
Figure 4: The rock that caused the aircraft to nose over.
