PRELIMINARY ACCIDENT REPORT

Accident and Incident Investigations Division

Accident
- Preliminary Report -
AIID Ref No: CA18/2/3/10362

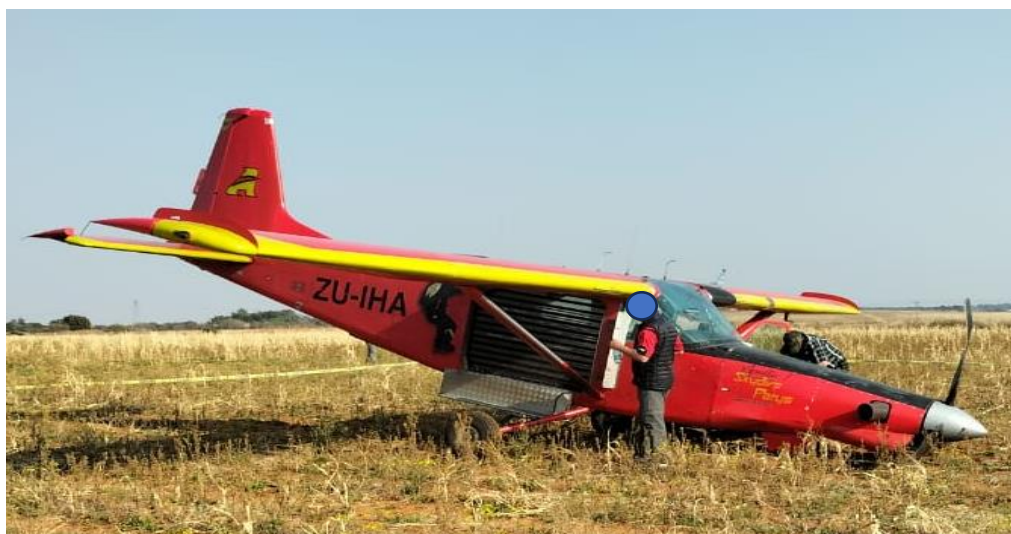
1.3.1 The aircraft sustained substantial damage.

Figure 3: The aircraft post-accident. (Source: Pilot)

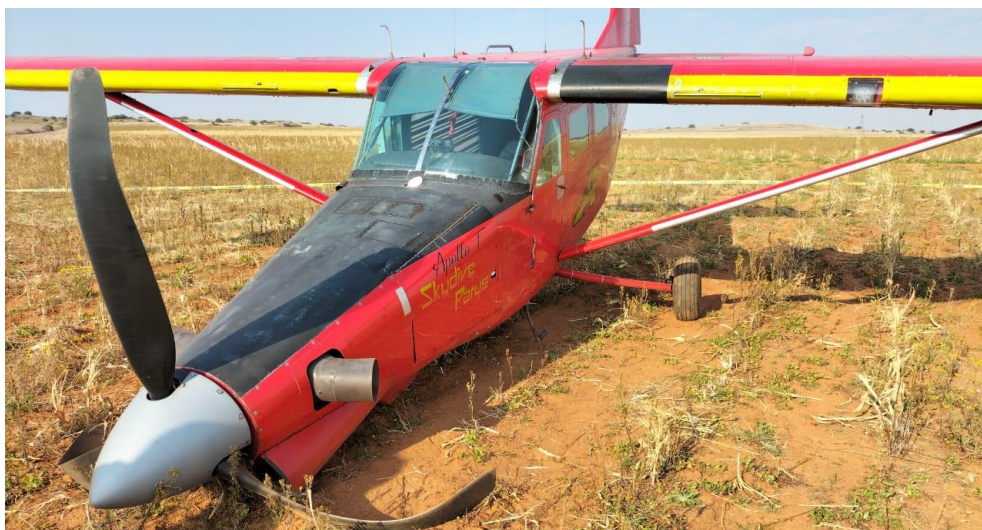
1.12.1 The pilot performed a forced landing on an open field approximately 0.83 nautical miles (nm) west of FATP. The nose gear collapsed during the landing roll which resulted in the aircraft propeller blades striking the ground. The aircraft came to rest in an upright position. The airframe and the cockpit cabin area remained intact. The aircraft sustained damage to the nose gear strut, the engine intake, the lower engine cowling and the propeller blades.

Figure 5: The aircraft at the accident site. (Source: Pilot)
