PRELIMINARY ACCIDENT REPORT

Accident
- Preliminary Report -
AIID Ref No: CA18/2/3/10312

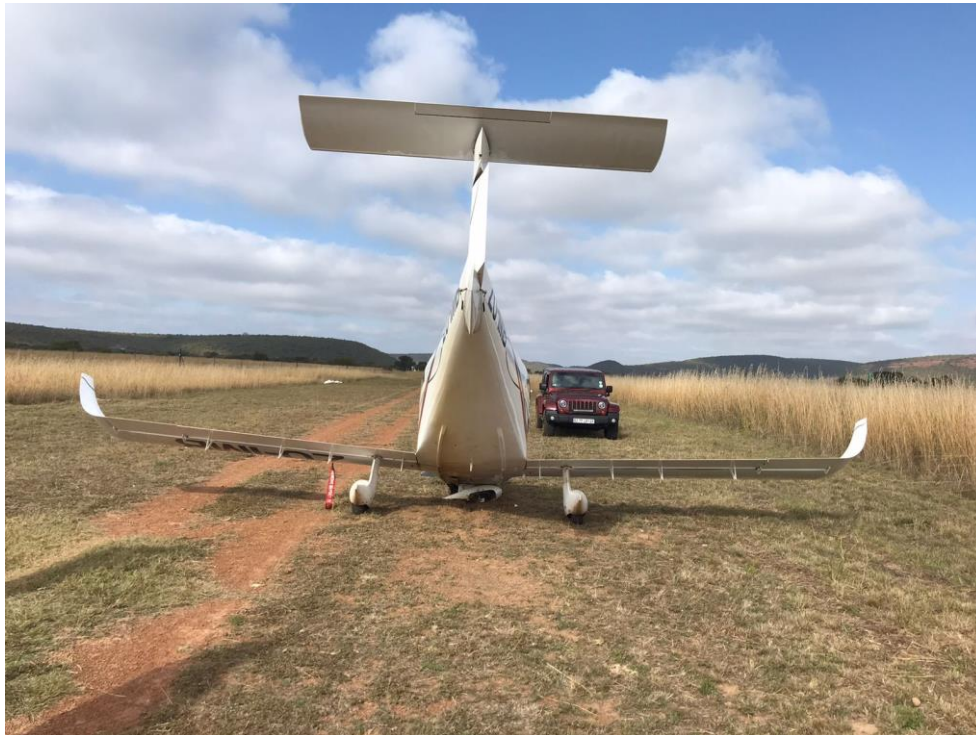
Figure 1: The ZU-IMB aircraft post-accident. (Source: Pilot)

1.1.2 The pilot reported that during taxi at FARA, the nose wheel separated from the nose wheel strut and the propeller tips contacted the ground. The aircraft came to rest in a tail-high position. No people were injured during the accident.

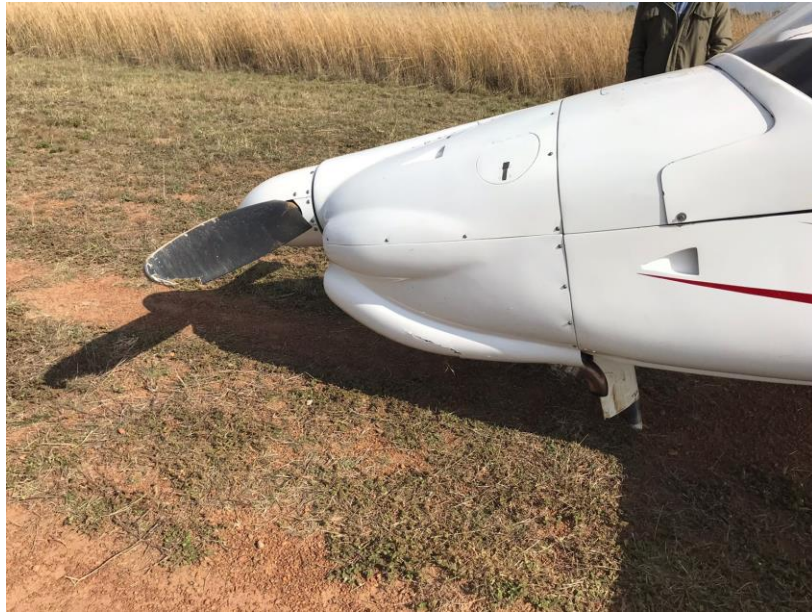
- 1.3.1 The aircraft sustained substantial damage to the propeller tips and the nose wheel separated from the strut.

Figure 3: One of the damaged propeller blades. (Source: Pilot)

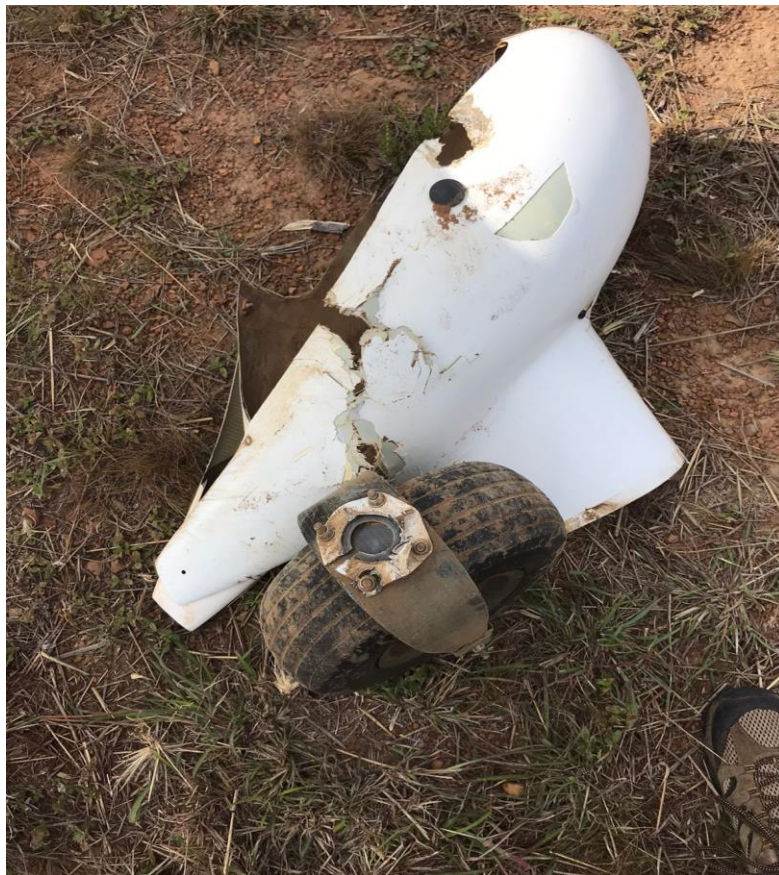
Figure 4: The nose wheel separated from the wheel strut. (Source: Pilot)

2.2.7 The nose wheel separated from the nose wheel strut during taxi.

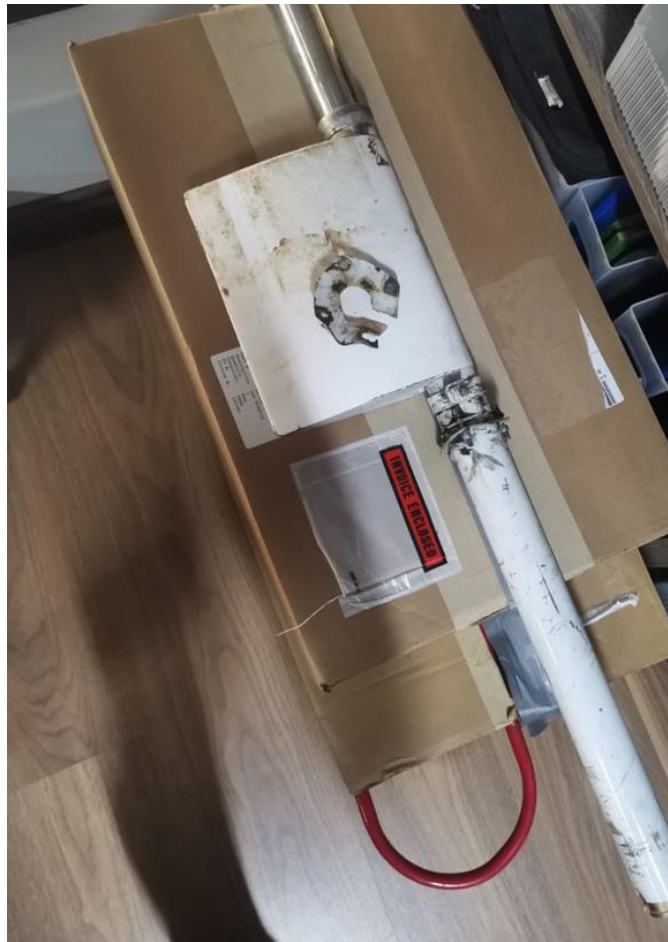
Figure 5: Strut of the aircraft taken for further analysis.
