PRELIMINARY ACCIDENT REPORT

Accident and Incident Investigations Division

Accident
- Preliminary Report -
AIID Ref No: CA18/2/3/10372

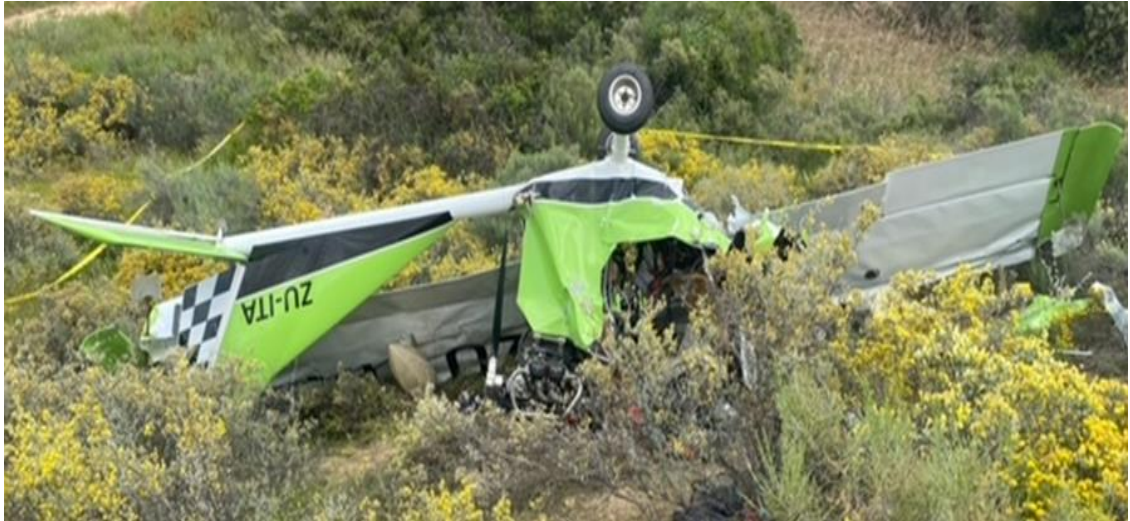
1.3.1 The aircraft was destroyed.

Figure 3: The aircraft at the accident site.

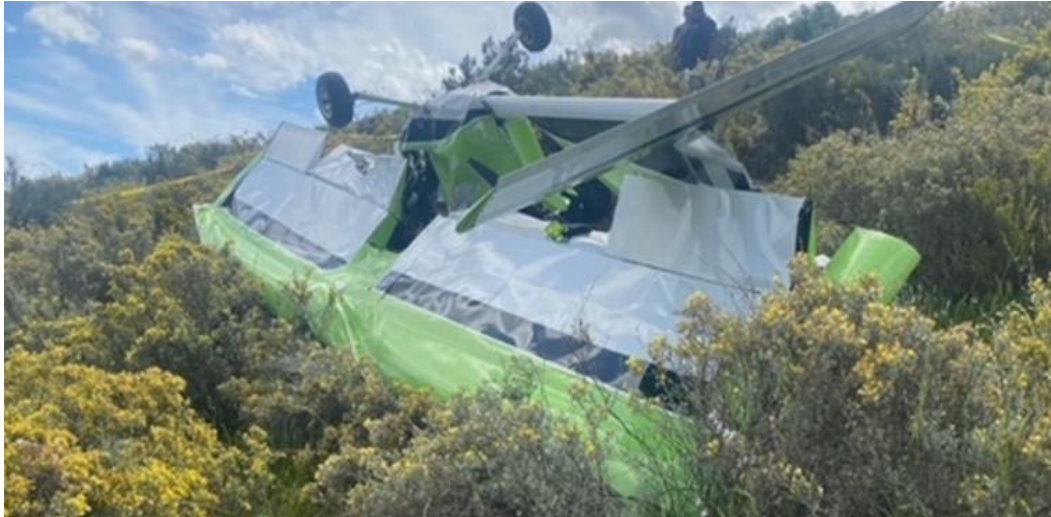
1.12.1 The aircraft struck the ground approximately 425 metres (m) south-west of FACE in a steep nose-down attitude. It impacted the ground with the right-side wing tip, and the left- and right-side wings separated from the airframe. The separated wings were found next to the main airframe. The main wheels were still attached to their respective axles. The aircraft came to rest in an inverted attitude on a heading of approximately 203° magnetic. The wreckage was contained in a single location.

Figure 4: The aircraft in an inverted attitude.

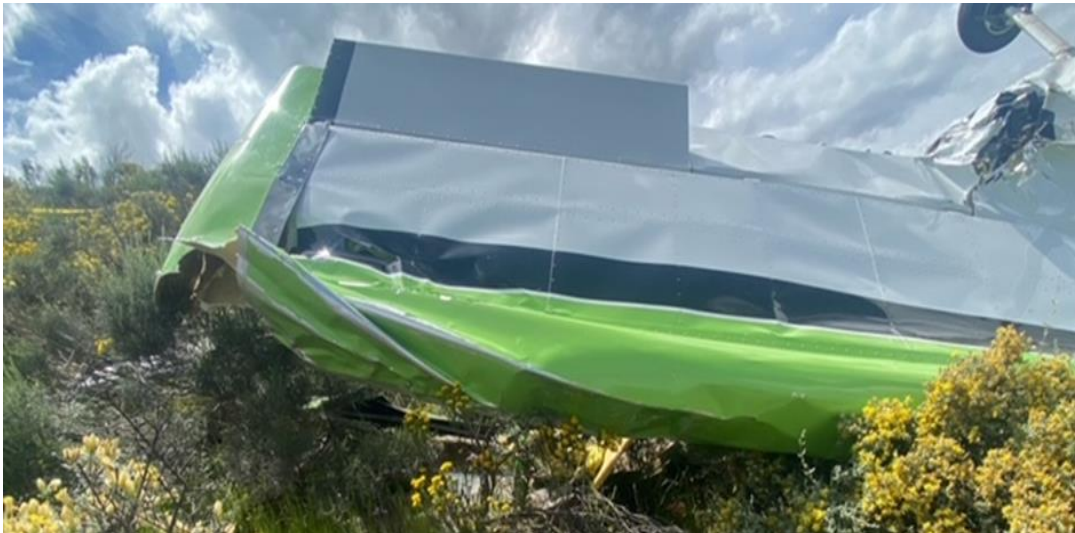
1.12.2 The aircraft's right wing tip first impacted the ground before the wings separated from the airframe.

Figure 5: The damaged right-wing tip.

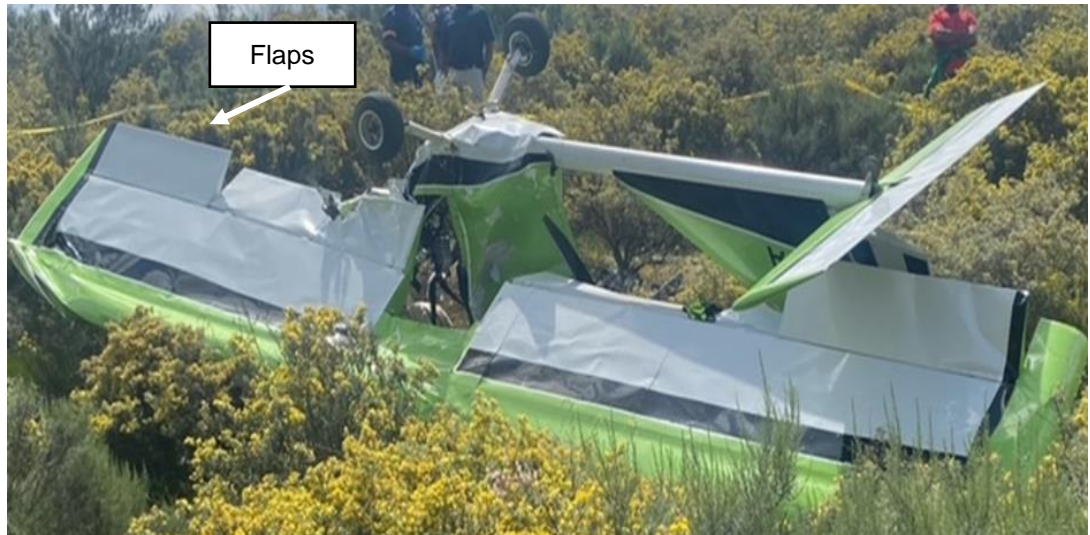
1.12.3 The wings separated from the main airframe and were found lying parallel to the main airframe; the flaps were at an angle of 15°.

Figure 6: The damaged wings.

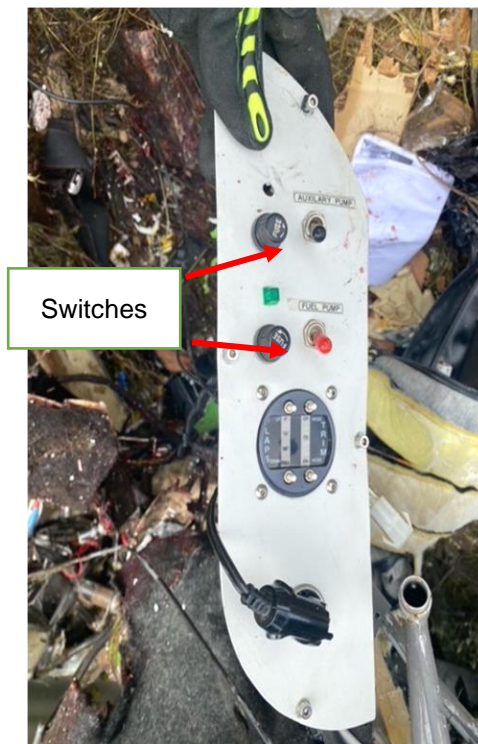
1.12.4 The instruments were heavily damaged as a result of the impact; they separated from the instrument panel. The auxiliary and fuel pump switches were found in the “OFF” position.

Figure 7: Auxiliary and fuel pump switches (red arrows).

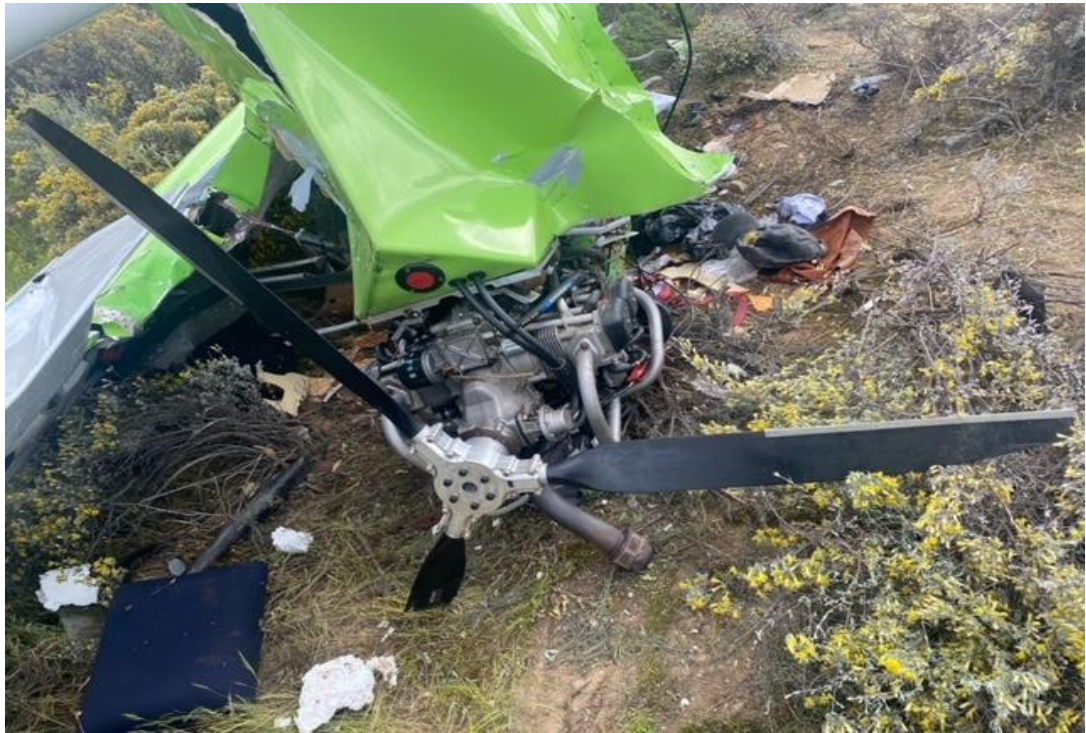
1.12.5 The on-site inspection of the engine and propeller indicated that there was no power at the time of impact; all damage was attributed to the impact forces. One propeller blade tip broke off during the impact sequence which indicated that the engine was not operating at the time of impact with the ground. A piece of the composite blade was found in the vicinity of the accident site. All associated components (fuel pipes,

electrical wires and exhaust system) of the engine were still intact. The engine propeller rotated by hand when checked. The filter was checked and there was fuel inside, and there was no sediment or contamination found.

Figure 8: The engine and the propeller.

2.2.5 The propeller blades were curled backwards, which indicated that the engine was not producing power at the time of impact.
