PRELIMINARY ACCIDENT REPORT

Accident and Incident Investigations Division

Accident
- Preliminary Report -
AIID Ref No: CA18/2/3/10454

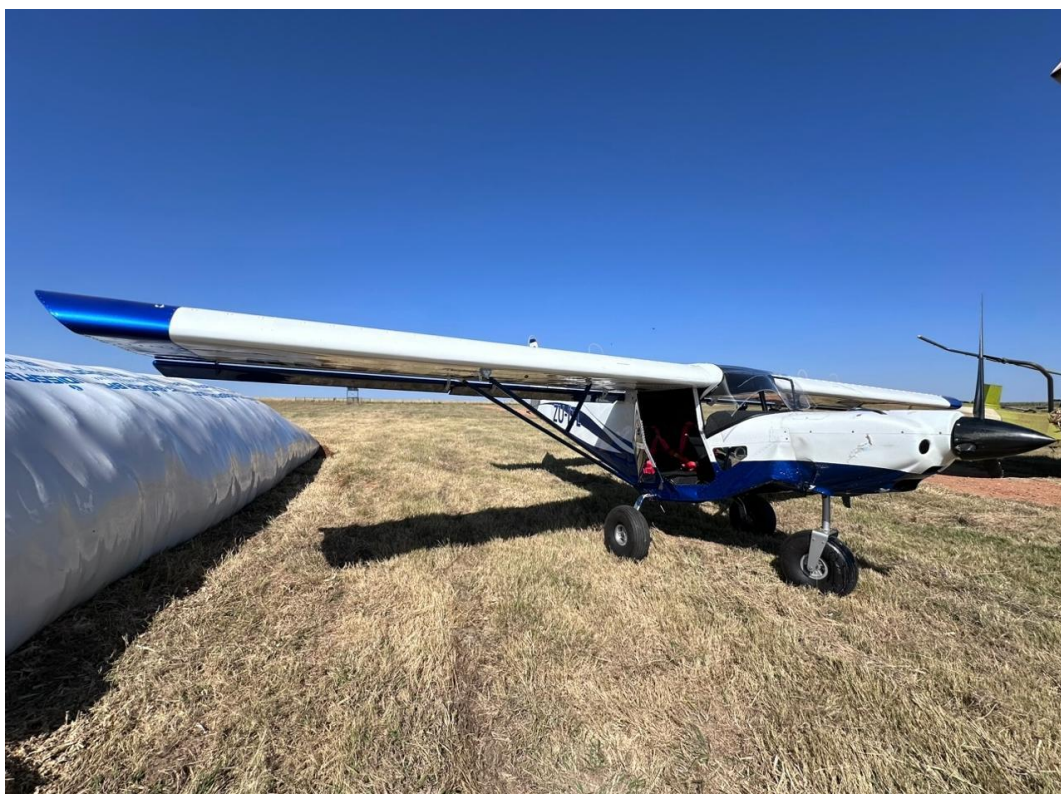
Figure 1: The ZU-ITL aircraft after the accident. (Source: pilot)

Whilst overhead a farm, the aircraft's engine ran rough, and the pilot elected to execute a forced landing. During the landing roll, the aircraft rolled over the water drainage and impacted a silage bag. The aircraft was substantially damaged; no person was injured.

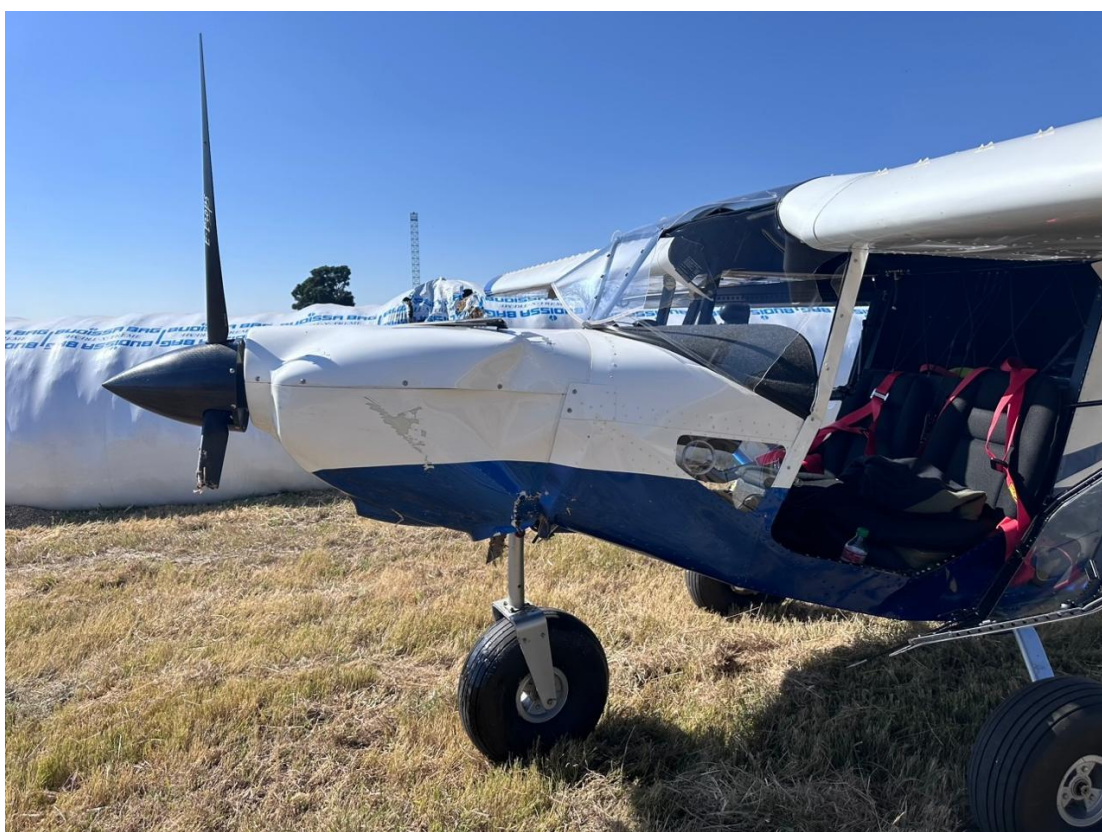
1.3.1. The propeller blades and the nose section were substantially damaged.

Figure 3: The aircraft post-accident with the damaged propeller blades and nose section. The silage bag is in the background.

1.12.1. The aircraft's engine ran rough, and the pilot elected to execute a precautionary landing. During the landing roll, the aircraft rolled over a water drainage and impacted a silage bag before it stopped. The propeller blades broke off and the nose section was damaged. The middle part of the nose section was also deformed.
