PRELIMINARY ACCIDENT REPORT

Accident and Incident Investigations Division

Accident
- Preliminary Report -
AIID Ref No: CA18/2/3/10552

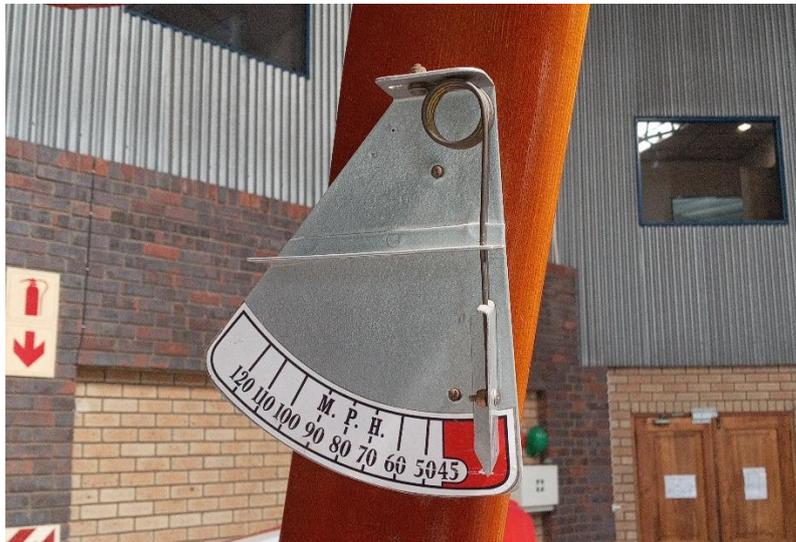
- 1.1.3. At 1204Z, the duo took off again from Runway (RWY) 35 and, whilst on a climb, the engine ran rough. The pilot declared an emergency and the tower air traffic control (ATC) personnel instructed them to turn right; however, the pilot rejected the instruction because of the built-up area to the right. He then told the ATC that he would turn left and aim to reach RWY 11. As he was turning left, he observed that the aircraft was losing height and that the speed was reducing and nearing the red mark of 45 miles per hour (MPH) on the indicated airspeed (IAS) (see Figure 2). He then decided to land on an open space between RWY 35 and 11.

Figure 2: An airspeed indicator of the aircraft.

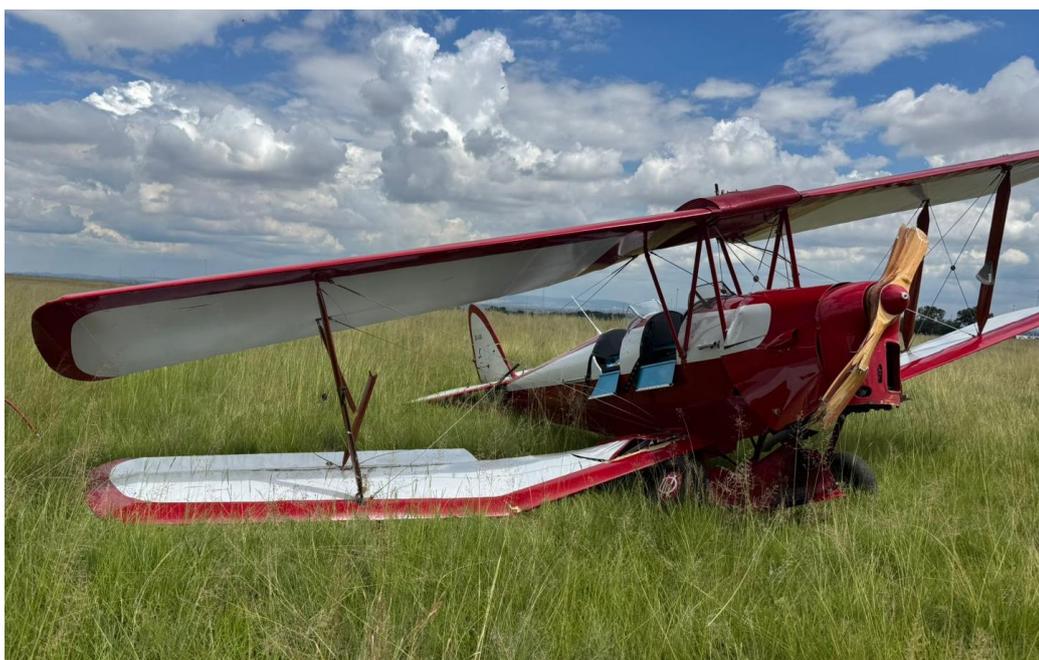
- 1.1.4. The aircraft passed RWY 11 and, as it was not straight and level, it impacted a heap of grass with the right undercarriage before it stopped 150 metres (m) from the runway (RWY 11). The aircraft sustained damage to the right undercarriage, right wing, engine cowling and propeller. The pilot and the passenger (AME) were not injured.

Figure 3: The ZU-IUV at the accident site. (Source: Pilot)

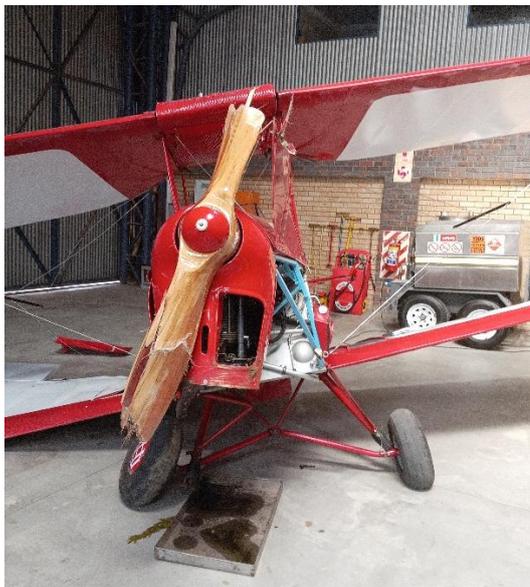
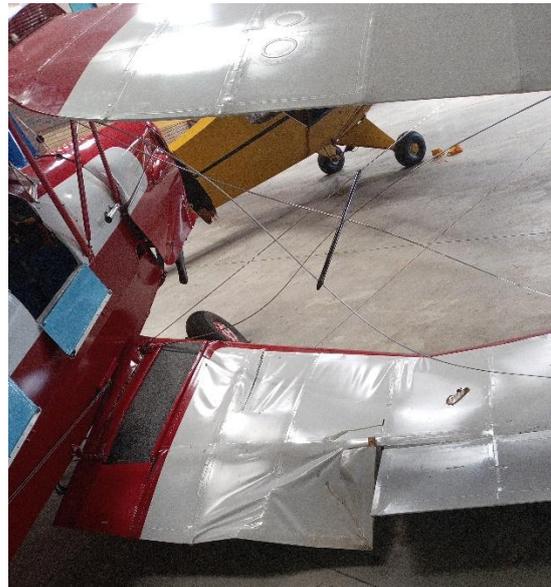
1.3.1. The aircraft damage was substantial; it included the right undercarriage, right wing, engine cowling and propeller.

RWY 11, he lost height and speed. The aircraft landed with the right undercarriage first and came to a stop past RWY 11. The aircraft sustained damage to the lower right wing, right undercarriage (which collapsed), engine cowling and the propeller.

Figures 4 and 5: Damage to the propeller, lower right-wing and right undercarriage.
