PRELIMINARY ACCIDENT REPORT

Accident and Incident Investigations Division

Accident  
- Preliminary Report -  
AIID Ref No: CA18/2/3/10511

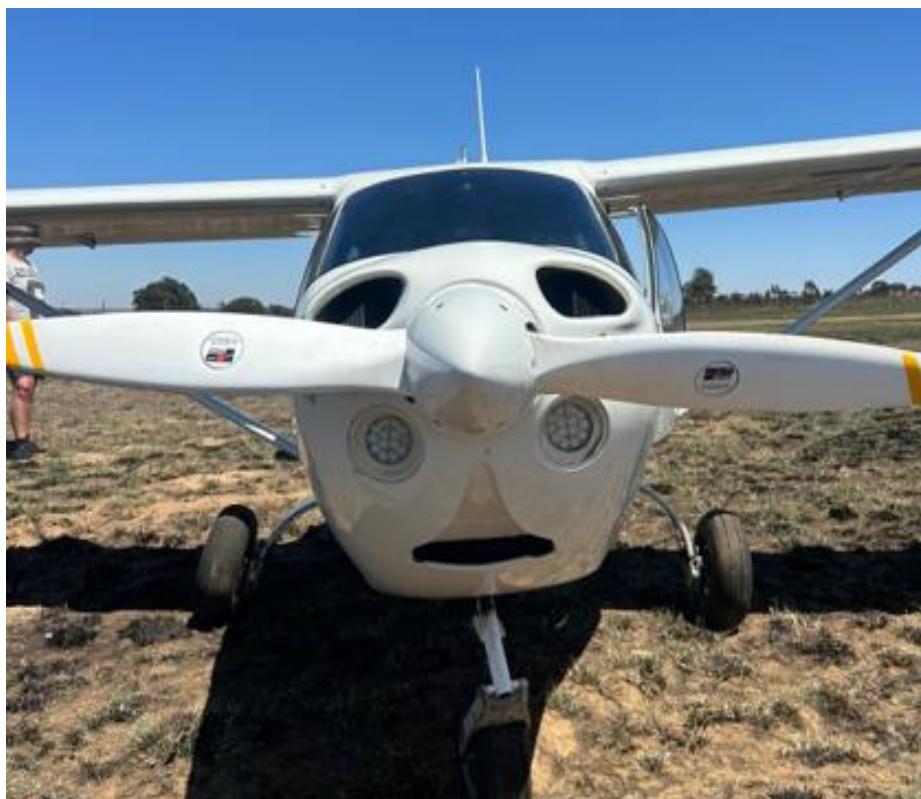
**Figure 1:** The ZU-JBA aircraft as it came to rest post-accident. (Source: Pilot)

The SP was conducting circuit-and-landing exercises. At 0850Z during a touch-and-go landing on Runway (RWY) 13, the aircraft landed hard and, subsequently, leaned to the right during the take-off roll. The FI immediately instructed the SP to abort take-off. Inspection of the aircraft revealed a crack on the right main gear strut. The aircraft was taxied to the hangar for further assessment. The FI and the SP were not injured during the accident.

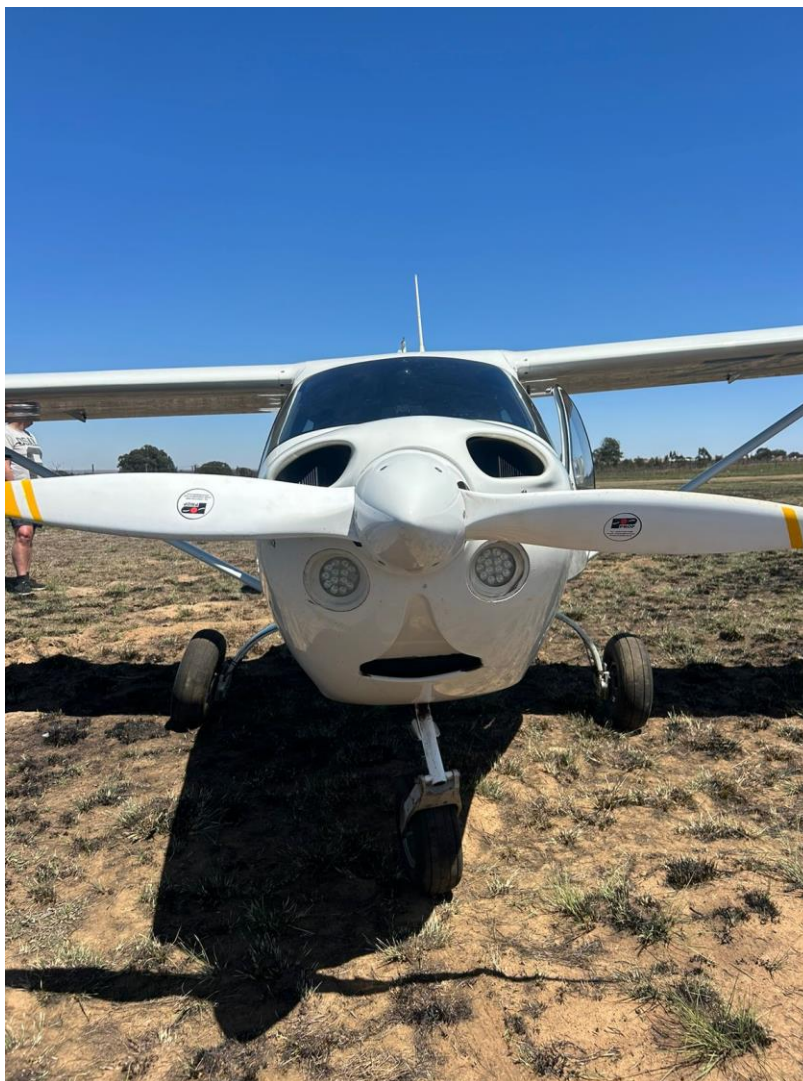
1.3.1. The aircraft's right main wheel strut had a crack.

**Figure 3:** The aircraft post-accident. (Source: Pilot)

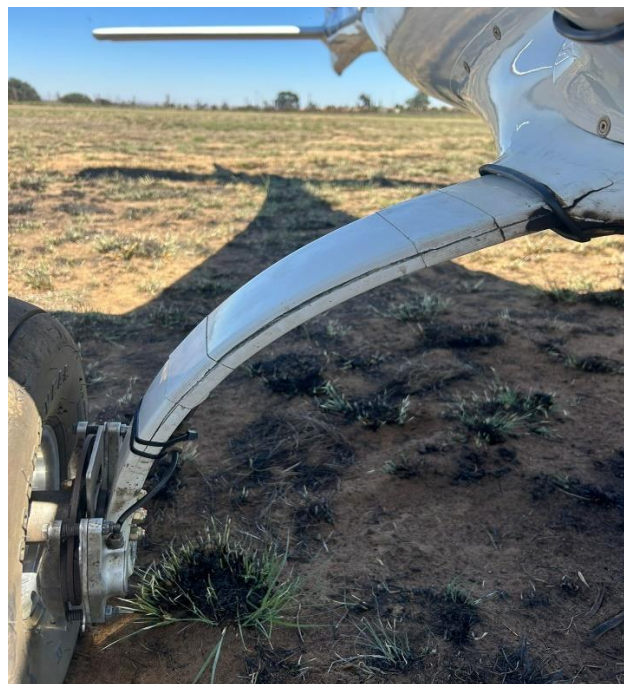
1.12.1 The accident occurred within the aerodrome's boundary. The right main landing gear wheel strut attachment point was found fractured, an indication of damage to the fairing. The overall view of the aircraft was intact after the aborted take-off.

**Figure 4:** The aircraft's right main wheel strut had a crack. (Source: Pilot)

2.2.4 The aircraft landed hard during a touch-and-go exercise and, during the take-off roll, leaned to the right.
