PRELIMINARY ACCIDENT REPORT

Accident
- Preliminary Report -
AIID Ref No: CA18/2/3/10641

Figure 1: A file picture of the Savannah S aircraft.

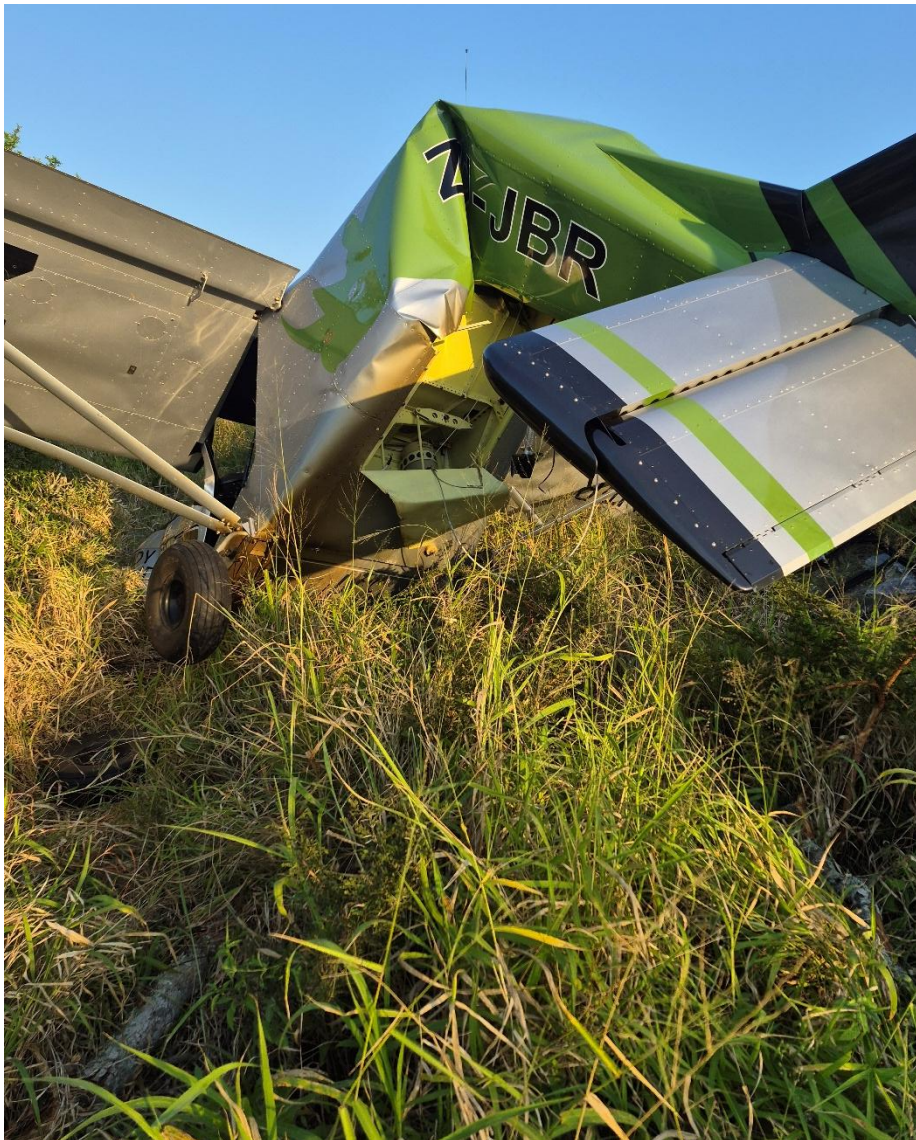
1.3.1. The aircraft was substantially damaged during the accident sequence.

Figure 3: The aircraft at the accident site.

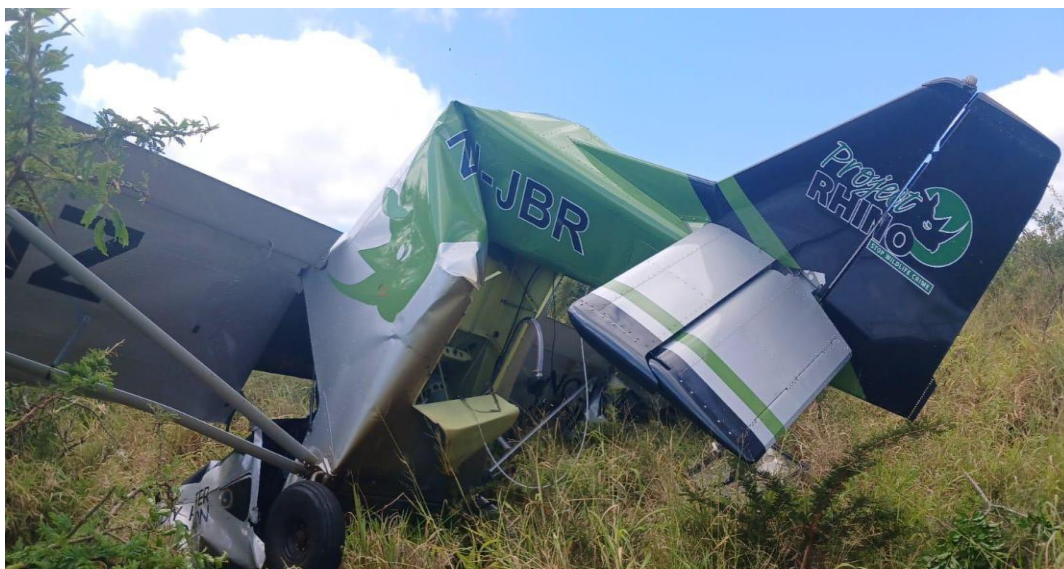
1.12.1. The aircraft impacted some thorn trees during glide; it crash-landed hard with the nose gear first and came to rest facing a south-easterly direction. As a result, the nose gear separated from the aircraft. The aircraft sustained damage to the propeller blades, bottom engine cowling, empennage and fuselage during the accident sequence.

1.12.2. The fuel tanks still contained fuel at the accident site although the quantity could not be determined. There were no noted pre-impact anomalies; all fractures were consistent with impact forces. All airframe components and controls were accounted for post-accident.

Figure 4: The final resting position of the aircraft after the accident.
