PRELIMINARY ACCIDENT REPORT

Accident and Incident Investigations Division

Accident
- Preliminary Report -
AIID Ref No: CA18/2/3/10638

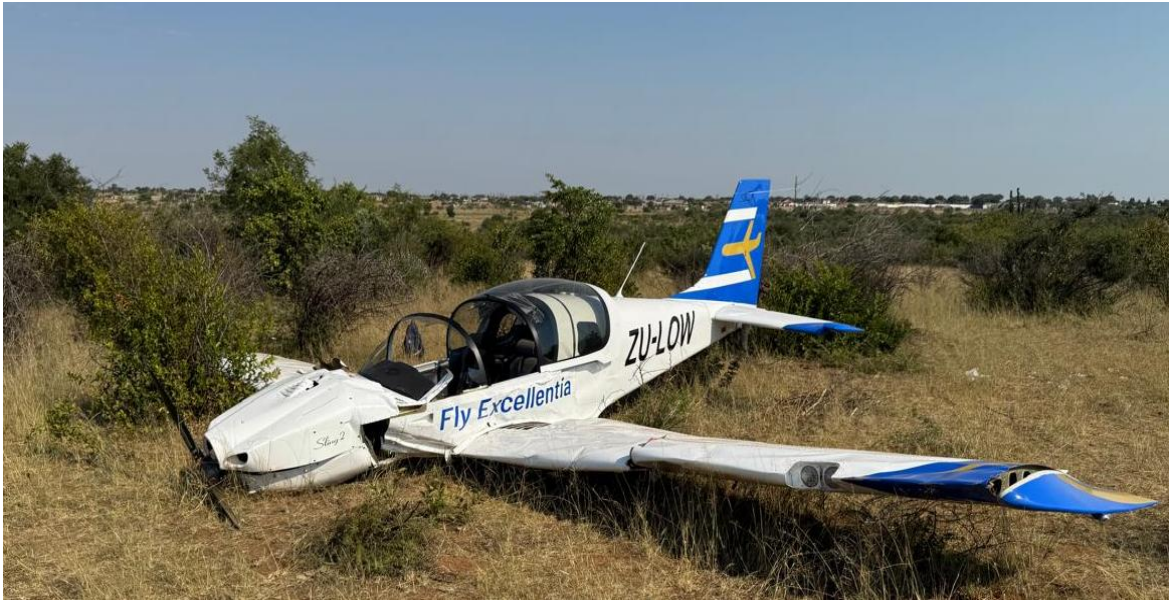
Figure 1: The ZU-LOW aircraft as it came to rest after the accident.

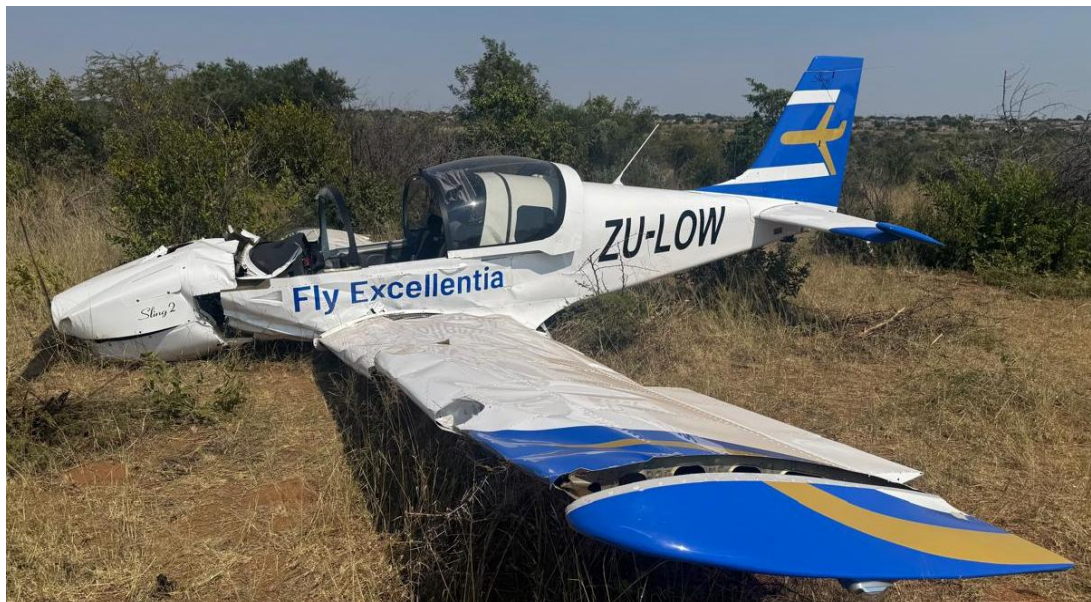
1.3.1. The aircraft was substantially damaged.

Figure 3: The aircraft at the accident site.

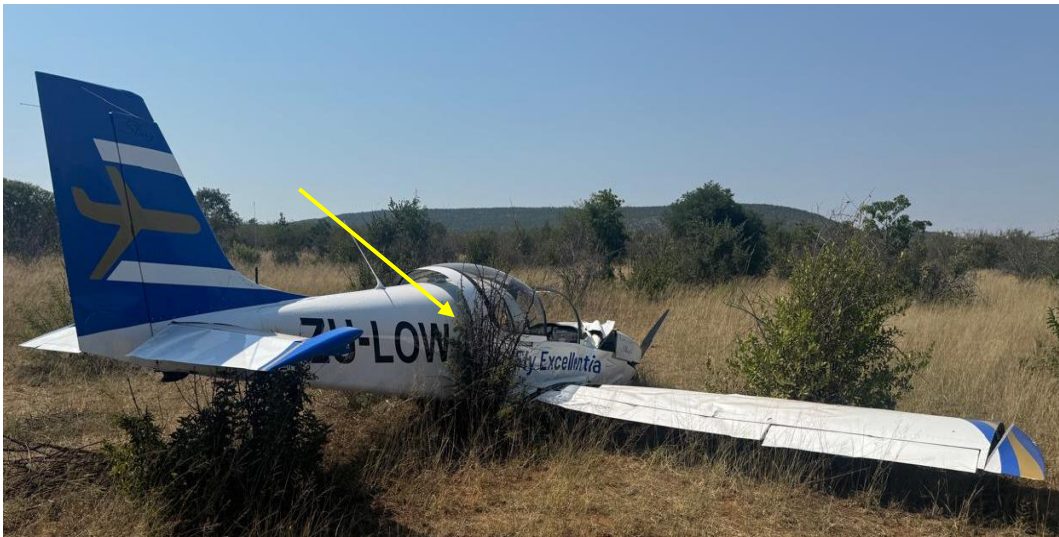
1.12.1 The accident occurred in a bush-type terrain near Sifasonke residential area in Klipgat. Witness marks at the accident site indicated that the aircraft was in a near vertical attitude when it impacted the ground with the landing gears. All three landing gears broke off; the pitot tube on the left side underwing also broke and was pushed up (UP position). The aircraft came to rest in an upright position. None of the trees/branches at the accident site was severed. There was also no evidence of skid marks at the scene (behind the aircraft). The fuel tanks ruptured on impact, and thus, there was a strong smell of fuel at the accident site. The flight controls were examined and were found

Figure 4: The aircraft in its resting position.

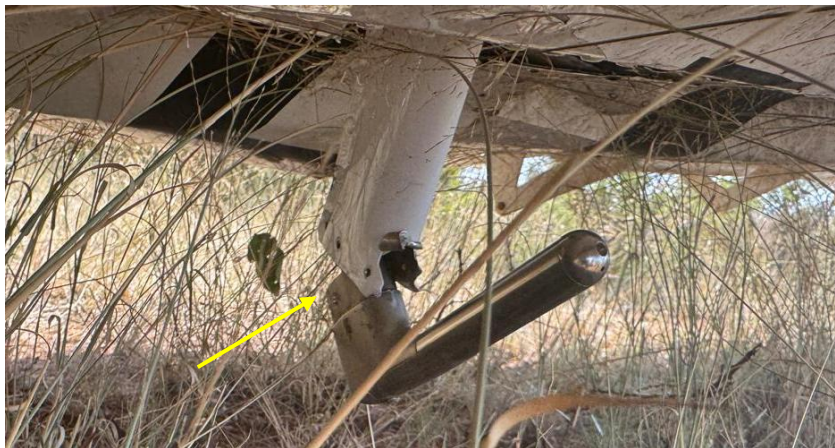
Figure 5: The broken pitot tube.

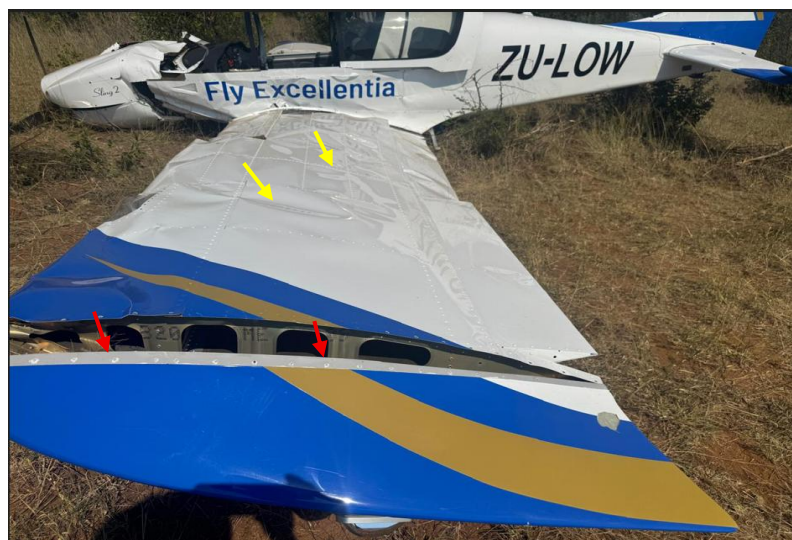
operational. Severe buckling was observed on the top surfaces of the wings. The rivets securing the wing-tip fairings had also sheared off.

Figure 6: Evidence of buckling (yellow arrows) on the left wing and the rivets that sheared off (red arrows), resulting in the separation of the wing fairing.

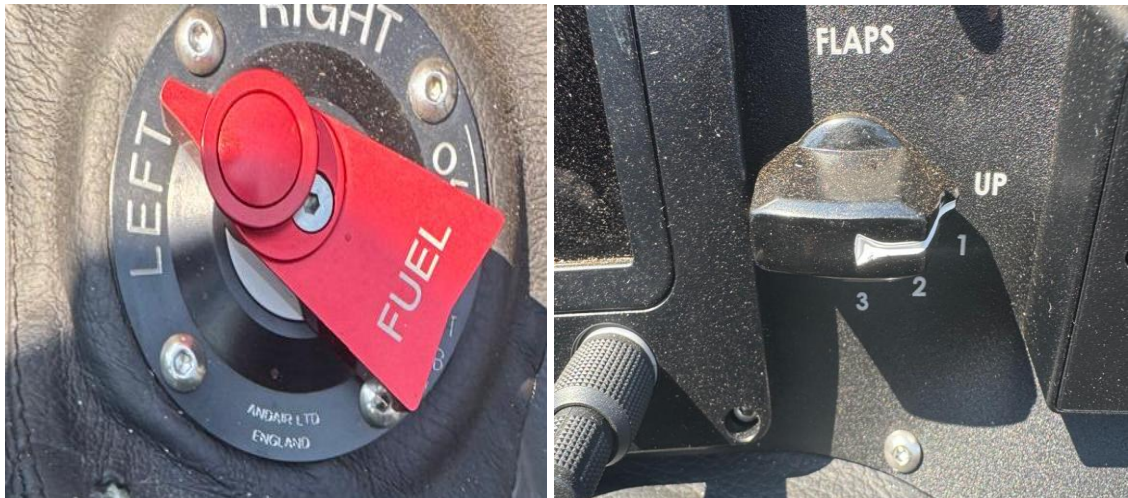
1.12.2 Examination of the cockpit cabin area showed nothing abnormal. None of the circuit breakers popped. The auxiliary fuel pump was in the ON position, and the fuel selector was selected to the left tank. The flaps control switch was in the UP position.

Figures 7 and 8: The fuel selector on the left tank (left picture). The flap control switch in the UP position (right picture).

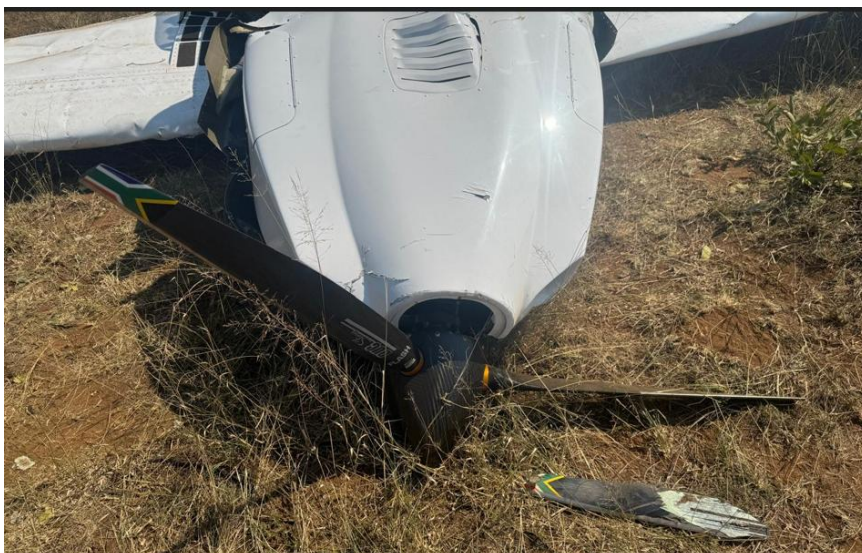
1.12.3 The engine axle partially separated from the firewall. The propeller had remained attached to the flange. Two composite propeller blades also remained intact which indicated that the engine was delivering power at the time of impact. The electronic flight instrument system (EFIS) and the engine control unit (ECU) were recovered by Rotax engineers for further investigation.

Figure 9: The propeller with one broken blade; the other two blades had remained intact.
