PRELIMINARY ACCIDENT REPORT

Accident
- Preliminary Report -
AIID Ref No: CA18/2/3/10569

Reference Number : CA18/2/3/10569
Occurrence Category : Category 1
Type of Operation : Private (Part 94)
Name of Operator : Thabi's Funeral Services and Tombstones CC
Aircraft Registration : ZU-MJM
Aircraft Make and Model : Jabiru J430
Nationality : South African
Place : Levubu residential area, Limpopo Province
Date and Time : 23 March 2025 at 0745Z
Injuries : 3
Damage : Destroyed

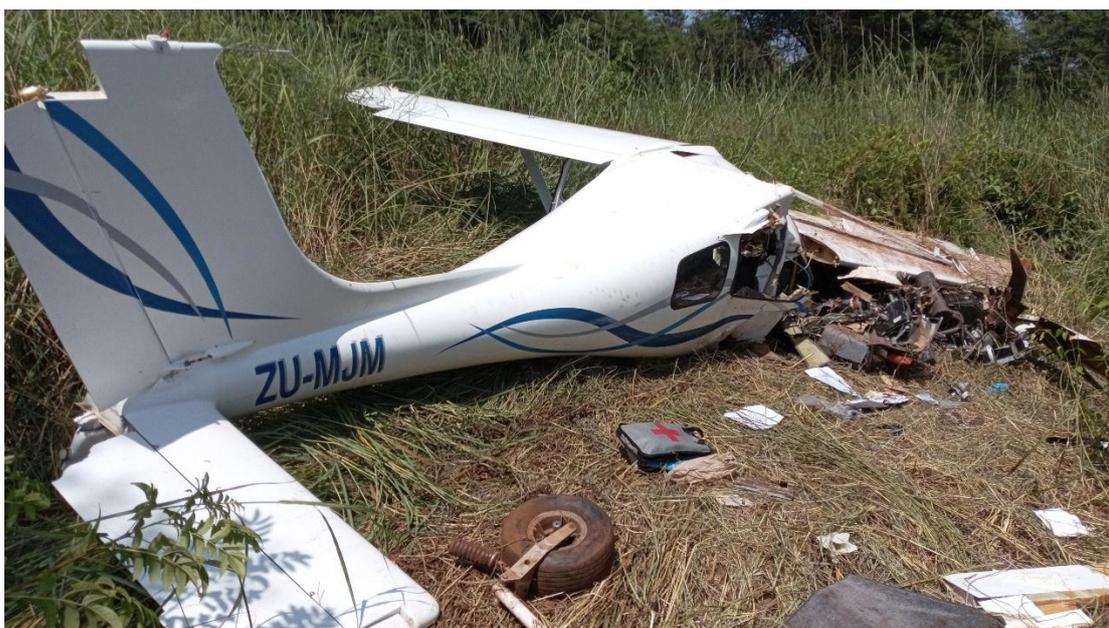
1.3.1 The aircraft was destroyed.

Figure 2: The main aircraft after the accident.

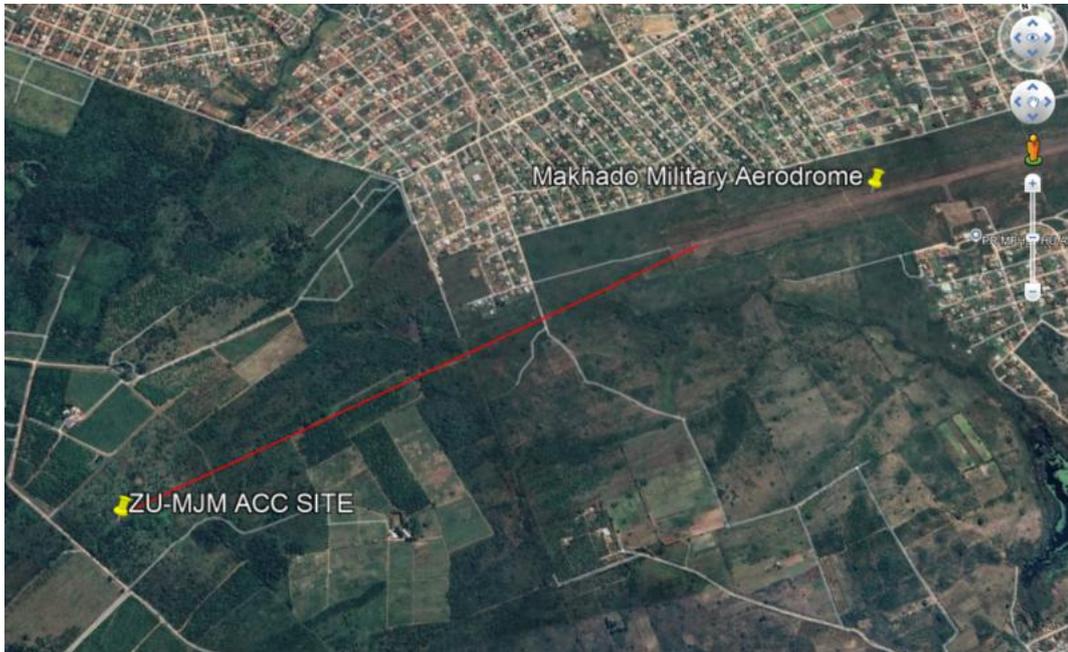
1.10.1. The aircraft crashed on an open field, 1.25nm south-west of FALM RWY 10 threshold. The aircraft could not reach the aerodrome as it had no power.

Figure 3: The aerial view shows FALM and the accident site. (Source: Google Earth)

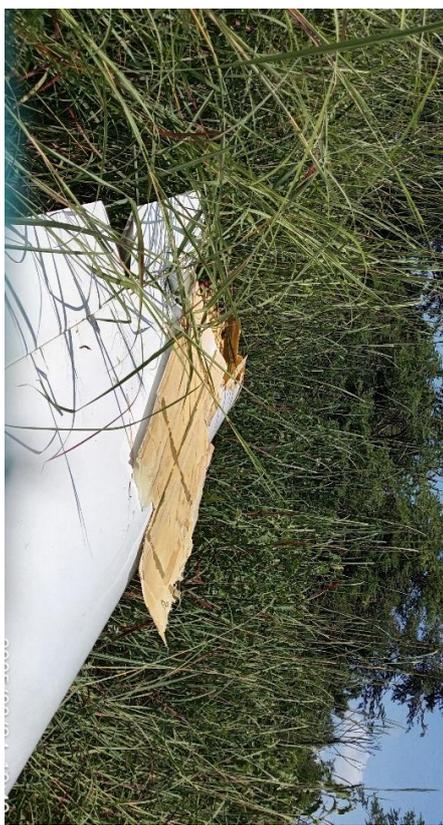
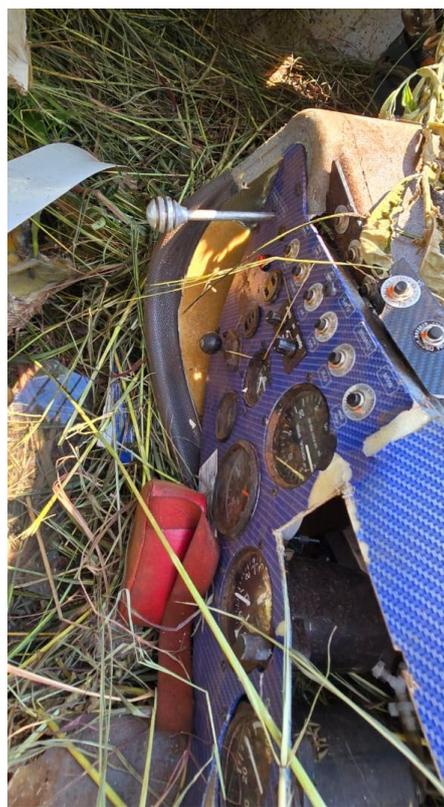
1.12.2. Just before the aircraft touched down, the pilot realised that there was a tree to the left and he banked right to avoid impacting it. The right wing and right main landing gear (MLG) impacted the ground first, and the left-wing tip impacted the tree, followed by the left horizontal stabiliser. The right-side airframe was extensively damaged. The right wing was severed from the root; it was found at the front of the aircraft. The fuel lines were severed and the fuel leaked from them. The front and back passenger doors, as well as the right main landing gear were found ripped off of the aircraft. The engine mounts had broken off and the engine was found near the main fuselage. One of the wooden propellers had broken in half (the severed piece was found slightly further from the main fuselage); the second propeller had snapped backwards (but remained attached).

Figures 4 and 5: The damaged left-wing tip and instrument panel (left). The pulled back power lever (right).

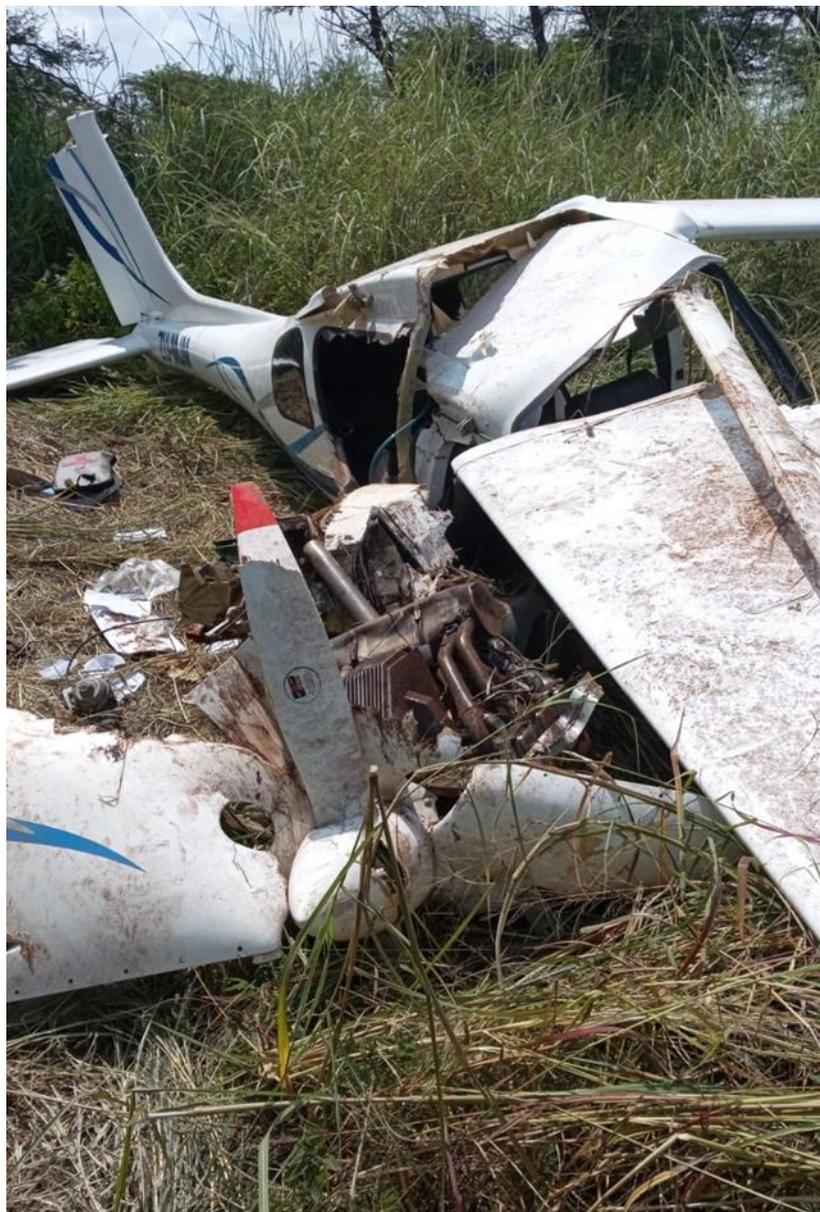
Figure 6: The main fuselage after the accident.

1.12.3. The cabin area sustained serious damage. The windshield was found shattered, the instrument panel was destroyed, and the floor area was deformed after the right MLG collapsed due to impact forces. The safety harnesses were not damaged. The pilot assisted the passengers to disembark from the aircraft and, thereafter, called for help.
