**PRELIMINARY ACCIDENT REPORT**

**Accident and Incident Investigations Division**

Accident  
- Preliminary Report -  
AIID Ref No: CA18/2/3/10381

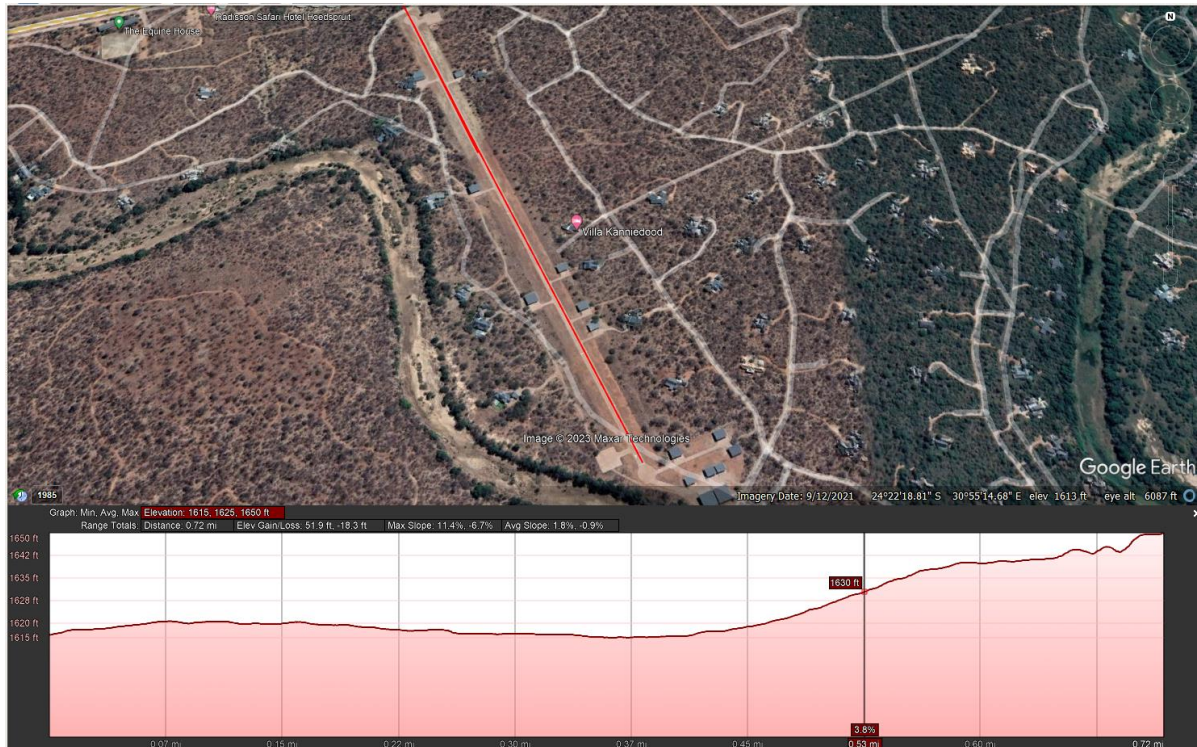
1.1.4 The accident occurred during daylight on Zandspruit Estate private airstrip in Hoedspruit at Global Positioning System (GPS) co-ordinates determined to be 24°22'22.2" South 030°55'55.5" East, at an elevation of 1700ft.

Figure 2: Aerial view of the runway and elevation profile.

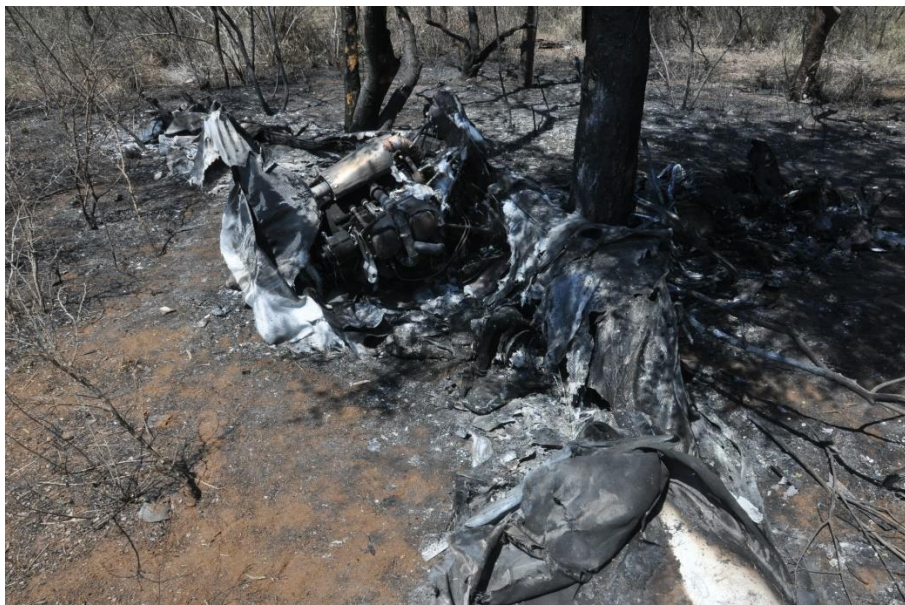
1.3.1 The aircraft was destroyed by impact forces and post-impact fire.

**Figure 3:** The wreckage post-accident.

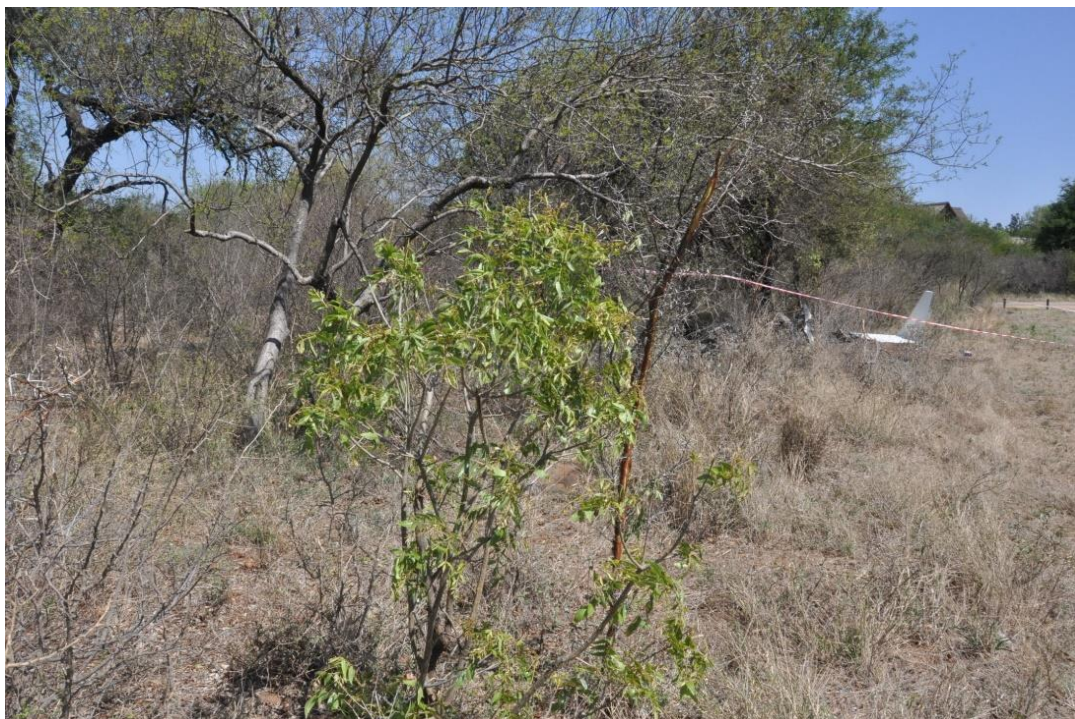
runway. It touched down again on the grass alongside the runaway about 5.8m from the threshold of RWY 17 and impacted small trees which were ranging in height between 1m and 1.77m with its left wing. The aircraft continued on this path and eventually impacted larger trees with its right wing as well as ruptured its right fuel tank; the fuel started the fire which consumed the aircraft. The flight folio and other aircraft documents that are kept in the aircraft were destroyed in the fire.

**Figure 6.** The small trees that the aircraft impacted with its left wing.

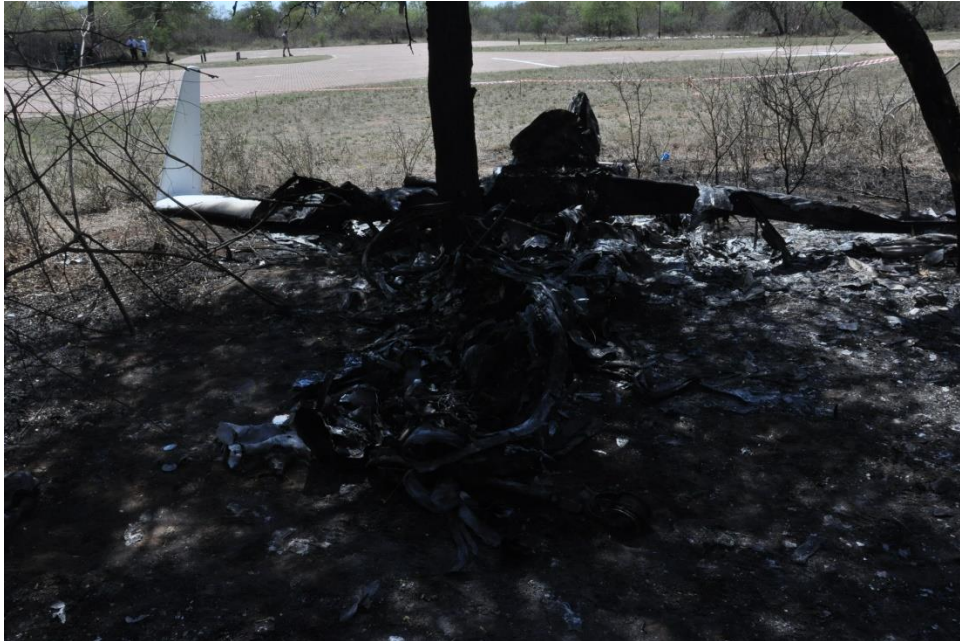
1.12.2 The nose wheel was found extended and did not collapse, the nose gear mechanism was intact, with only damage caused by the fire. The control surface cables were intact and only snapped due to intense heat. The right wing burnt only at the root; the tips did not burn. The engine and the three propeller blades were burnt (the propellers were found in the position they were in when the engine stopped). The cockpit area was also burnt.

**Figure 7:** The burnt aircraft.

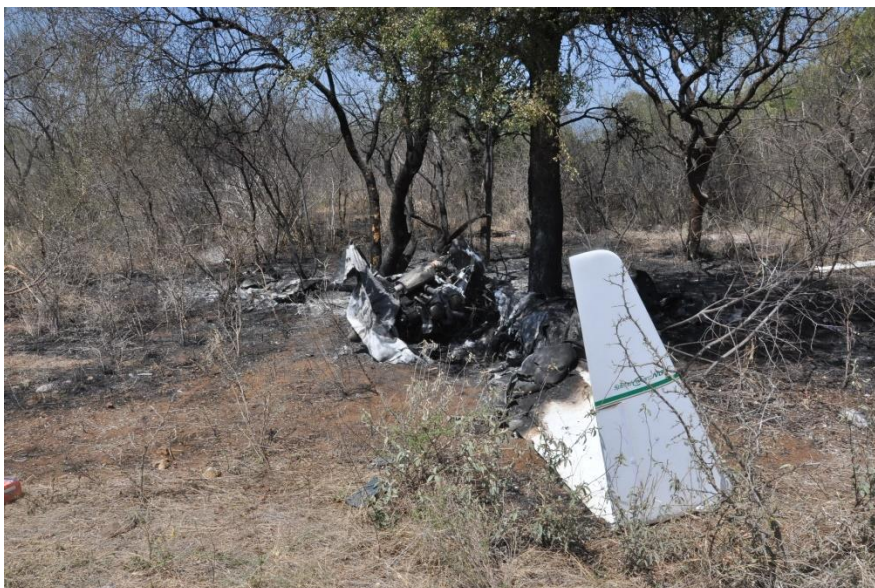
1.15.1 The accident was not survivable because the aircraft careered through the trees with the fuel tank that ruptured in the accident sequence, and thus, the fuel started the fire.

**Figure 8:** The wreckage after the accident.
