**PRELIMINARY ACCIDENT REPORT**

**Accident and Incident Investigations Division**

Accident  
- Preliminary Report -  
AIID Ref No: CA18/2/3/10607

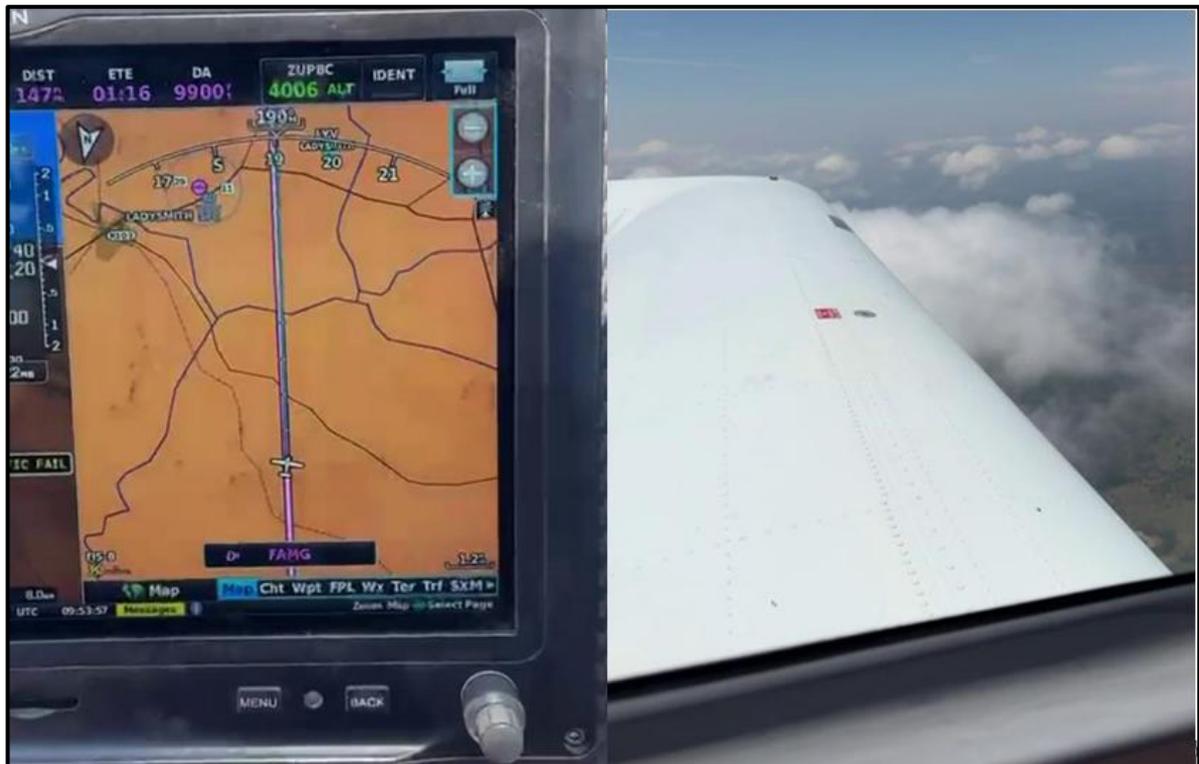
1.1.2. According to the operator, the pilot had planned the private navigational flight earlier on the same week. However, the intended flight (a hire-and-fly arrangement) was postponed due to prevailing unfavourable weather conditions along the route. Hence, the pilot continued to monitor meteorological updates using an electronic weather service application to find a suitable weather window for a safe flight operation. A day before the accident on 14 October 2025, the pilot underwent an aircraft differences training and was signed off with the aircraft type endorsed on his pilot logbook. After the differences training, he conducted post-flight checks as well as reviewed the latest weather information, which he discussed with his friends. The pilot's planned route included a return segment from FAMG to FASC which was to be undertaken in the company of either a chief flight instructor (CFI) or an accountable manager (AM) from the same approved training organisation (ATO) at which the aircraft was hired. Both individuals were already at FAMG at the time. On 15 October 2025 at approximately 0900Z, the pilot performed a pre-flight inspection of the aircraft at FASC and did not find anomalies; the aircraft was deemed airworthy. Later, the pilot departed for FAMG under visual meteorological conditions (VMC) and was followed by ZU-PBD, another aircraft from the same ATO that was also en route to FAMG. During the flight whilst abeam Ladysmith, the pilot took a video of the cockpit instruments and a photo of the outside cloud conditions which he sent to the CFI, indicating that the aircraft was flying safely (see Figure 3).

**Figure 3:** The snapshot of the video and the picture taken by the pilot. (Operator)

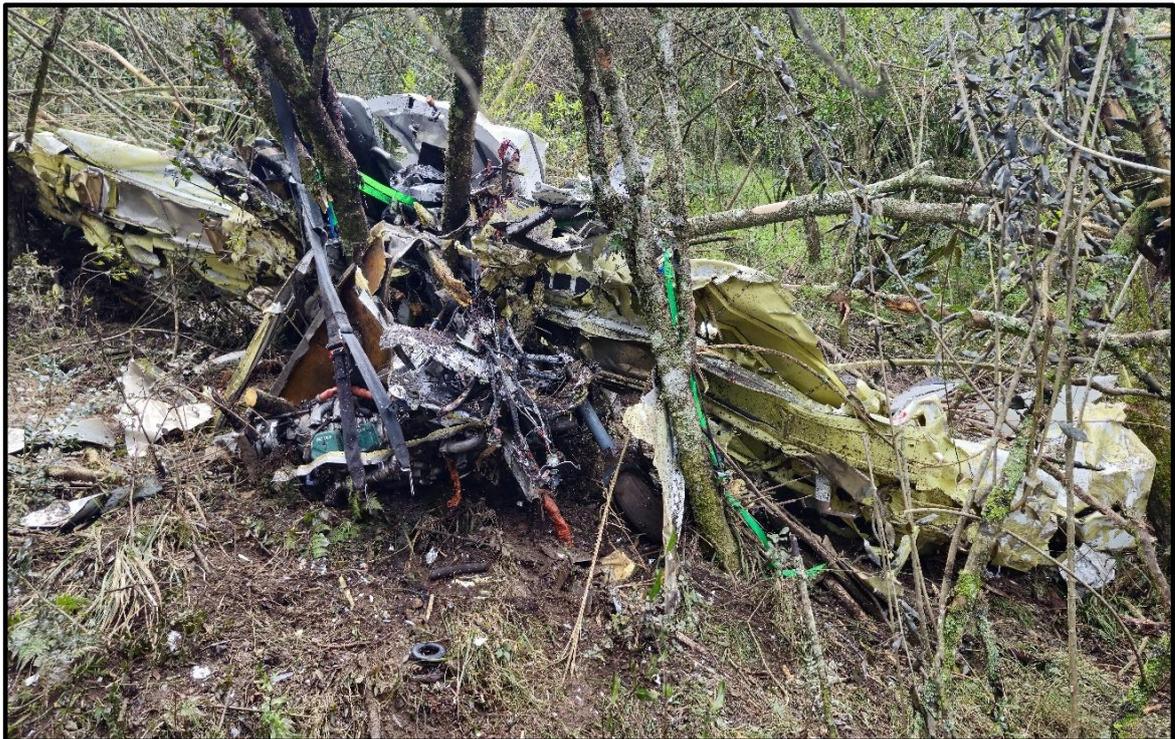
1.3.1. The aircraft was destroyed during the accident sequence.

**Figure 4:** The wreckage at the accident site.

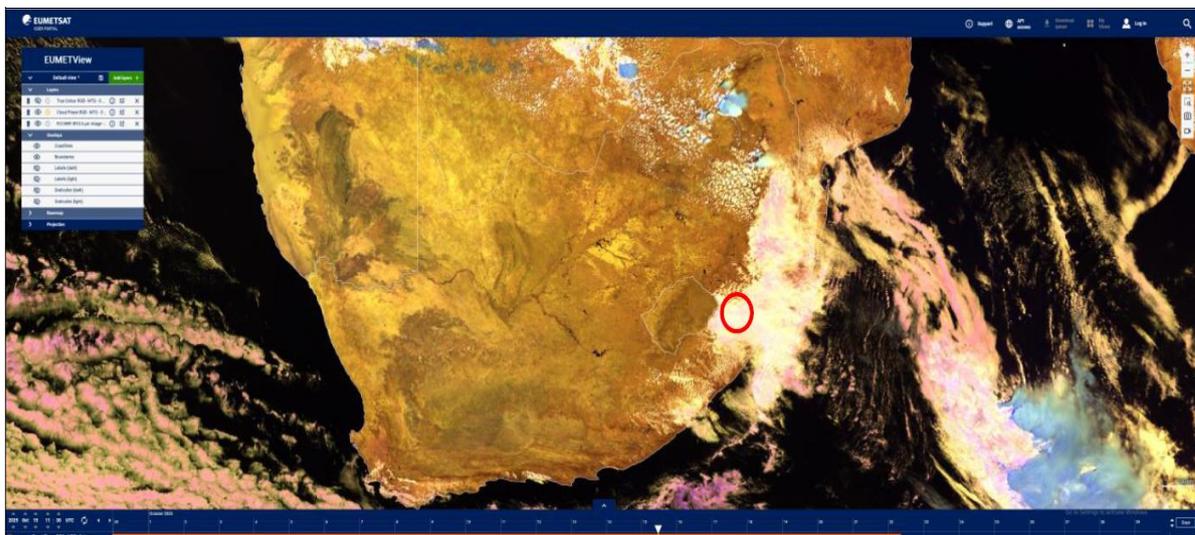
Figure 5 below is a satellite image of the Cloud Phase RGB of the Meteosat Third Generation (MTG) prior to and after the accident. The satellite image shows clear skies between FASC and the north-western parts of KwaZulu-Natal; the presents of low clouds is indicated by the pinkish colour on the image. The low clouds are present in the vicinity of the accident, which is marked in a red circle.

**Figure 5:** RGB Cloud Phase satellite image before and after the time. (Source: SAWS)

*Based on the forecast and observed data, it is evident that low cloud, mist and drizzle were present in the vicinity of the accident, resulting in the reduction of visibility to approximately 4500m. The satellite imagery confirmed the presence of extensive low cloud caused by the advection of moisture from the ocean observed on the FAPM METARs. The Cedara automated weather station (AWS) recorded high humidity, favourable for mist formation which may result in reduced visibility, as forecasted in the significant weather charts. The airman’s meteorological information (AIRMET) warnings for low cloud, mountain obscuration, reduced visibility and severe turbulence between 6500 ft and 10 000 ft were valid during the accident period. In summary, the weather conditions in the vicinity of the accident were not favourable for visual flight rules (VFR) conditions.*

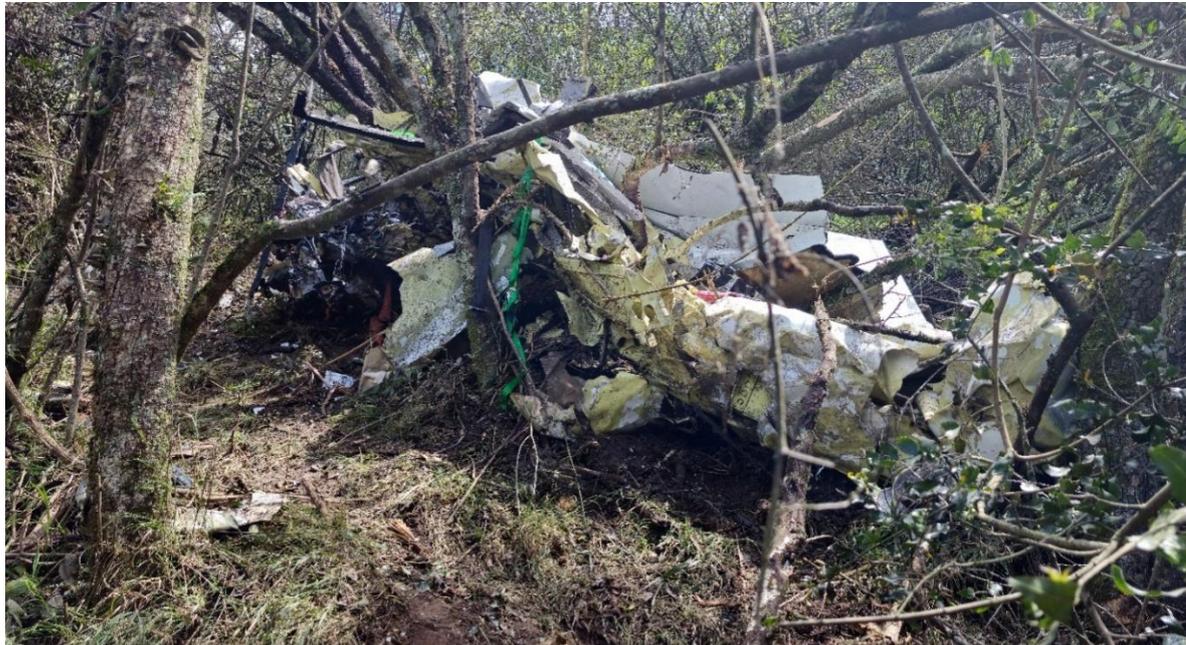
**Figure 6:** The wreckage as it was found at the accident site.

1.12.2. The cockpit section was destroyed (see Figure 6). Fragments of the glass canopy were found on trees in the vicinity, indicative of an object that disintegrated and flung out in the direction of impact.

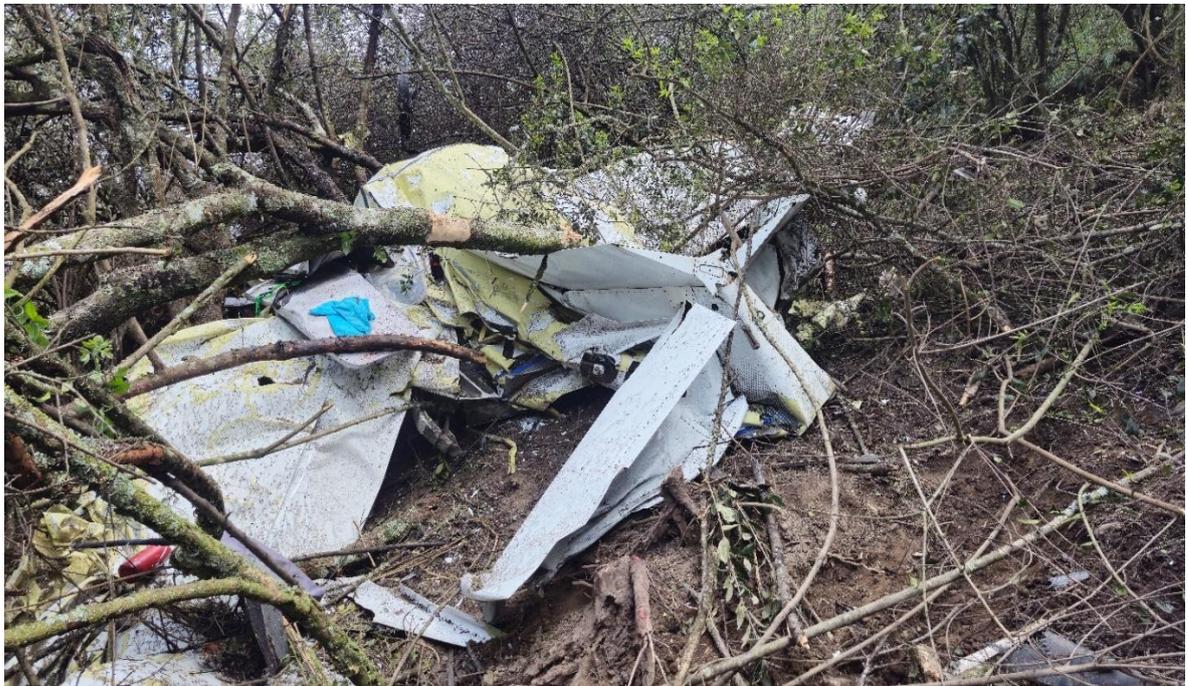
**Figure 7:** The rear view of the wreckage.

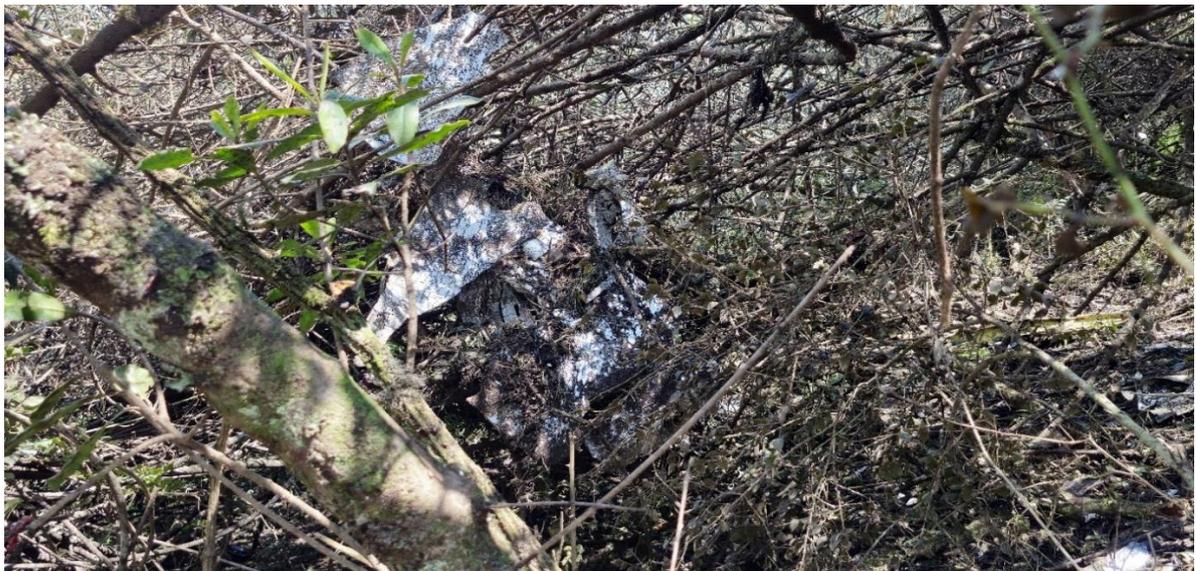
1.12.1. The accident occurred on a mountainous terrain with dense thick bushes. The aircraft impacted a high-rise terrain and bushes at a slightly low-nose attitude. The wreckage distribution was contained in a confined space due to the surrounding thick bush which trapped the wreckage fragments (see Figure 8).

**Figure 8:** Fragments of the wreckage caught in the surrounding trees.
