PRELIMINARY ACCIDENT REPORT

Accident and Incident Investigations Division

Accident
- Preliminary Report -
AIID Ref No: CA18/2/3/10608

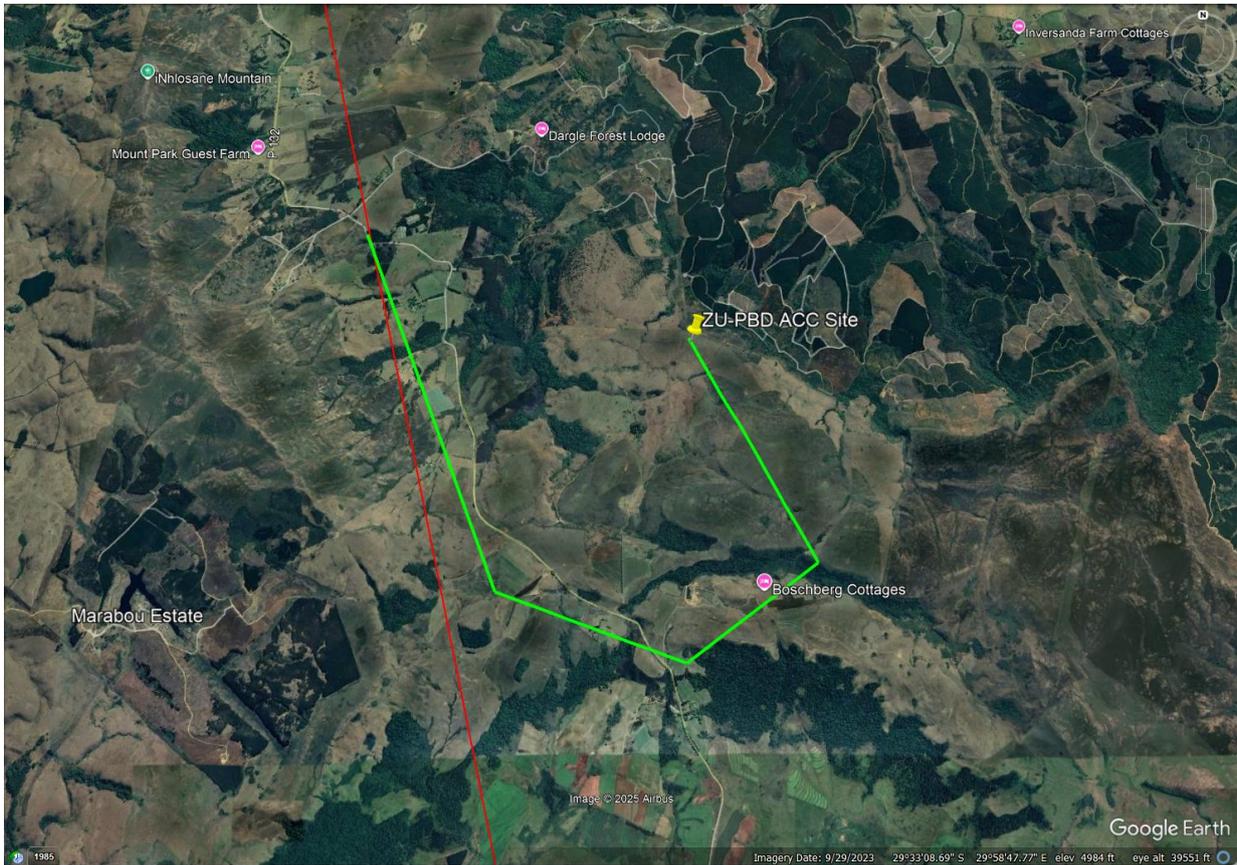
- 1.1.6. The accident occurred 6.2 nautical miles (nm) north-west of Boston in instrument meteorological conditions (IMC) at Global Positioning System (GPS) co-ordinates determined to be 29°34'13.19" South 030°0'49.31" East, at an elevation of 4924 feet (ft).

Figure 2: The accident site of ZU-PBD (red line: intended track; green line: projected track).
(Source: Google Earth)

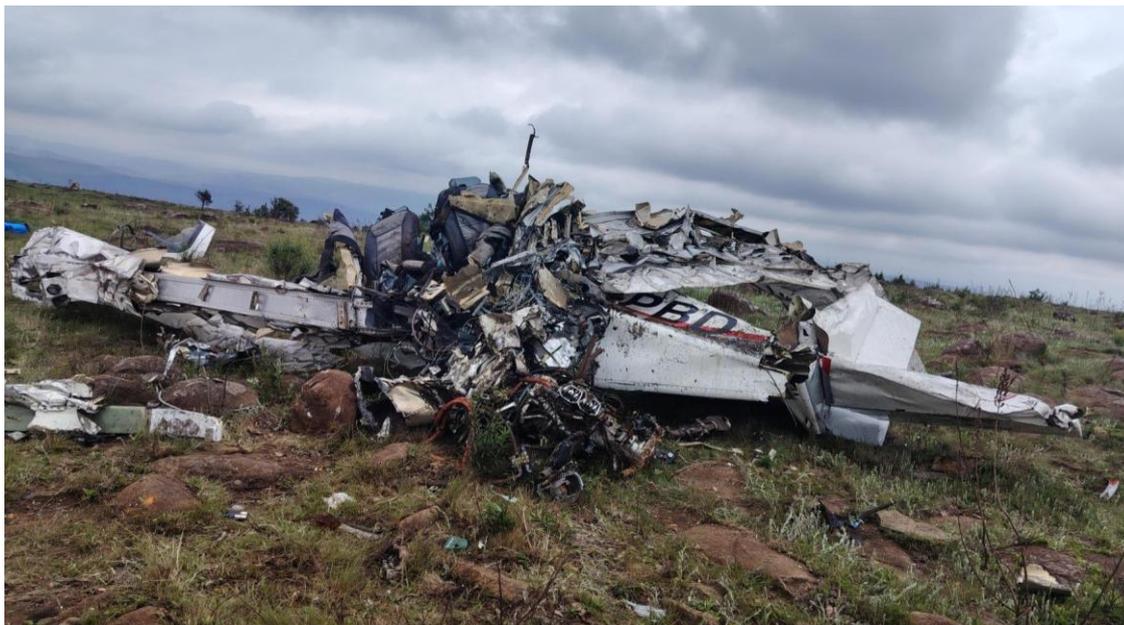
Figure 3: The wreckage of ZU-PBD.

1.3.1. The aircraft was destroyed.

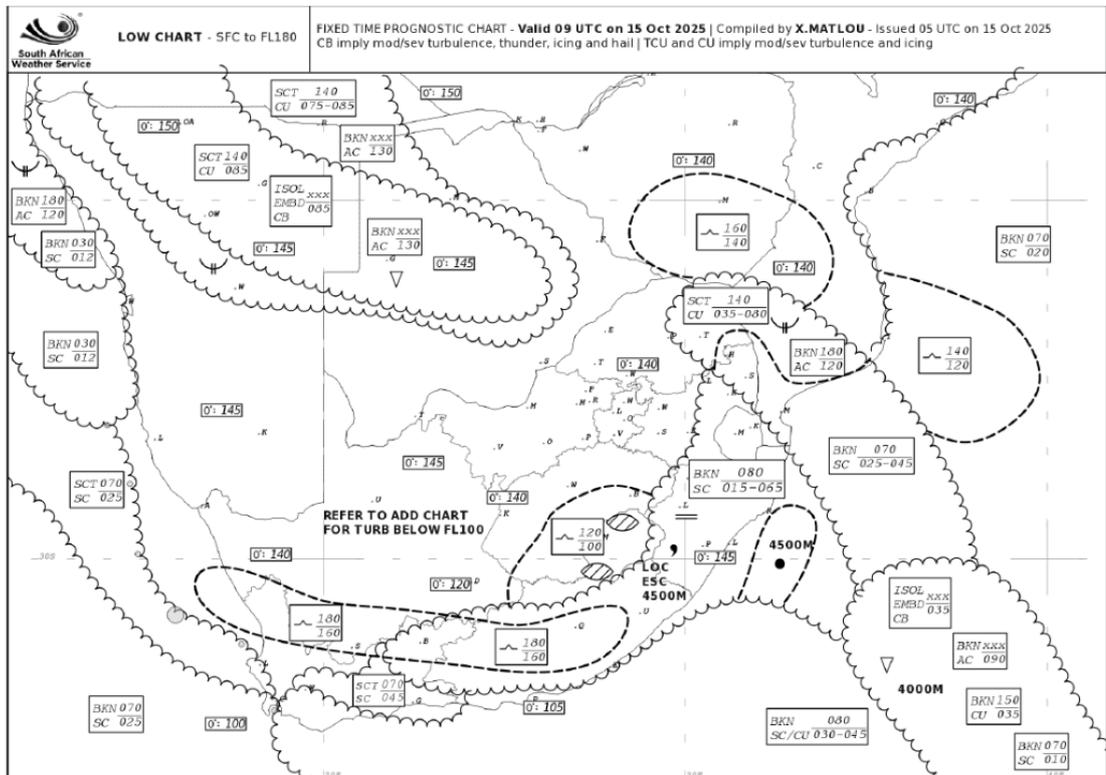
Figure 5 shows the low-level chart valid for 15 October 2025 at 0900Z. Although the chart was valid for 0900Z, forecasters accommodate forecasts between 0900Z and 1200Z. Figure 5 shows a significant reduction in visibility to 4500m with drizzle and mist in the mountainous terrain escarpment (ESC) of KwaZulu-Natal; therefore, the forecast was for instrument meteorological conditions (IMC).

Figure 5: Low-level significant weather chart valid for 15 October 2025 at 0900Z. (Source SAWS)

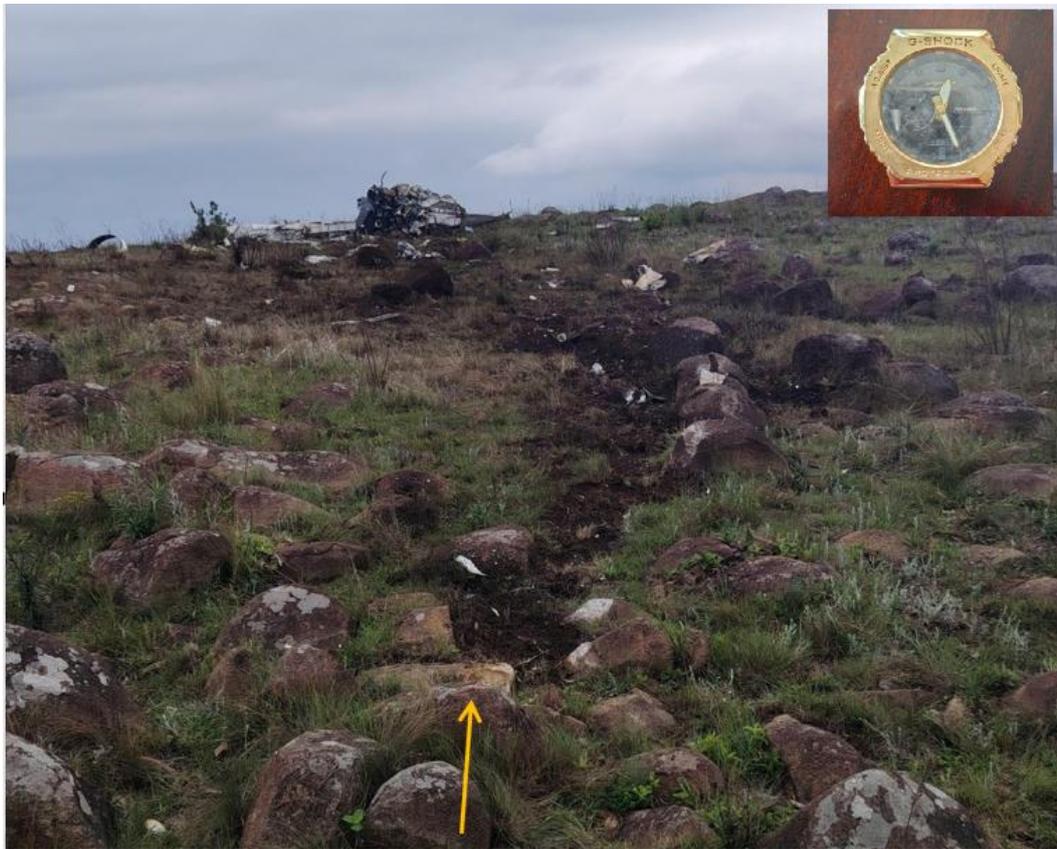
1.12.1. The accident occurred at 1020Z on a rocky terrain within a private farm in the Midlands, KwaZulu-Natal. Evidence at the site suggested that the aircraft impacted the ground with the left-wing down first at an approximate angle of 30 degrees. It then struck the ground with the nose, impacting and displacing large rocks as it tumbled over the rugged landscape. The sequence is indicative of a high-energy impact. The wreckage trail was saturated with spilled fuel and oil.

Figure 6: Initial impact on the ground; the yellow arrow indicates the direction of the aircraft. The inset shows the pilot's watch with the possible time of impact.

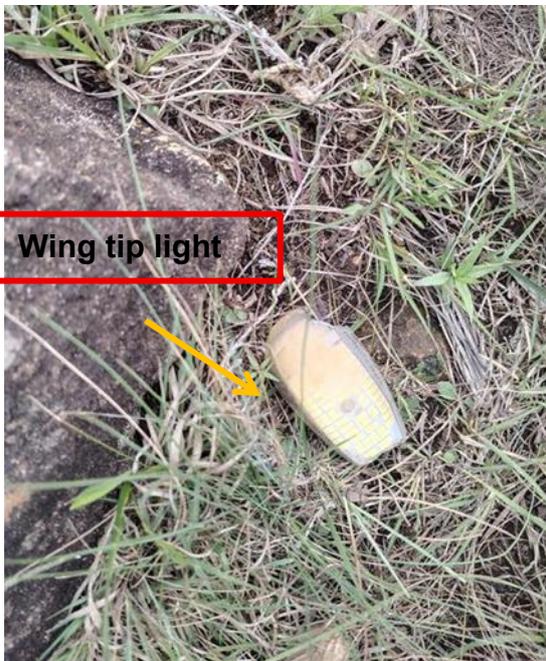
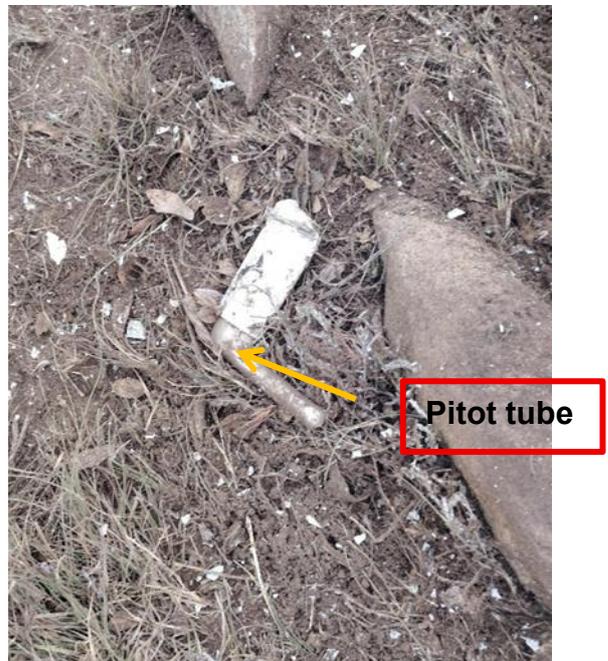
Figures 7 and 8: Wing-tip light and the pitot tube found at the initial impact point.

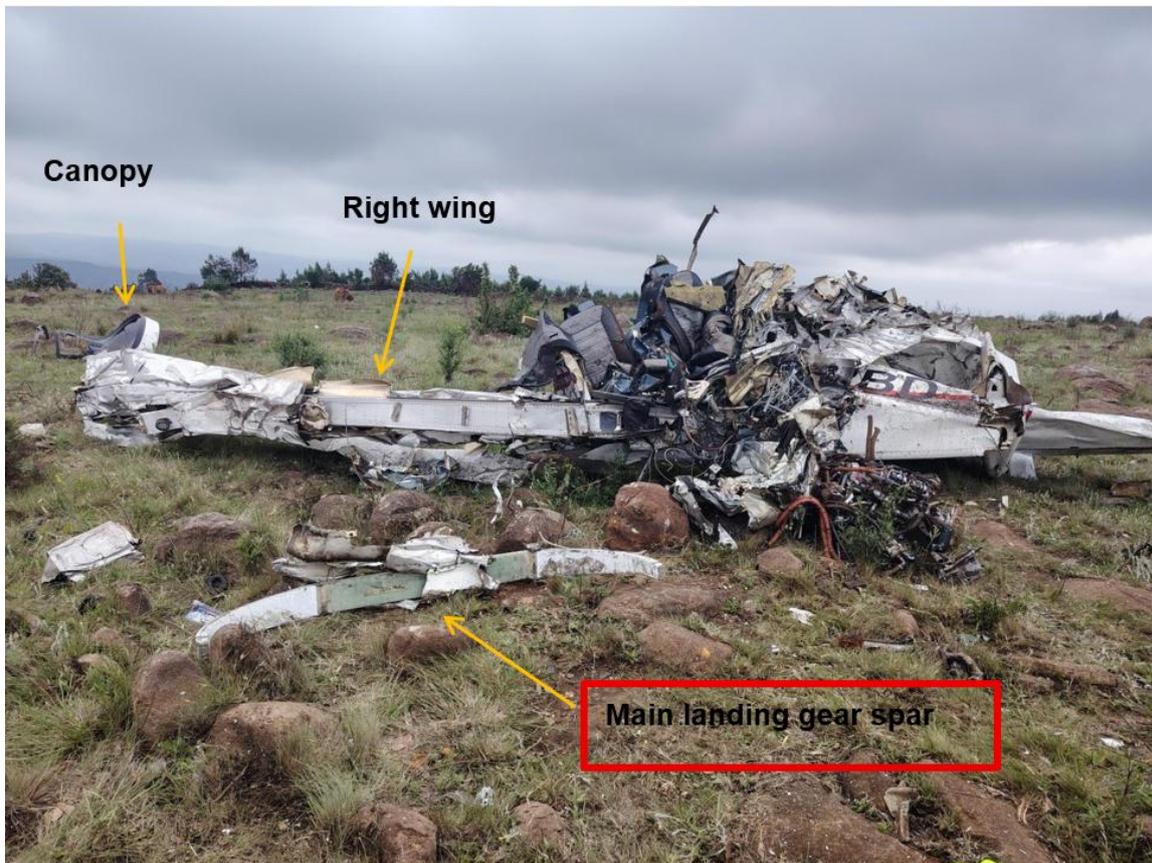
1.12.2. The left wing was found curled around the fuselage, indicating significant structural deformation. The right wing had remained in its original position but sustained extensive damage.

Figure 9: The main wreckage with the detached canopy and main landing gear frame.

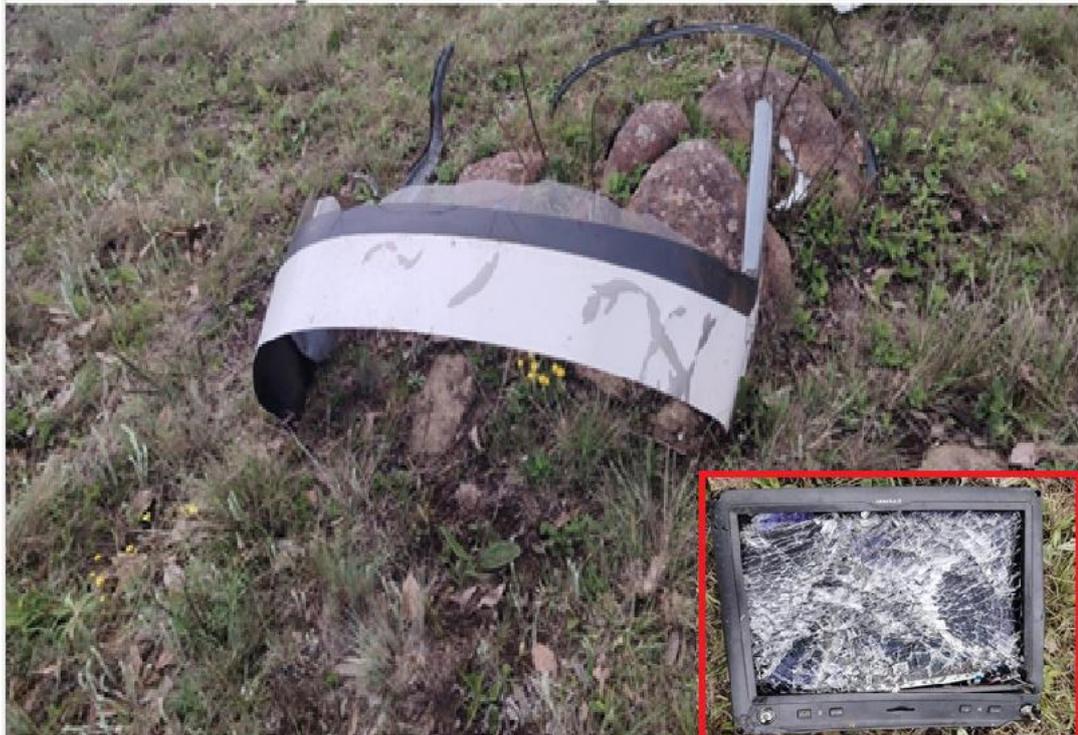
1.12.4. The canopy separated from the main airframe; it was located approximately 10m from the wreckage. The glass top of the canopy was found broken with traces of damage sustained during the impact sequence. The engine sustained impact damage, and the cylinders and mount bracket were found detached from the main airframe. The EFIS screen had broken off from the instrument panel and was shattered; the data card was not recovered. The three wheels of the aircraft were not found at the site, and the main landing gear frame had separated from the airframe.

Figure 11: The canopy that separated from the fuselage.
