PRELIMINARY ACCIDENT REPORT

Accident
- Preliminary Report -
AIID Ref No: CA18/2/3/10246

Figure 1: The Sling 4 TSi aircraft, ZU-PPA.
(Source: <https://www.avcom.co.za/phpBB3/viewtopic.php?t=225496>)

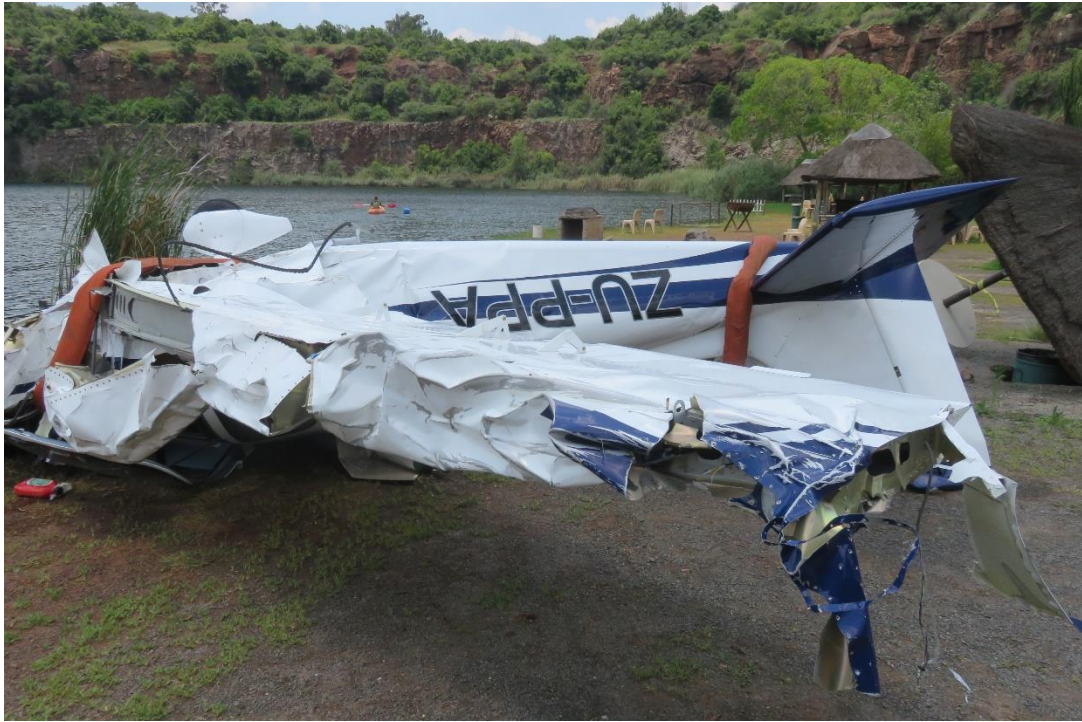
1.3.1 The aircraft was destroyed during impact with the water.

Figure 3: The main wreckage after it was recovered from the lake.

- 1.12.2 The wreckage was floated with the assistance of several divers and was very slowly towed to the shore with a boat from where it was lifted out of the water with the assistance of a mobile crane. Initial observations indicate severe deformation of the engine and nose section as well as the right wing of the aircraft. The three propeller blades were severed near the spinner, which is indicative of an engine that was producing power on impact. Aircraft integrity was not compromised and all flight controls were accounted for.

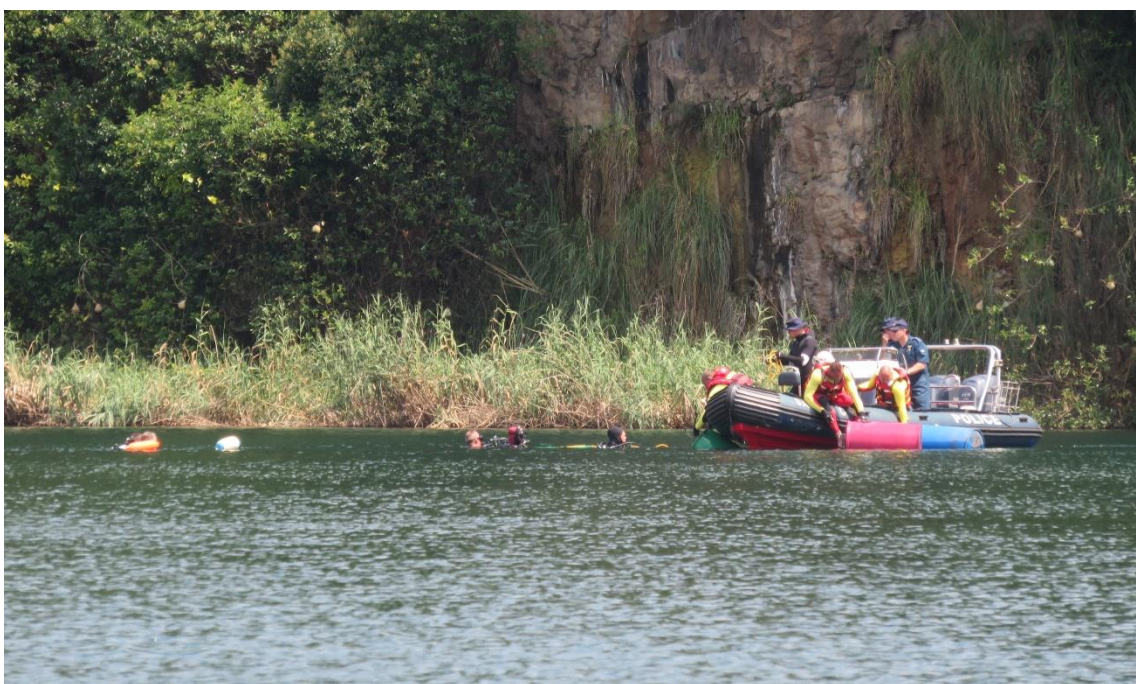
Figure 4: Police boat with several divers in the water during the process to float the wreckage.

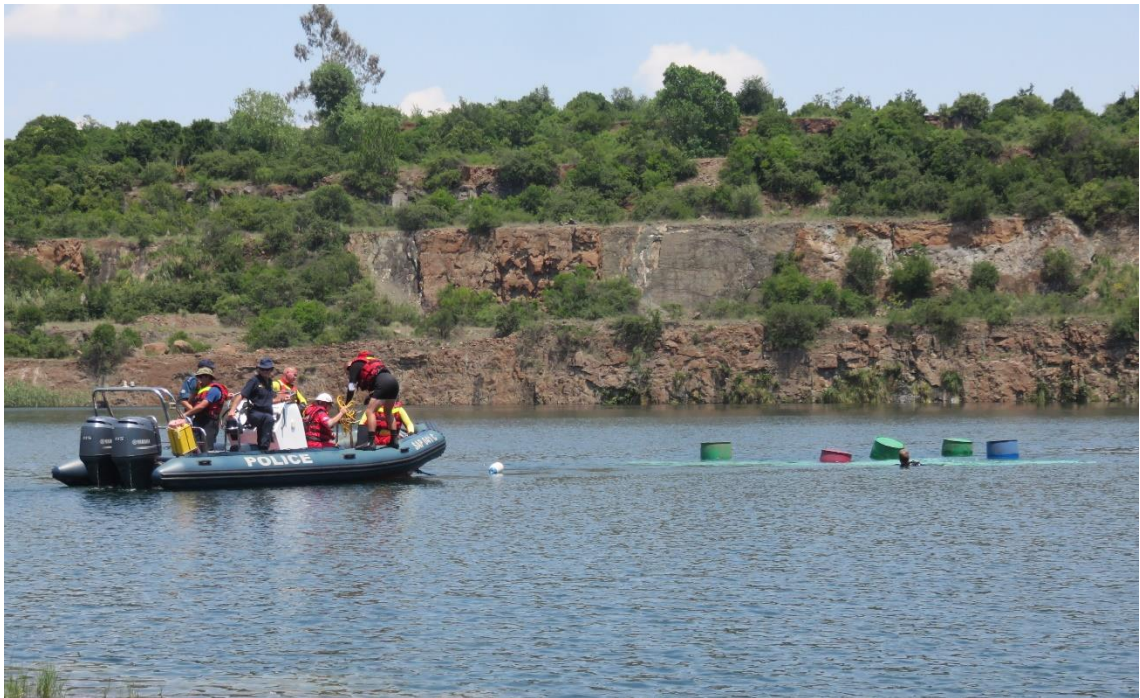
Figure 5: Police boat slowly towing the wreckage to shore.

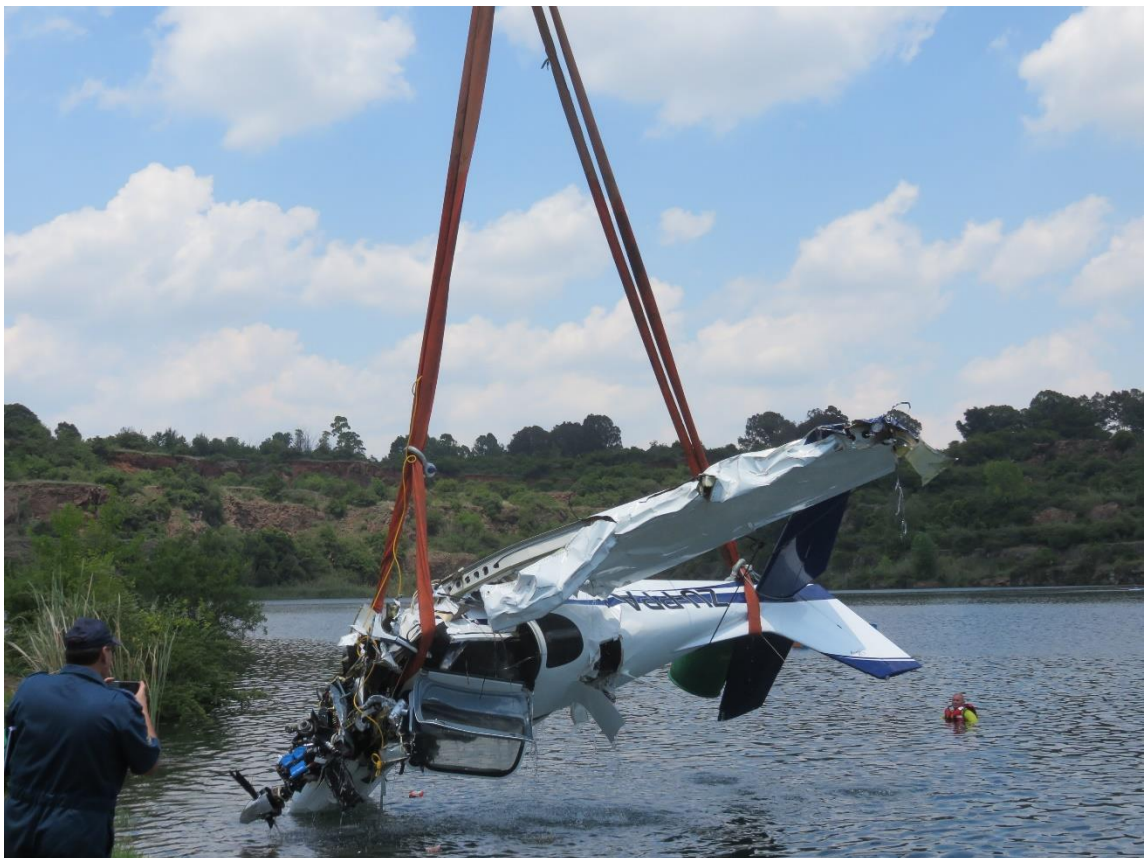
Figure 6: Wreckage being lifted from the water by a crane.

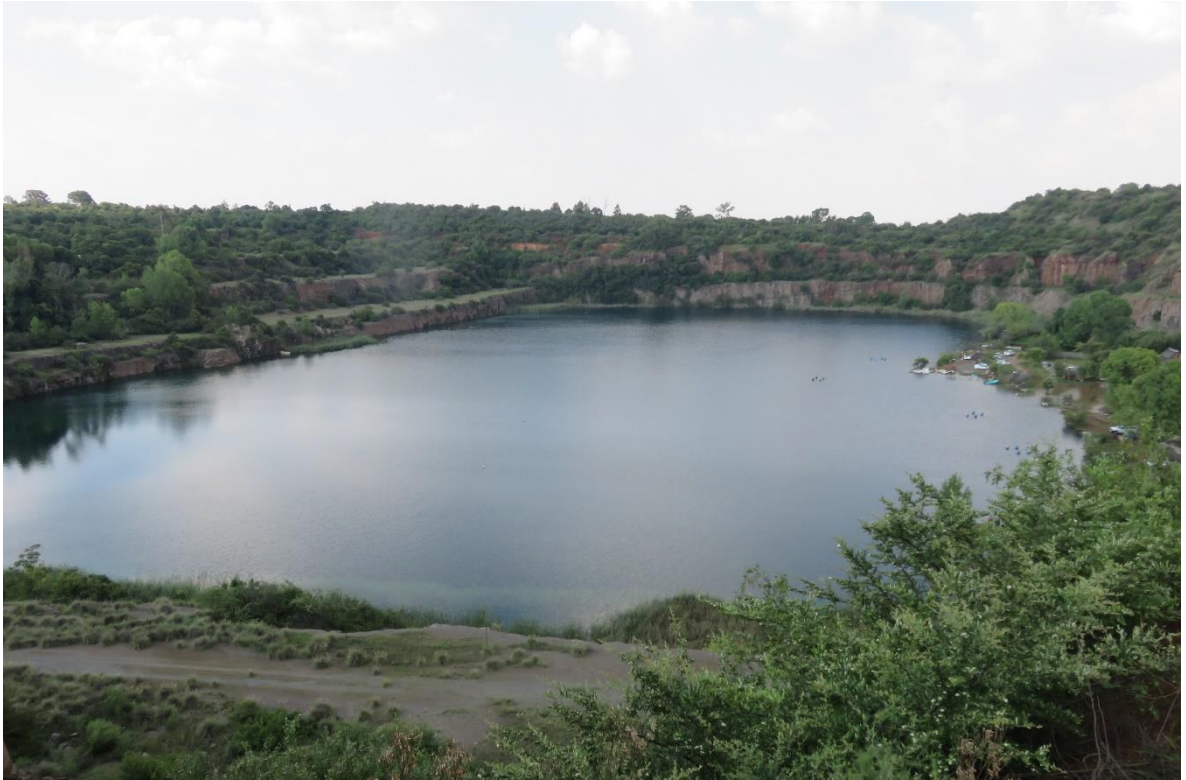
Bass Lake is a flooded Dolomite quarry, with a 10-hectare surface area. It has been used for more than 30 years as an outdoor recreational facility where people engage in water sport, freshwater fishing, scuba diving and camping.

Figure 7: A view of Bass Lake taken looking in a northerly direction.

- 4.1 It is recommended to the Director of Civil Aviation that Bass Lake area be declared a Restricted or Prohibited area, which ever be applicable. This is a confined area where people enjoy all kinds of water sport and fishing. It also surrounded by mining activity and other quarries.
