PRELIMINARY ACCIDENT REPORT

Accident and Incident Investigations Division

Accident
- Preliminary Report -
AIID Ref No: CA18/2/3/10611

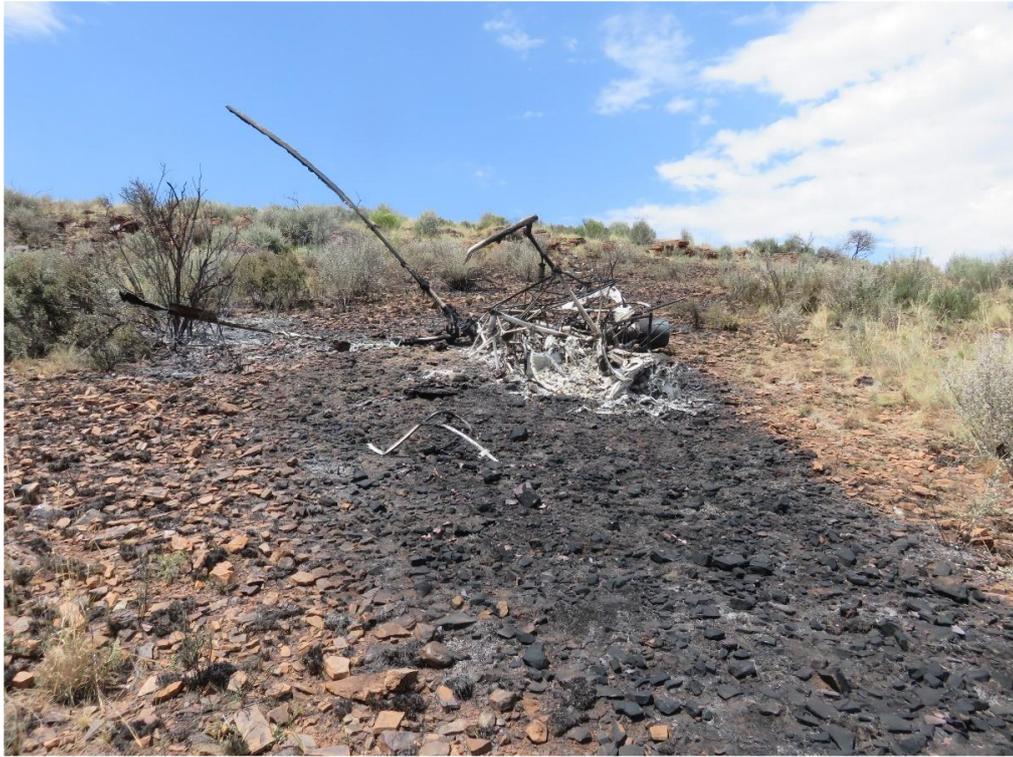
- 1.3.1 The helicopter was destroyed by a post-impact fuel-fed fire that erupted during the accident sequence.

Figure 3: The wreckage of ZU-RAL.

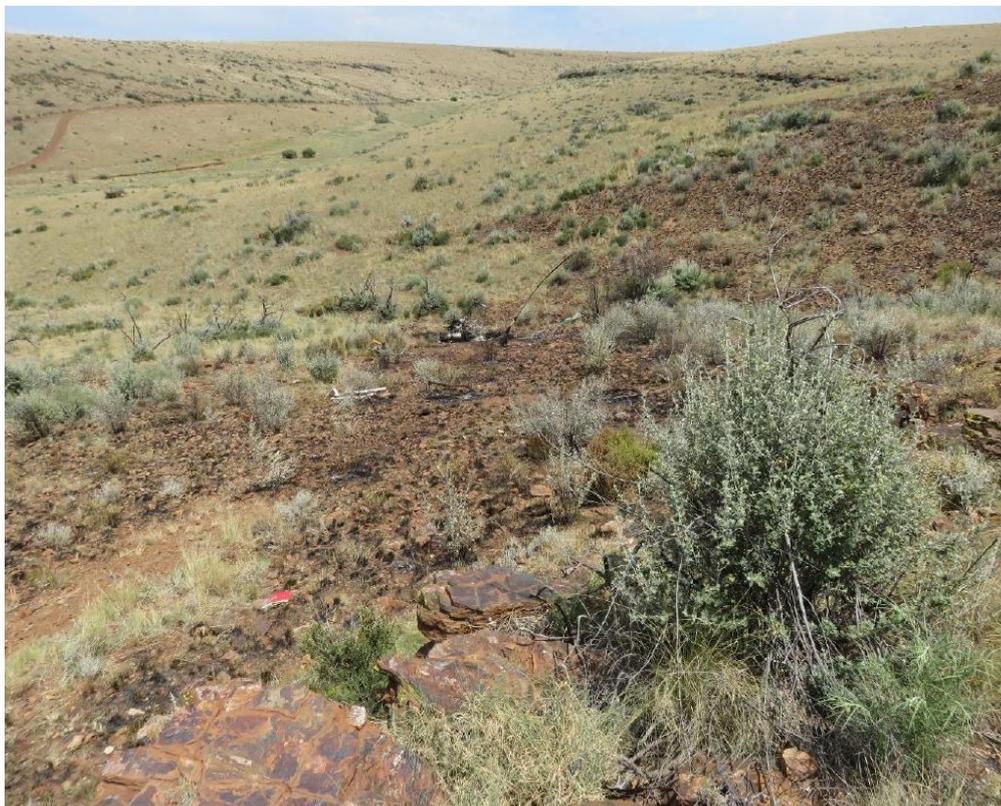
1.12.1 The helicopter struck vegetation on the top of a mountainous terrain and careered down a ravine; it came to rest on its right side. The aft section of the tail boom, with the tail rotor assembly still attached, broke off on impact and was not damaged by the post-impact fire. The cabin and centre section were consumed by the fire. The engine, main rotor gearbox, main rotor driveshaft and head assembly were heavily scored. The three main rotor blades were still attached to the main rotor, with all three blades displaying evidence of bending. Two of the three blade tips broke off but were accounted for at the accident site; the third blade tip was still attached to its blade. The outer section of one of the tail rotor blades was severed (see Figure 6) and was not located.

Figure 4: The wreckage and accident site.

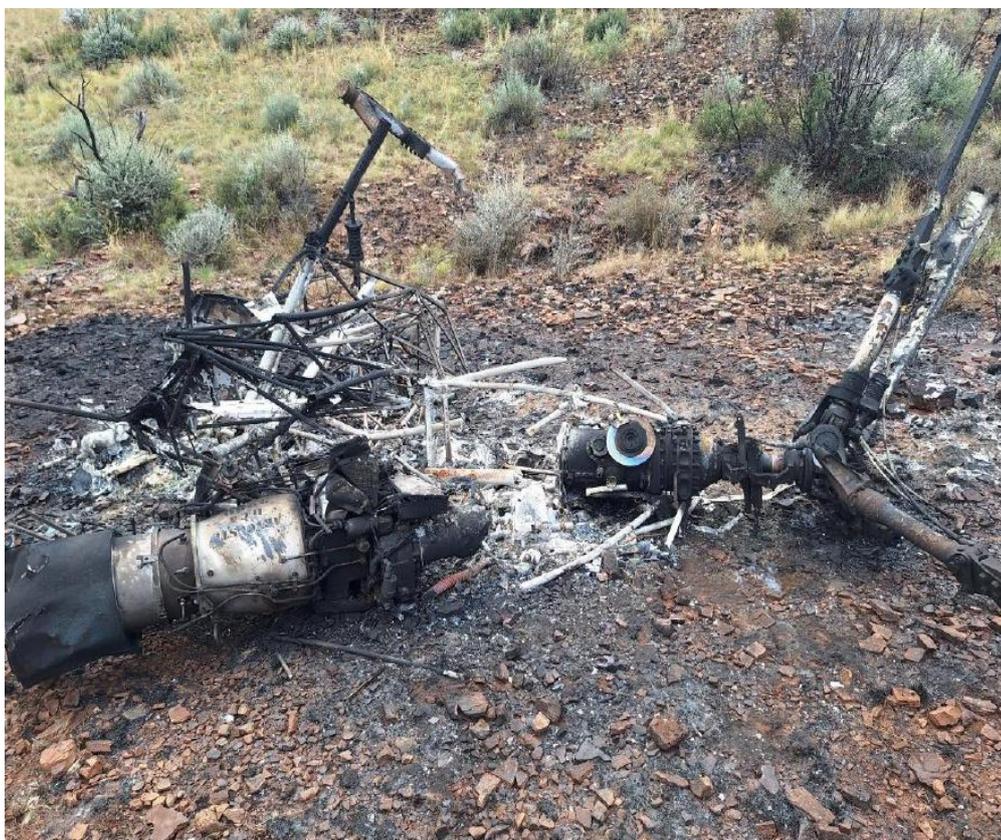
Figure 5: The wreckage after the fire was put out.

1.14.1 A post-impact fuel-fed fire consumed the helicopter and set the veld alight.

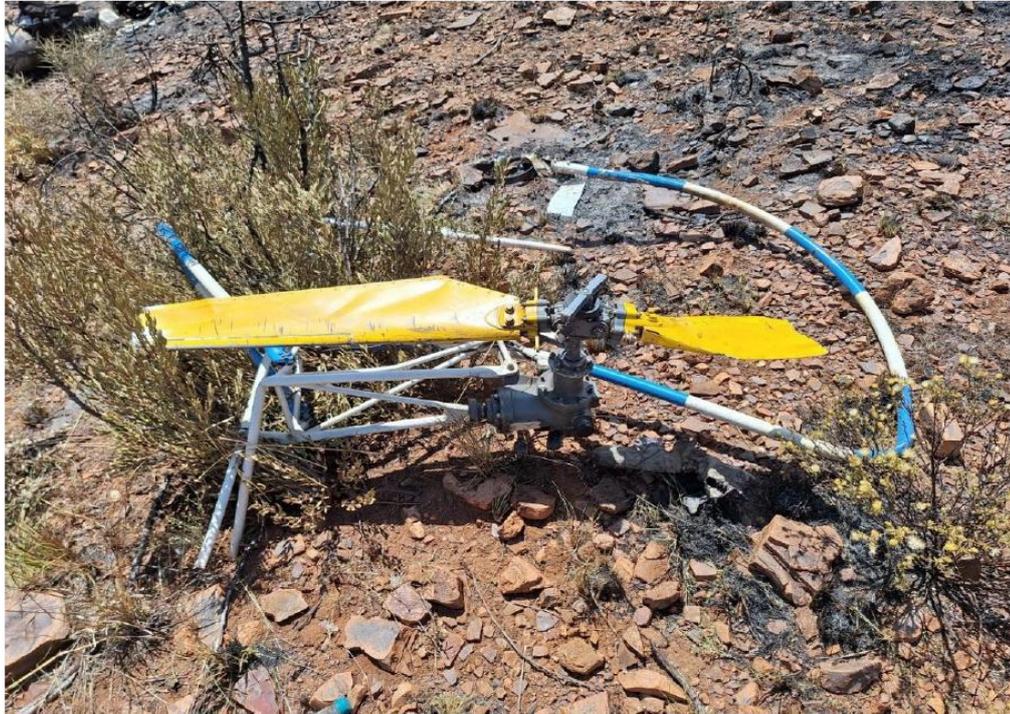
Figure 6: The aft tail boom with the tail rotor assembly still attached.
