PRELIMINARY ACCIDENT REPORT

Accident  
- Preliminary Report -  
AIID Ref No: CA18/2/3/10169

<b>Aircraft Make and Model</b>	: SE3160 Alouette III
<b>Aircraft Registration</b>	: ZU-RFE
<b>Damage</b>	: Substantial
<b>Date and Time</b>	: 5 June 2022 at 1550Z
<b>Injuries</b>	: 1
<b>Name of Operator</b>	: CKTET Charter (PTRY) Ltd
<b>Nationality</b>	: South African
<b>Occurrence Category</b>	: Category 1
<b>Place</b>	: Boipatong, near Vanderbijlpark, Gauteng Province
<b>Reference Number</b>	: CA18/2/3/10169
<b>Registration Marks</b>	: ZU-RFE
<b>Type of Operation</b>	: Private (Part 94)

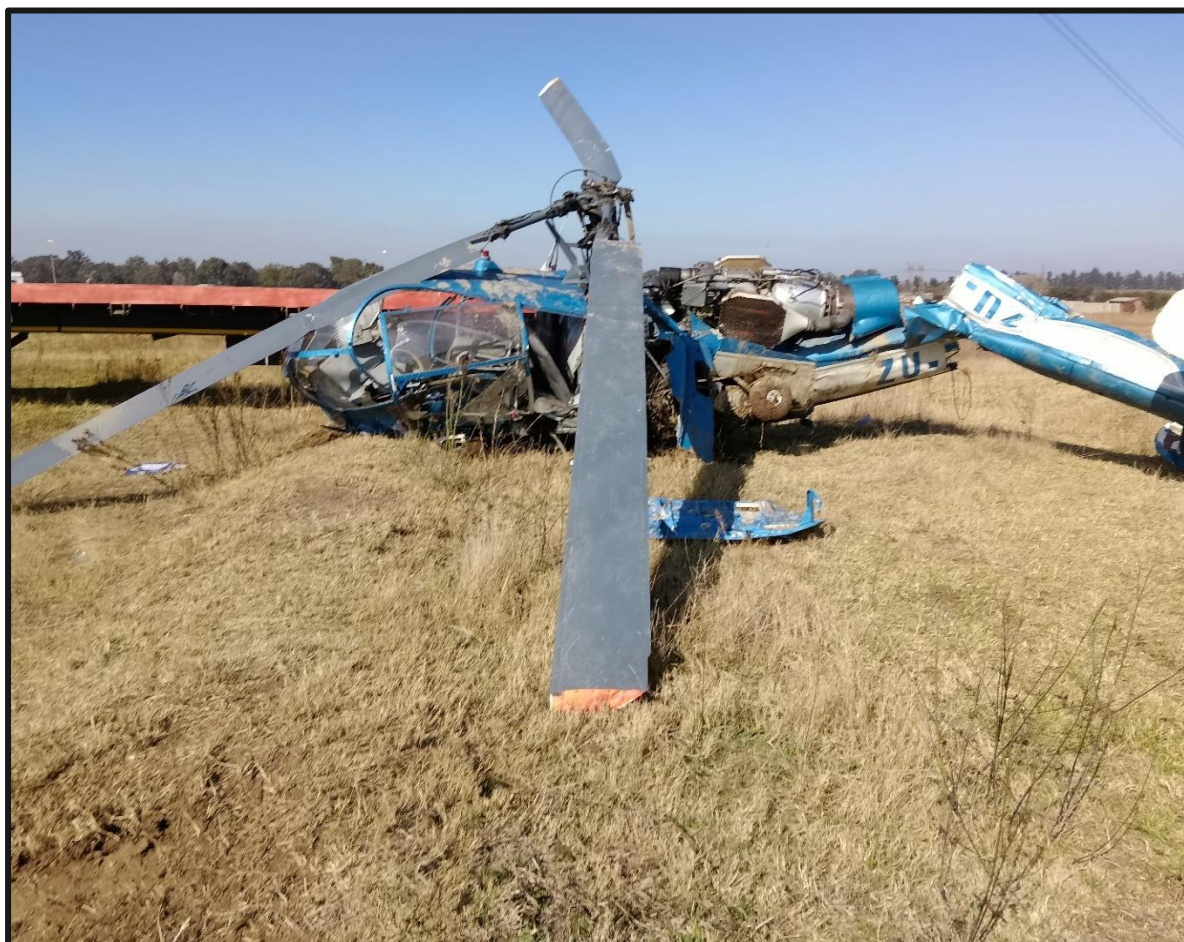
1.3.1. The helicopter was substantially damaged during the accident sequence.

**Figure 4:** The helicopter after it was recovered.

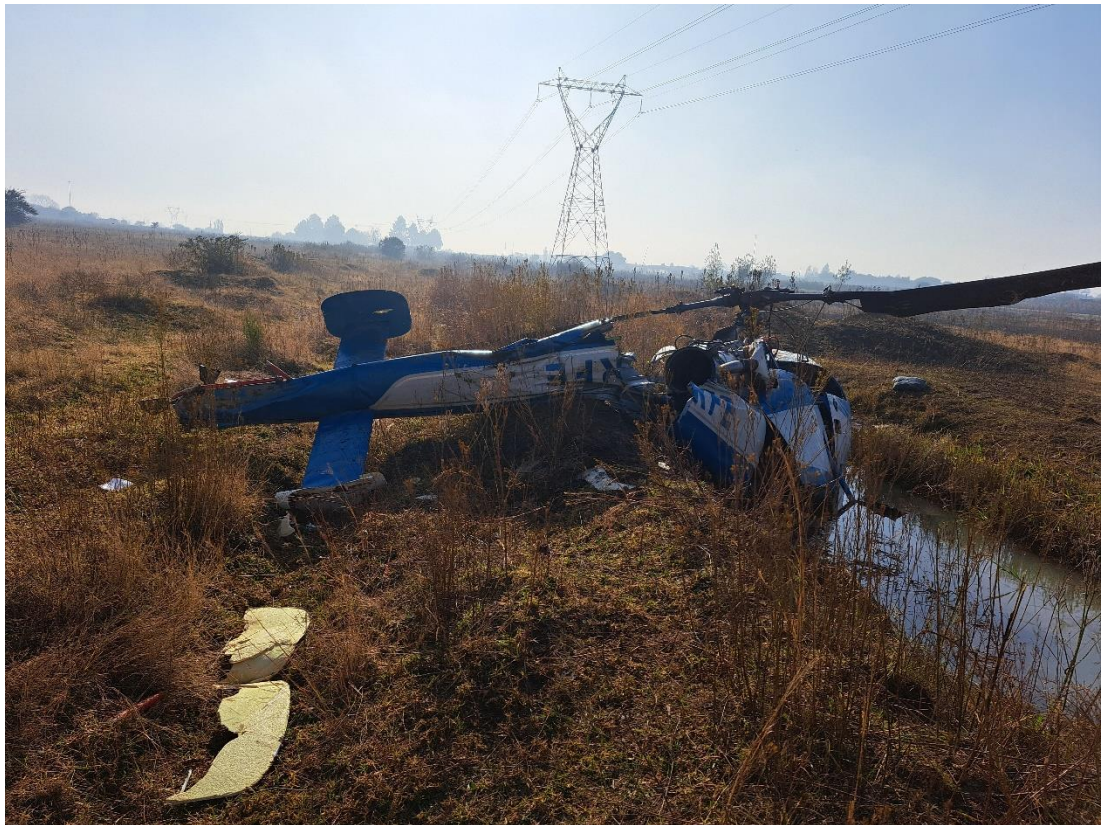
- 1.12.1 The helicopter crashed into a water channel located in an established Boipatong residential area, approximately 80 metres (m) from the regional road. The area around the accident site had obstacles such as an uneven surface area and high-tension electrical power lines. A video footage filmed by one of the residents at the accident site revealed that the accident scene was tampered with. The tail boom was moved from its location by some people who were at the crash site. It was found positioned perpendicular to the main wreckage and towards the left-side of it.

**Figure 5:** The rear view of the helicopter and the electrical lines running parallel to the water channel.

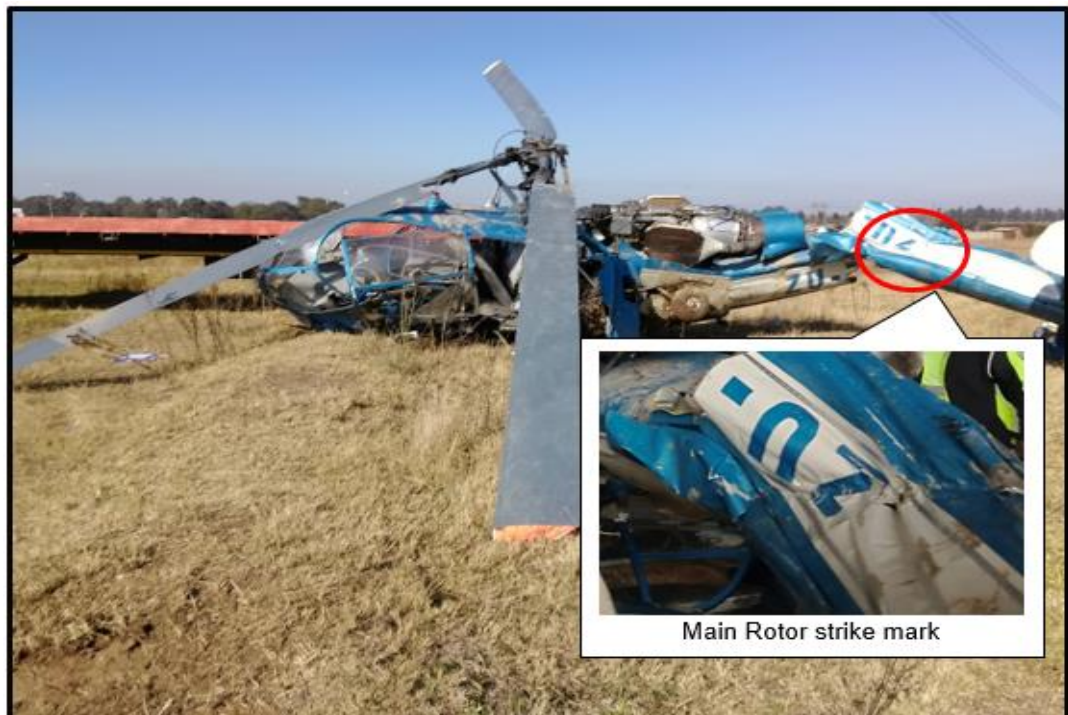
1.12.2 The initial impact marks on the ground indicated that the helicopter contacted the ground with its tail section first at a high nose-attitude and in a slightly tilted angle towards the left, followed by the fuselage impacting the ground with its left-side; hence, the helicopter's substantial damage on the left. The equipment compartment detached from the mounting point and was destroyed. The left cockpit and cabin doors had also detached from the mounting points. The windshield was partially damaged towards the left-side.

**Figure 6:** The left-side view of the wreckage after it was removed from the water channel.

1.12.3 Damage on the main rotor blades indicated low-energy impact with the ground. One of the main rotor blades struck the tail boom; moreover, two of the three main rotor blades sustained substantial damage, whilst the third was found intact. The left-side seats had moved to the front during the accident sequence. The cabin section had compression load damage towards the left-side.

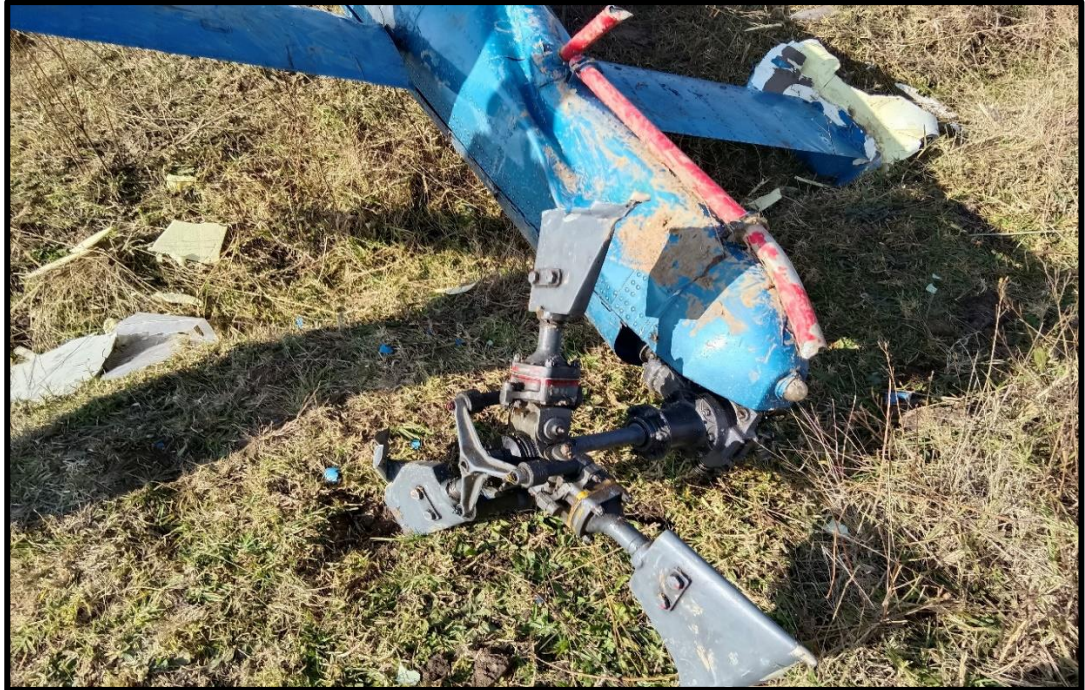
**Figure 7:** The damaged tail rotor.

1.12.4 During impact, the three tail rotor blades came into contact with the ground and broke off midsection, and all three pieces of the tail rotor blades scattered in different directions. The nearest blade tip was found within a 15m radius of the accident site, towards the left of the wreckage. The tail rotor drive shaft broke off during the impact sequence.

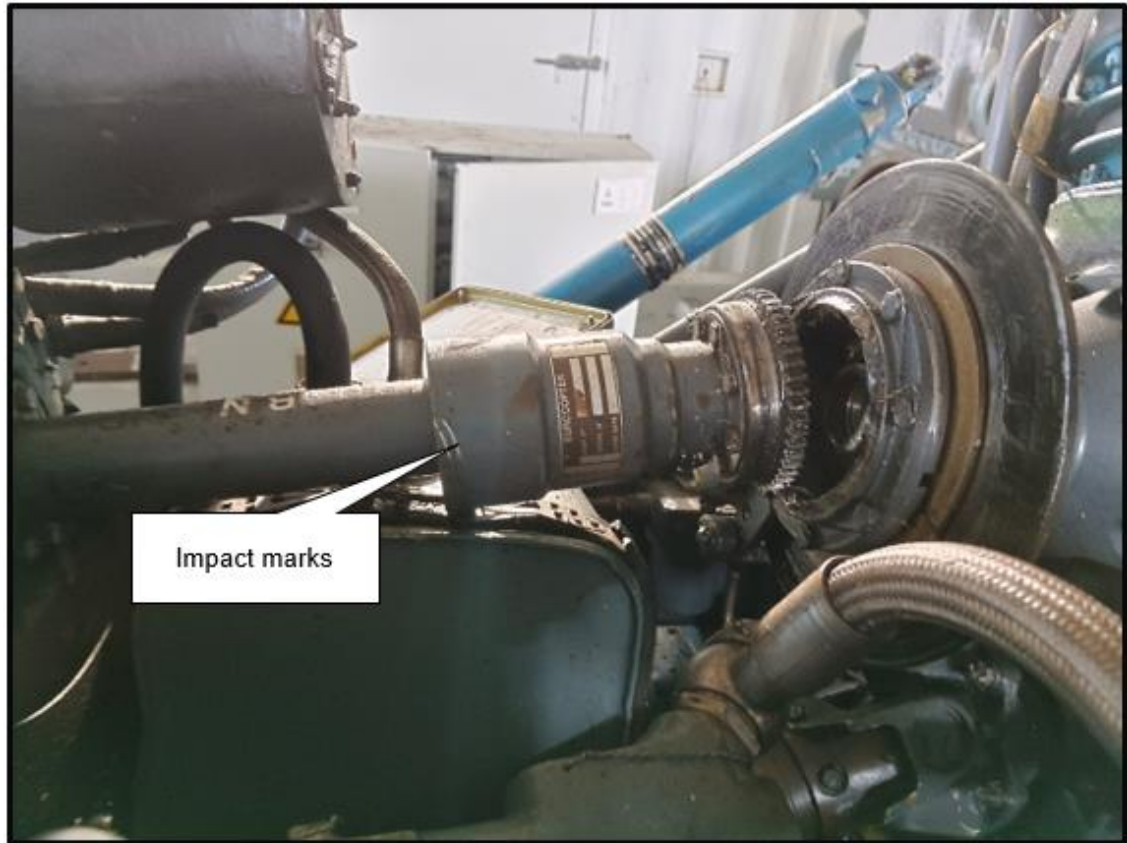
**Figure 8:** The decoupled engine gearbox drive shaft.

1.12.5 All flight control tubes and cables were accounted for. The collective control lever was found broken towards the point where it attaches to the cross tube and was found stuck in the up position. The overall condition of the engine was intact with no visible damage observed. The engine rotated freely when tested by hand. The main drive shaft decoupled during the impact sequence. The main drive shaft also exhibited scar marks sustained during the accident sequence, consistent with impact with an object whilst not turning. The investigators' wreckage assessment was consistent with the pilot's statement.
