PRELIMINARY ACCIDENT REPORT

Accident and Incident Investigations Division

Accident
- Preliminary Report -
AIID Ref No: CA18/2/3/10518

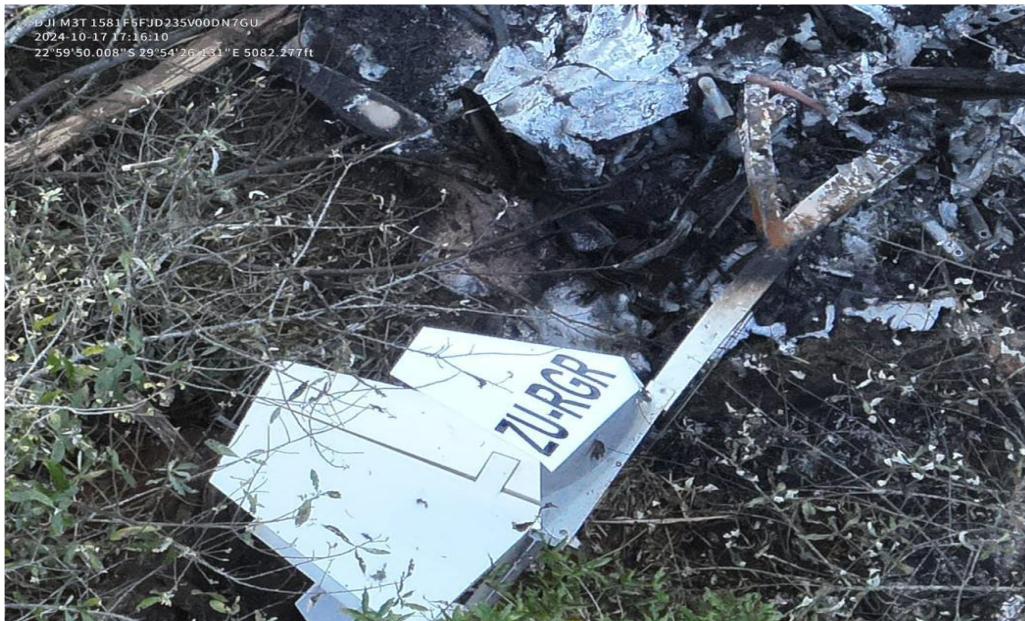
1.3.1 The aircraft was destroyed by impact forces and the post-impact fuel-fed fire.

Figure 3: The wreckage with the tail number still visible. (Source: ARCC)

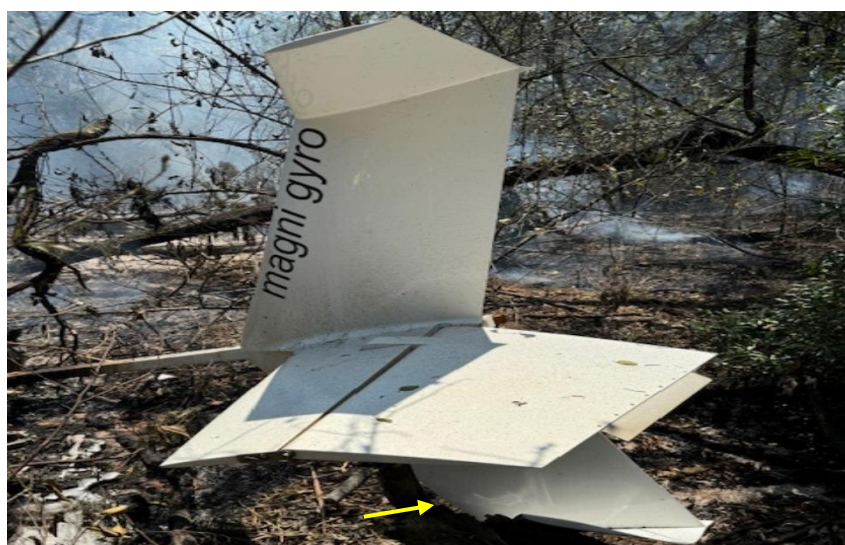
1.12.1. The aircraft crashed near the top of Hanglip Mountain at an elevation of approximately 4 770ft. The elevation (to the top of the mountain) is 5 640ft. The aircraft initially impacted trees on the east side of the mountain at a heading of approximately 331°. It was evident that a significant amount of the energy at impact was absorbed by the canopy before the aircraft reached the ground. The aircraft was destroyed by the post-impact fuel-fed fire. Despite the extensive damage to the aircraft structure due to impact and the fire blaze, it was possible to establish that the aircraft was intact at the time of the accident. There was no evidence of any pre-impact damage to either the propeller or main rotor blades. The rudder had remained attached to the keel. The right horizontal stabiliser was undamaged, however, the left fin and the left horizontal stabiliser sustained substantial damage.

Figure 5: The tail section and the damaged left fin/horizontal stabiliser.

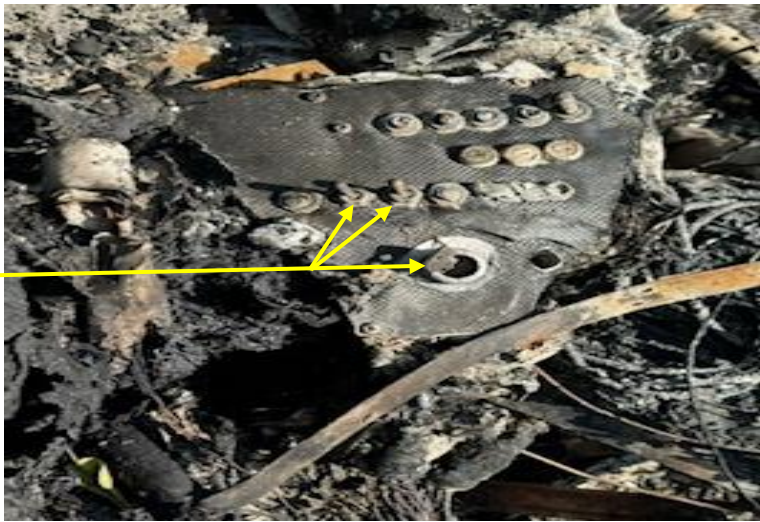
1.12.3 The fuel pump toggle switches and the ignition key were found in the “on” position; some switches had broken off. Most of the instruments were destroyed by the fire blaze. The beams supporting the pilot’s side of the seat had bent rearwards. The buckles on each of the four-point harnesses were connected and in the “locked” position and all the seat harness attachment fittings were still attached to the aircraft’s structure. The nosewheel fork had broken which was consistent with the impact force. The main landing gear beams and wheel assemblies were still attached; however, the tyres were burnt. The door frames and the windshield were destroyed by the post-impact fire.

Fuel pumps toggle switches and the ignition key in the "on" position

Figure 6: The fuel pumps switches and the ignition key in the "on" position.

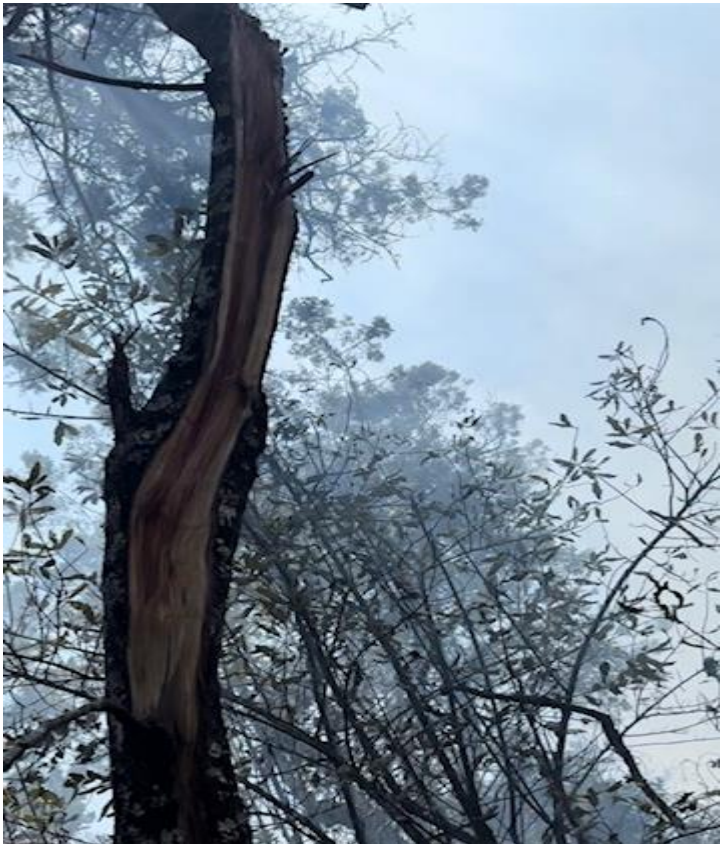
1.12.4 Before impact with the ground, one of the aircraft's main rotor blades severed one of the tree branches at an estimated height of approximately 3 metres (m). The tree was damaged by the turning rotor, an indication that the engine was producing substantial power at the time of the accident.

Figure 7: The area where a tree branch separated after it was hit by the rotating main rotor blade.

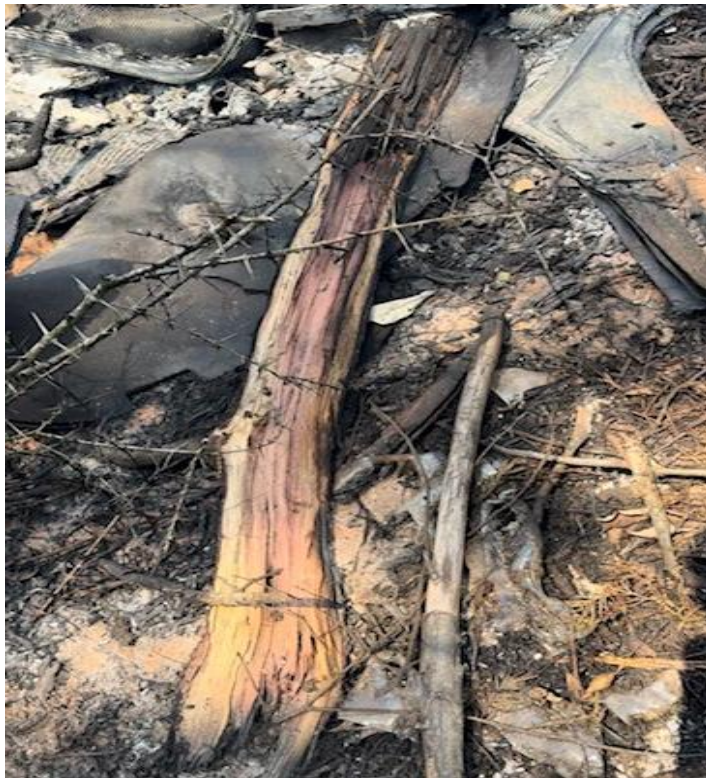
Figure 8: The severed tree branch.

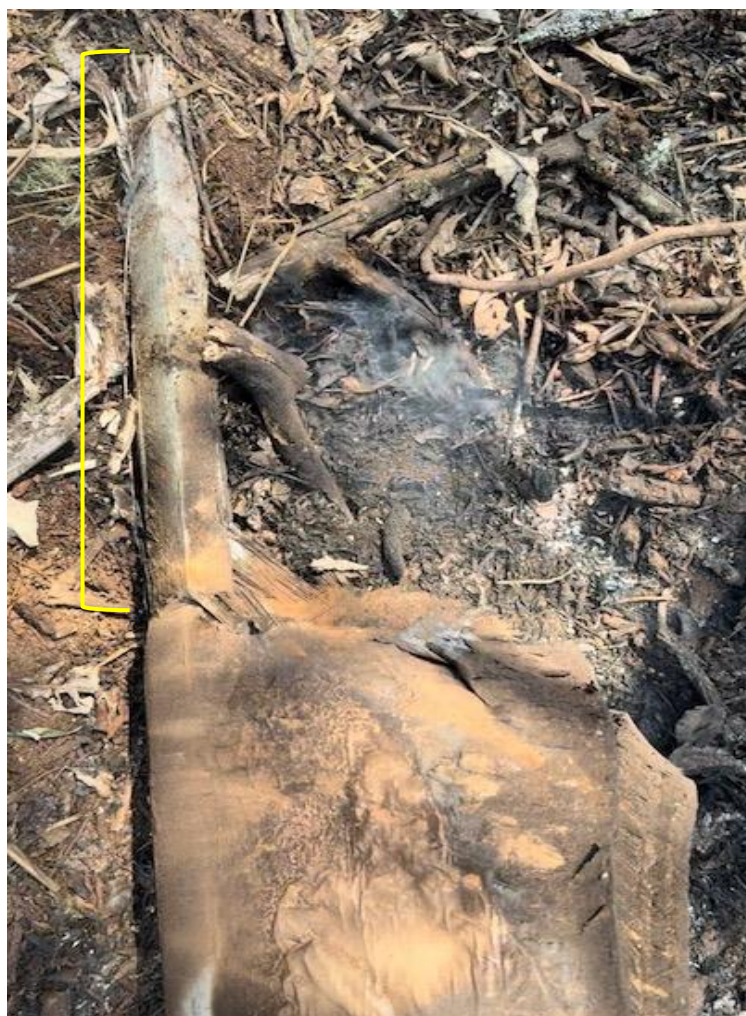
1.12.5 The main rotor blade tip that hit the tree was severed. The rotor head was in place; however, one of the rods had bent slightly.

Figure 9: The severed tip of the main rotor blade that hit the tree branch.

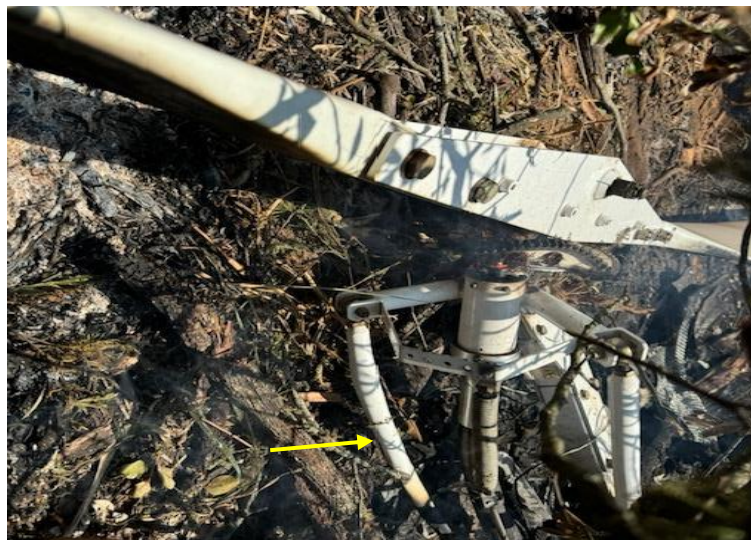
Figure 10: The main rotor head and the bent rod.
