PRELIMINARY ACCIDENT REPORT

Accident
- Preliminary Report -
AIID Ref No: CA18/2/3/10556

Reference Number	: CA18/2/3/10556
Occurrence Category	: Category 2
Type of Operation	: Private (Part 94)
Name of Operator	: Worcester Flying Club
Aircraft Registration	: ZU-SIG
Aircraft Make and Model	: Sling 2
Nationality	: South African
Registration Marks	: ZU-SIG
Place	: 400 metres from Runway 15 at Worcester Airfield (FAWC)
Date and Time	: 1 March 2025 at 0715Z
Injuries	: Minor
Damage	: Substantial

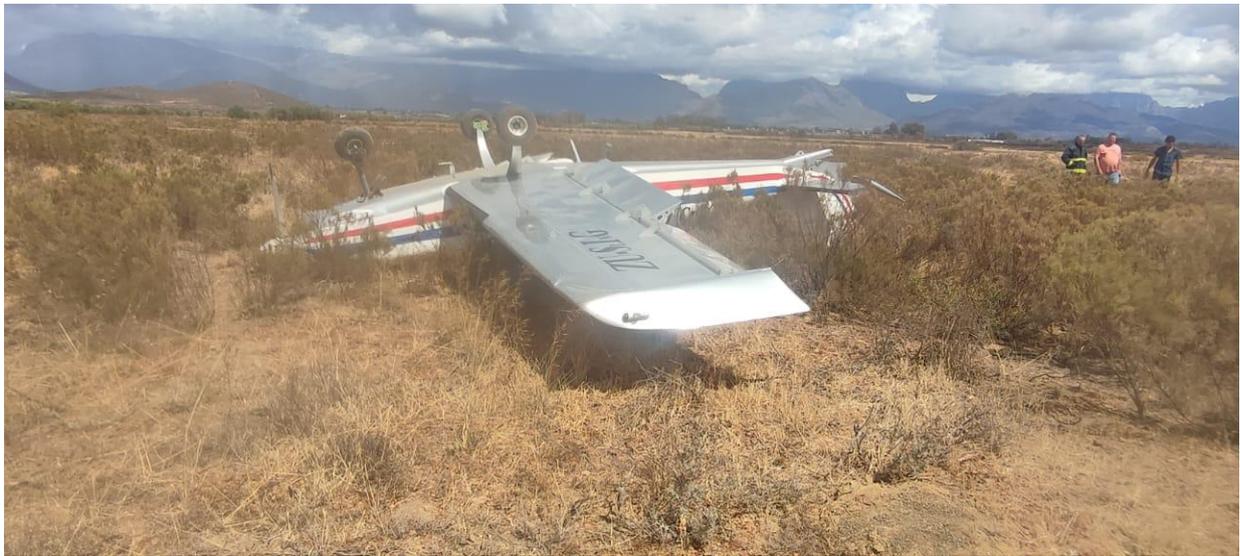
1.3.1. The aircraft sustained substantial damage to the nose gear, propeller, fuselage, left wing and vertical stabiliser.

Figure 3: The aircraft in an inverted position.

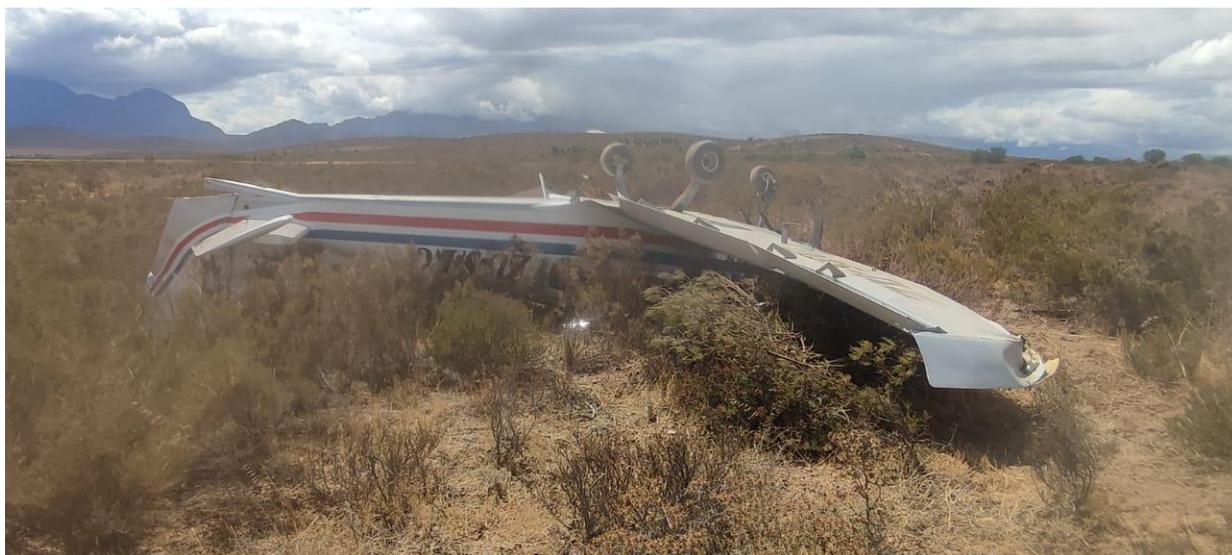
1.12.1. During final approach for landing on RWY 15 and with the flaps selected to 20 degrees, the electric system failed, followed by engine stoppage. The pilot executed a forced landing on a bushy terrain towards the left side of RWY 15. The aircraft impacted the shrubs with the left wing and the nose wheel, and it nosed over; it was found resting in an inverted position facing south. The canopy, which was damaged on impact, was further damaged as the pilot and the passenger made their way out of the aircraft.

Figure 4: The aircraft after impact.
