PRELIMINARY ACCIDENT REPORT

Accident  
- Preliminary Report -  
AIID Ref No: CA18/2/3/10265

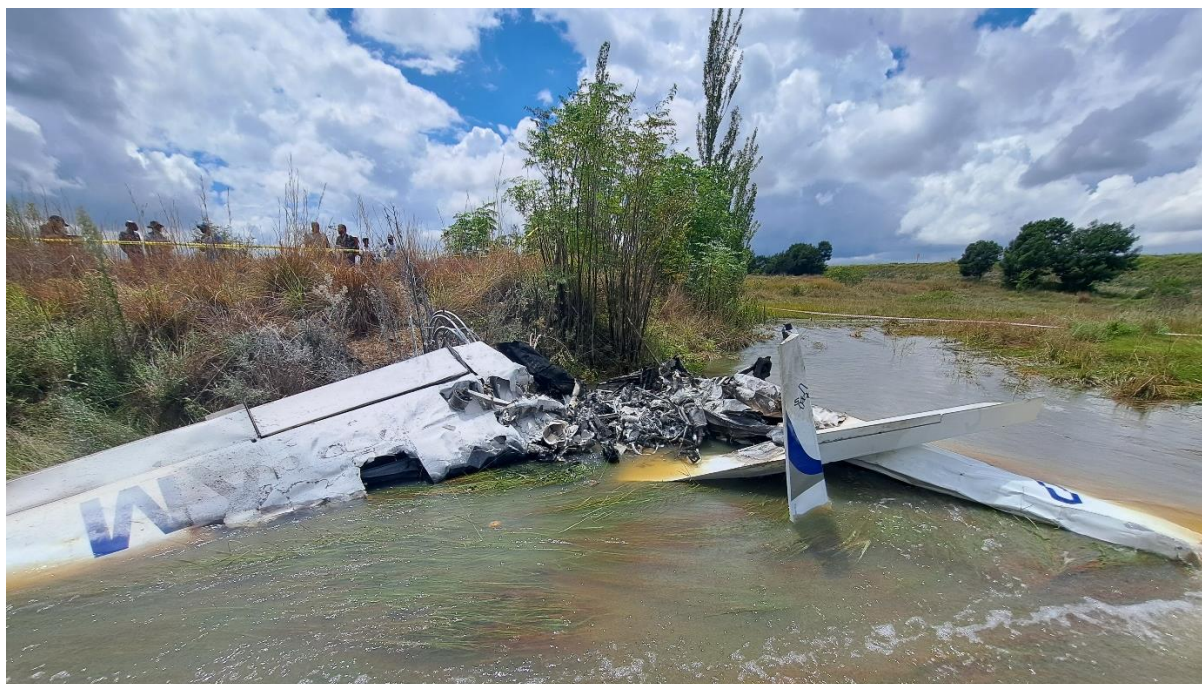
**Figure 3:** Moments after the fire was extinguished.

1.3.1. The aircraft was destroyed by impact and post-impact fire.

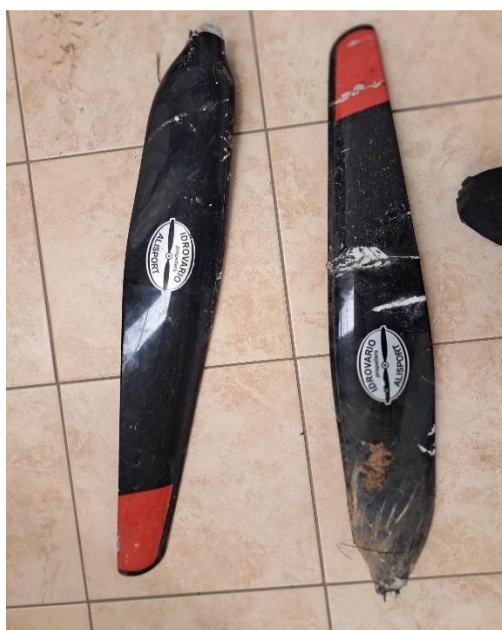
**Figure 4:** The damaged propellers.

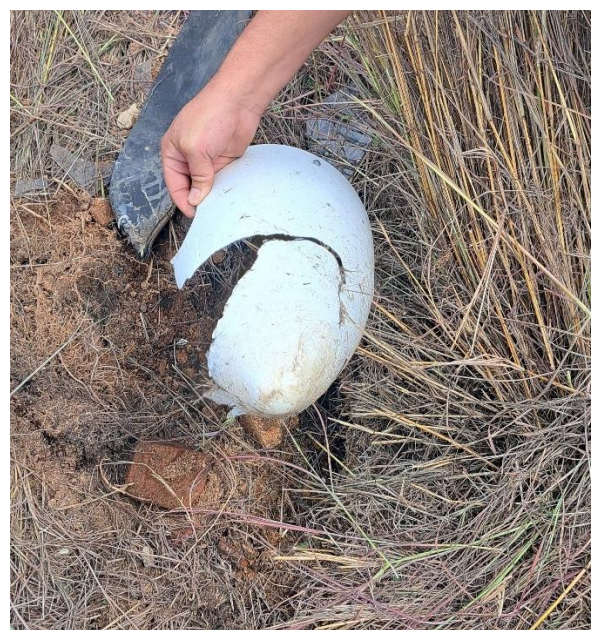
**Figure 5:** The cracked aircraft spinner.

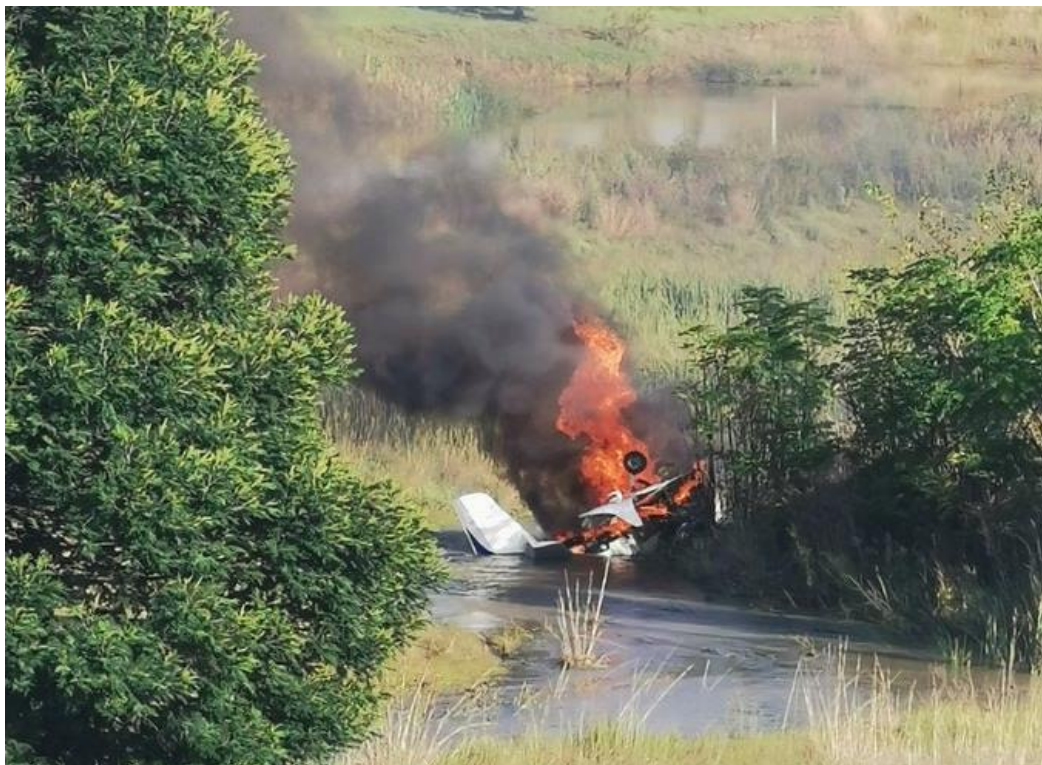
**Figure 8:** The aircraft burst into flames immediately after impact with the ground.  
(Source: Investigator-on-call)

1.14.1. The aircraft burst into flames moments after impacting the ground. Fellow aviators at the airport grabbed the fire extinguishers and rushed to the accident site with the intention to extinguish the flames and assist the pilot.
