PRELIMINARY ACCIDENT REPORT

Accident
- Preliminary Report -
AIID Ref No: CA18/2/3/10393

Reference Number : CA18/2/3/10393
Occurrence Category : Category 1
Type of Operation : Private 94 (NTCA)
Name of Operator : Plane ADS (PTY) LTD
Aircraft Make and Model : Micro Aviation SA; Bat Hawk R
Nationality : South African
Registration Marks : ZU-XCO
Place : Grassland Airfield, Centurion, Gauteng Province
Date and Time : 26 November 2023 at 0545Z
Injuries : Fatal
Damage : Substantial

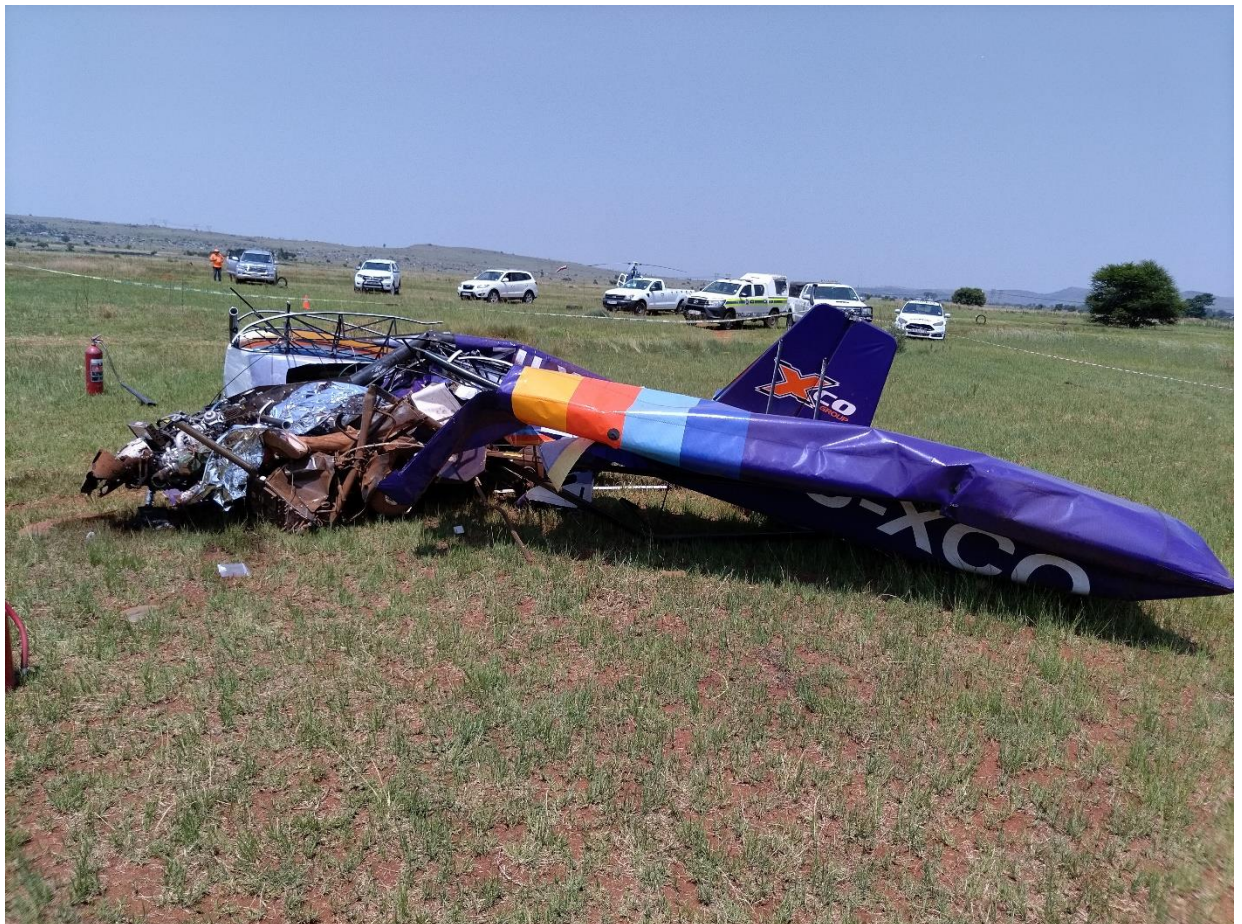
1.3.1. The aircraft sustained substantial damage.

Figure 3: The aircraft at the accident site.

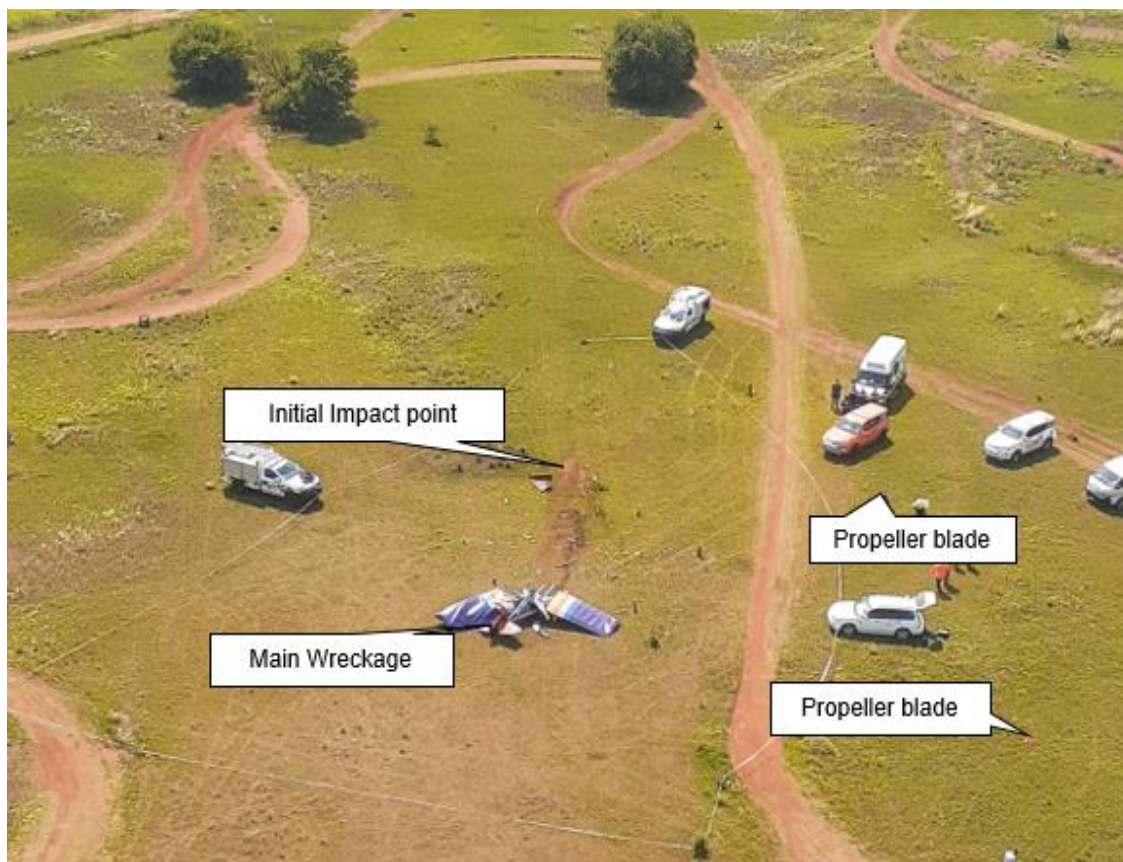
Figure 5: Wreckage distribution at the accident site. (Source: SAPS Air-Wing)

- 1.12.1 The accident occurred at an open area, approximately 500 metres (m) from the airfield. The wreckage was fairly localised within a radius of approximately 20m.

- 1.12.2 After impact, the aircraft skidded in the initial direction whilst facing the opposite direction of approach. The nose section and the cockpit windshield fragments were found at the impact point. The cockpit area was compromised, and both occupants were trapped inside the wreckage. They were fatally injured.

- 1.12.3 The aircraft's left-wing tip portion of the leading-edge towards the inner part was bent, indicative of impact forces sustained mostly on the left side. The left side of the nose section and the cockpit sustained extensive damage. The right wing was still intact with no visible damage or deformation.

- 1.12.4 The fuel tank was damaged which caused fuel to spill to the ground. There was no visible damage to the aircraft's engine.
