AIRCRAFT ACCIDENT REPORT AND EXECUTIVE SUMMARY

Reference:		CA18/2/3/10003	
Aircraft Registration	ZS-CKM	Date of Accident	13 May 2021		Time of Accident	1420Z	
Type of Aircraft	PA-32RT-300T		Type of Operation		Private (Part 91)		
Pilot-in-command Licence Type	Airline Transport Pilot Licence (ATPL)		Age	32	Licence Valid	Yes	
Pilot-in-command Flying Experience	Total Flying Hours		2 327.4		Hours on Type	87.3	
Last Point of Departure	Port Elizabeth Aerodrome (FAPE), Eastern Cape Province						
Next Point of Intended Landing	Pietermaritzburg Aerodrome (FAPM), KwaZulu-Natal Province						
Damage to Aircraft	Substantial						
Location of the accident site with reference to easily defined geographical points (GPS readings if possible)							
Umtentweni, about 50nm south-west of FAPM at GPS S 30°33'11.1" E030°17'20.2", and at an elevation of 1 411 feet							
Meteorological Information	Wind direction: 90°; Wind speed: 10kts; Visibility: 10km; Temperature: 22°C; Cloud cover: CAVOK; Dew point: 7°C

COMPILED BY:	UNIVERSITY OF PRETORIA LABORATORY FOR MICROSCOPY & MICROANALYSIS	PAGE 1 OF 12	
	FAILURE ANALYSIS REPORT: Crankshaft Assembly, Lycoming TIO-540-S1AD, Piper Turbo Lance II, ZS-CKM	DOCUMEN

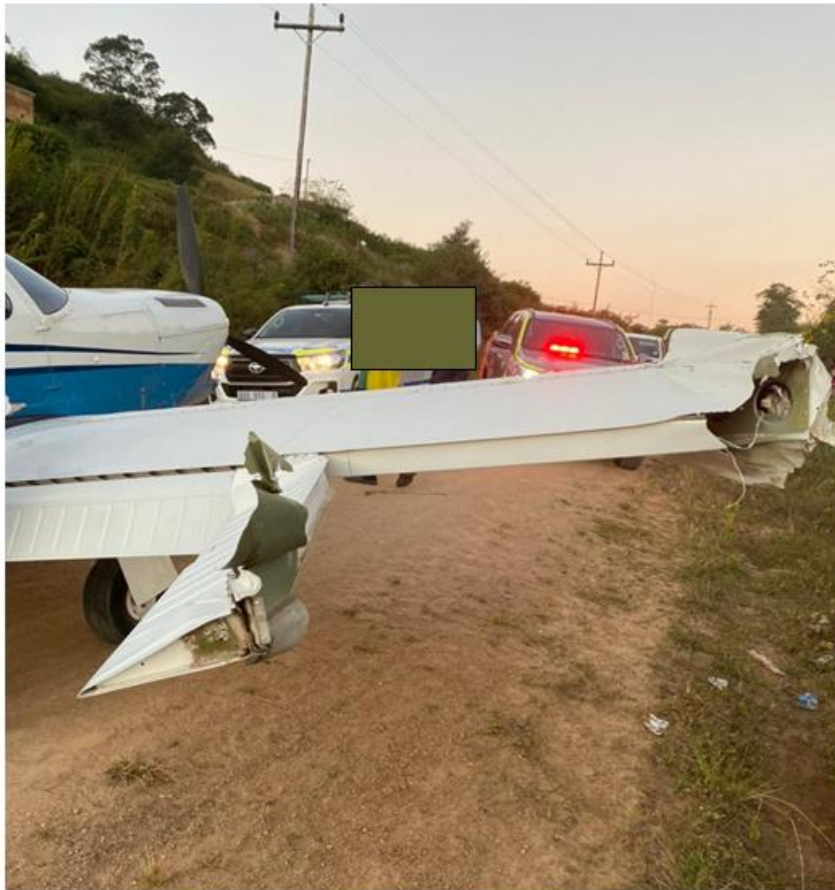
1.3.1 The aircraft sustained substantial damage during the accident sequence.

Figure 2: The aircraft at the accident site after it had come to a stop. (Source: Pilot)

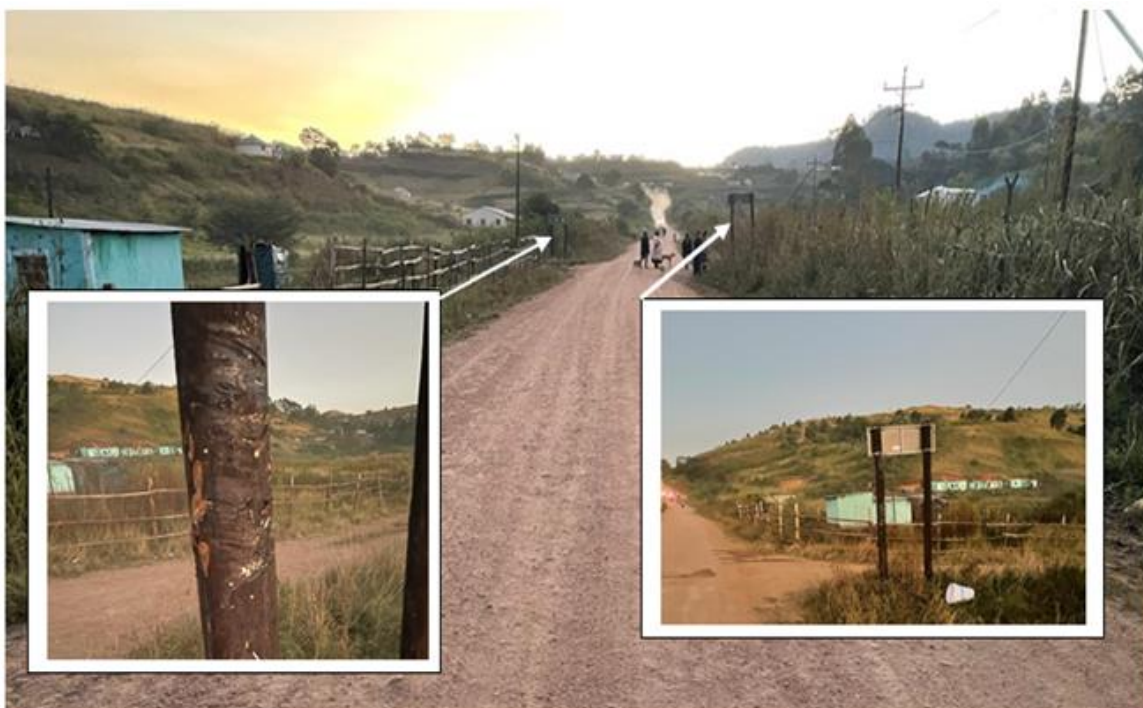
- 1.4.1 Minor damage to the two road sign poles, approximately 20 metres (m) apart, which were struck by the aircraft's wing tips.

Figure 3: Minor damage to the road sign poles.

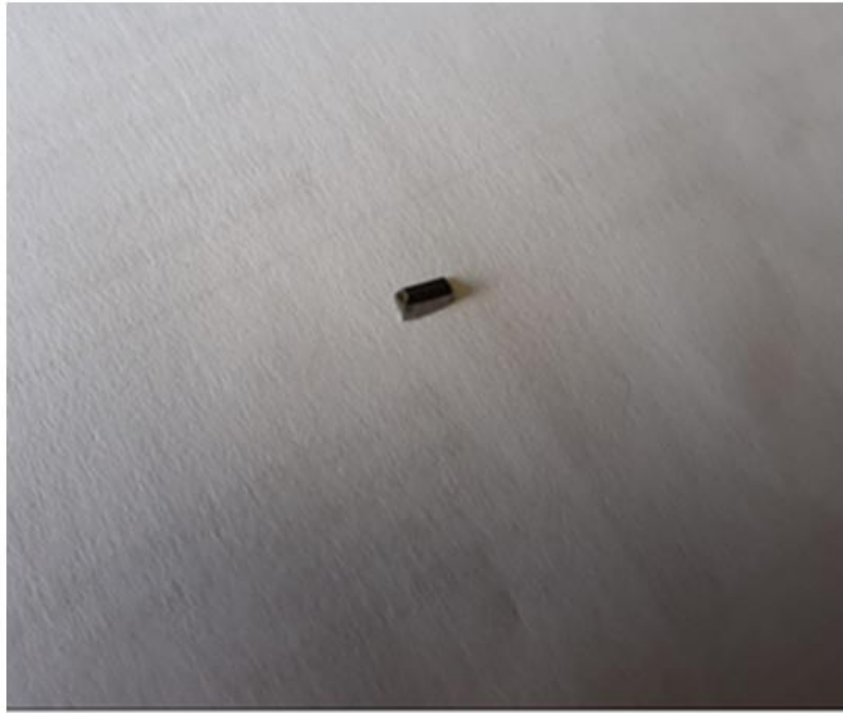
- On 1 June 2018 at 3 979.5 engine hours, the engine's 100-hour MPI was carried out and a gear tooth was found inside of the oil sump suction filter.

Figure 4: The gear tooth found inside an oil sump filter. (Source: AMO)

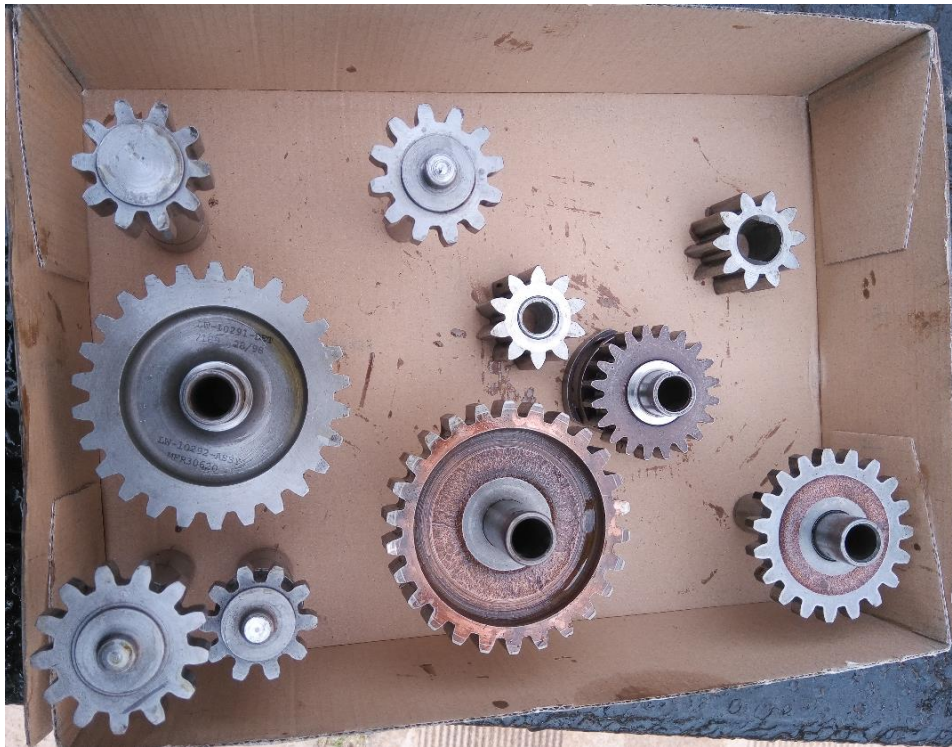
- The engine was removed for further (gears) inspection by an approved AMO. After the gear box was stripped down and inspected; no broken or damaged gears were found. The engine was then reassembled and refitted to the ZS-CKM on 29 June 2018. During the engine run, oil leaked from the engine and, therefore, it was taken back to the engine shop. According to the AMO, the engine was dismantled, cleaned and inspected in accordance with Overhaul Manual 60294-7-14 and Service Table of Limits SSP1776-4-PT1. The engine was assembled using new gaskets and seals. The crankshaft was not stripped. An Airworthiness Directive (AD) (2002-19-03) which required crankshaft material testing was not carried out because it was not applicable to the engine and crankshaft serial number. The engine was re-fitted to the ZS-CKM.

Figure 5: The serviceable gears from the ZS-CKM aircraft.

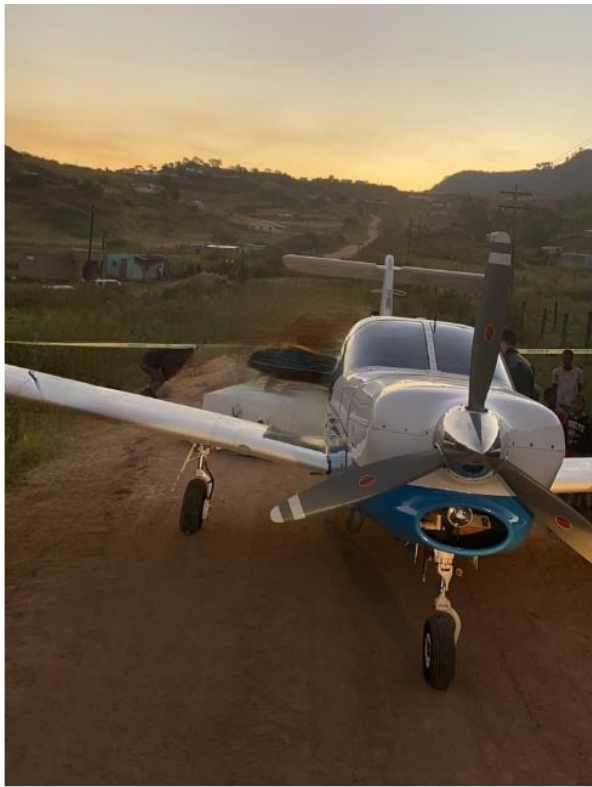
1.12.1 The pilots executed an emergency landing on a gravel road. The aircraft remained centred on the road and, during the landing roll, both wing tips struck two road sign poles on the opposite sides of the road which were approximately 20m apart.

Figure 6: The aircraft at the accident site where it came to a stop. (Source: Pilot)

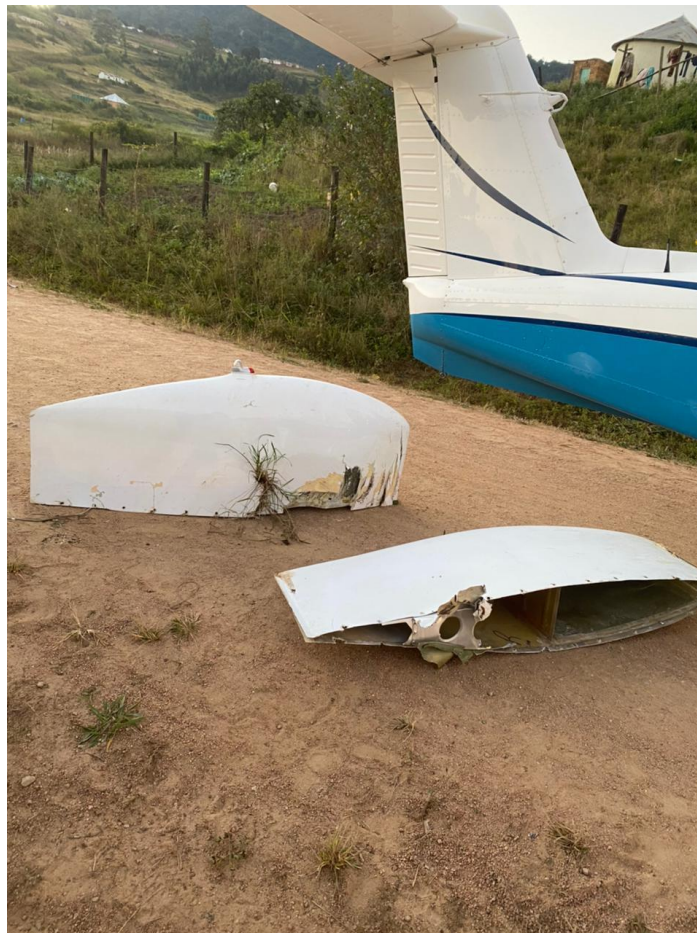
1.12.2 Both the left- and the right-wing tips hit the road sign poles on each side of the road, approximately 20m apart.

Figure 7: The severed left- and right-side wing tips. (Source: Pilot)

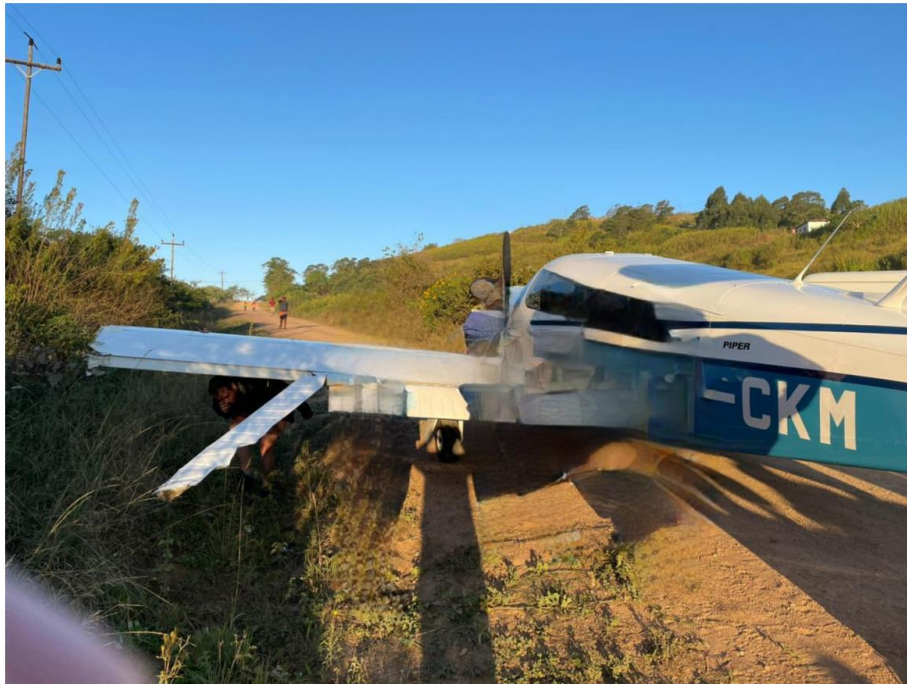
1.12.3 Both the left and the right-side ailerons separated from the outboard side of the wings (see Figures 8 and 9).

Figure 8: The damaged left-side wing and aileron. (Source: Pilot)

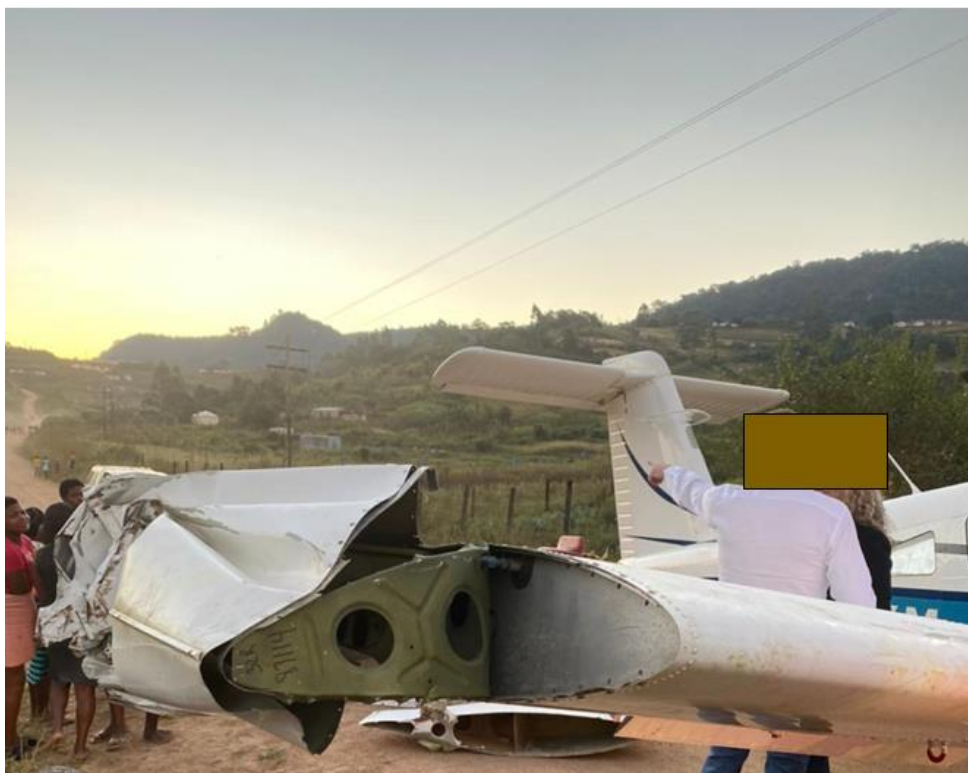
Figure 9: The damaged left-side wing. (Source: Pilot)

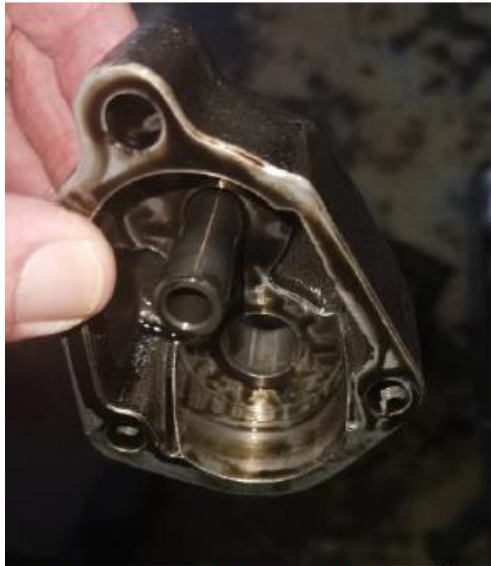
The oil pump revealed no clear signs of failure during operation (Photo 4).

Photo 4: Oil pump condition⁴

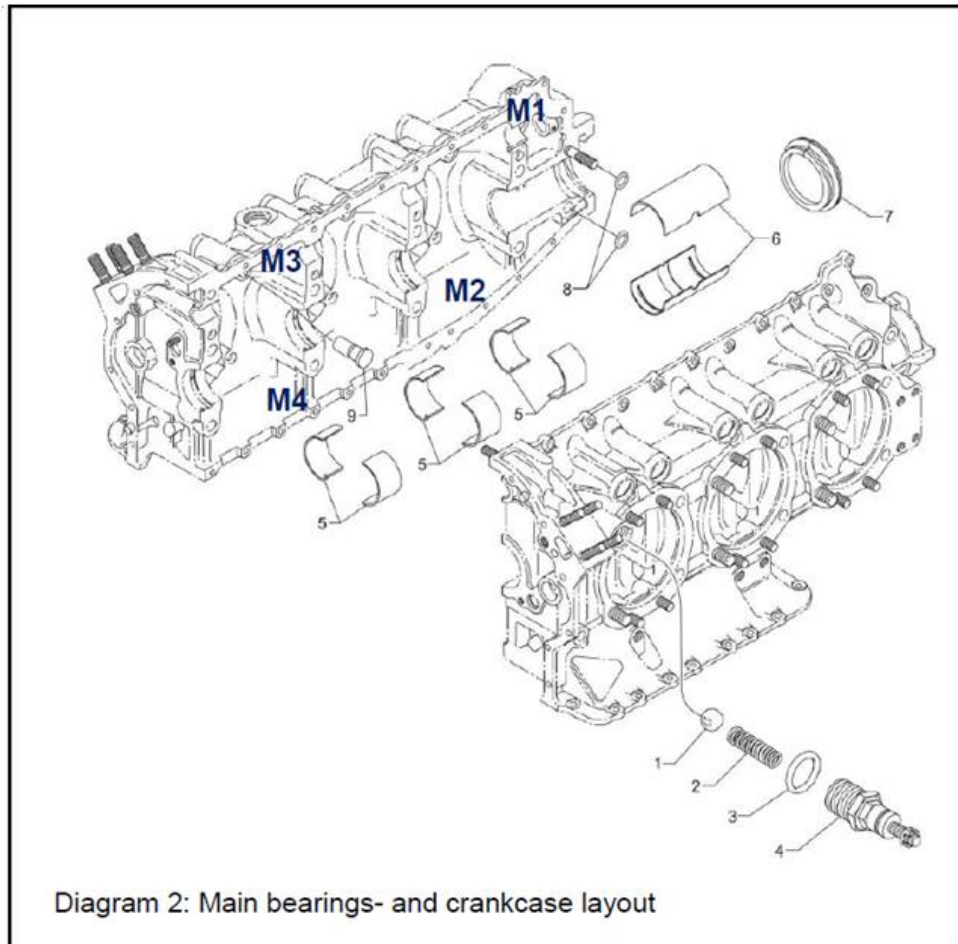
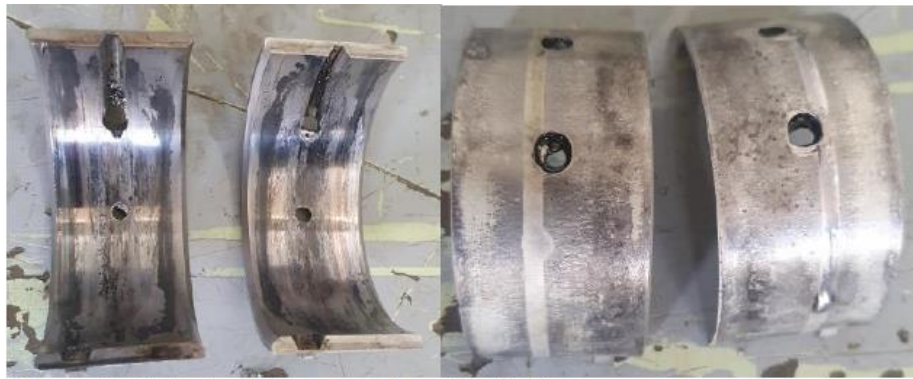
The main sleeve bearings (Diagram 2) revealed signs of wear, metal impregnation and temperature exposures (Photo 5).

Photo 5: Main bearing condition (Digital)

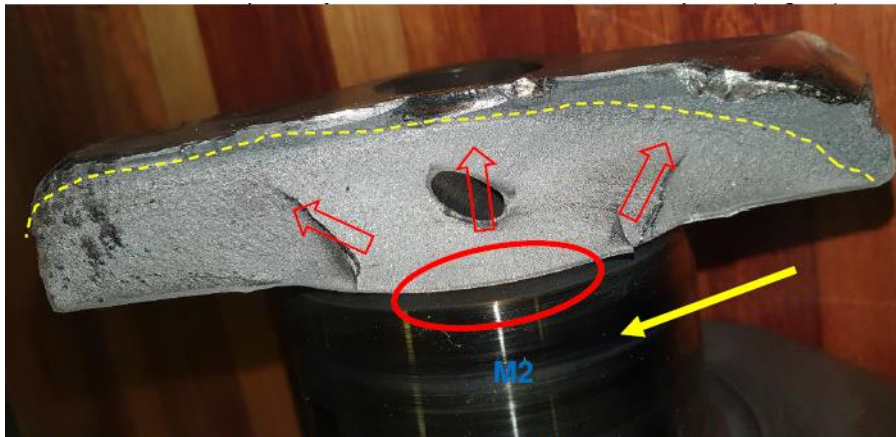
Visual inspection of the supplied crankshaft revealed two fractures marked A and B (Photos 7 and 8) within the web sections between the adjacent main bearings M2 and M3 and piston conrod positions 3 and 4 (Photo 6; Diagrams 1 and 3). Both fractured surfaces revealed signs corresponding with a fatigue mode of failure and initiated within the radius sections of the main bearings M2 and M3, respectively (Photos 7 and 8, red circles). The fractures progressed through the web sections in the directions as indicated (yellow arrows) until final fast fracture.

The 'benchmark' spacing, level of secondary damage and surface contamination indications suggest that fracture A initiated prior, or progressed at a higher rate, than fracture B.

Both the main bearing contact surfaces M2 and M3 (Photos 7 and 8, yellow arrows) revealed slight signs of wear and temperature exposure. This is not consistent with a total bearing seizure scenario and can be considered as collateral damages induced during the crankshaft failure sequence.

Photo 7: Fracture A, surface geometry (Digital)

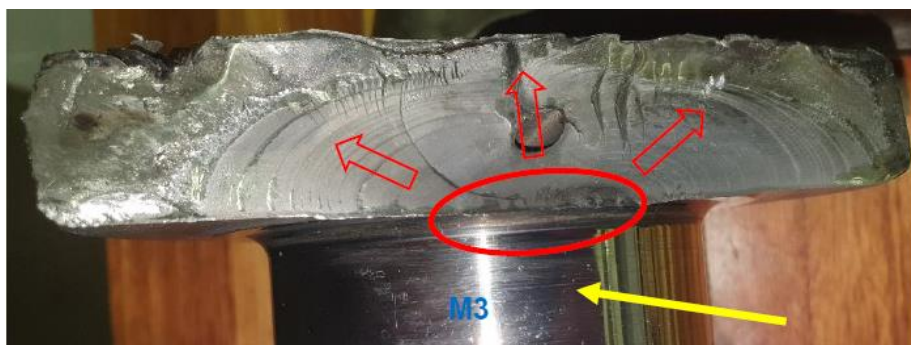
Photo 8: Fracture B, surface geometry (Digital)

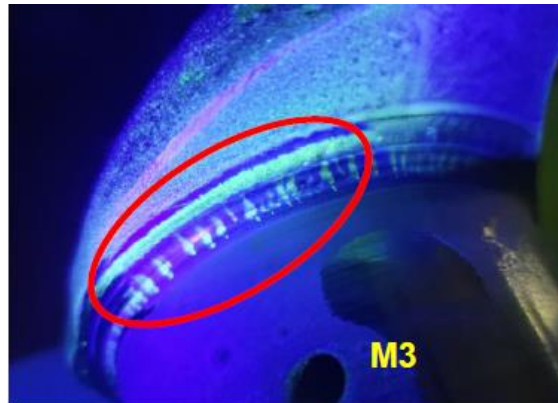
A qualitative Non-destructive Testing (NDT) Dye-Penetrant Inspection (DPI) revealed extensive micro-fracture initiations around the main bearing (M3) contact surface circumference at fracture position B (Photo 10, red circle). This is indicative of severe stress exposure to the crankshaft in the radial direction during rotation and not related to a typical bearing failure (seizure, break-up, etc.).

Photo 10: Dye-penetrant inspection result (Digital)

main bearing (M3) contact surface circumference at fracture position B (Photo 10, red circle). This is indicative of severe stress exposure to the crankshaft in the radial direction during rotation and not related to a typical bearing failure (seizure, break-up, etc.). According to the manufacturer, engine overhaul should be carried out at every 2000 hours or 12-year mark. The crankshaft should be inspected for condition and wear limits and measured to determine if it is still within limits. The crankshaft that is out of limits should be replaced.

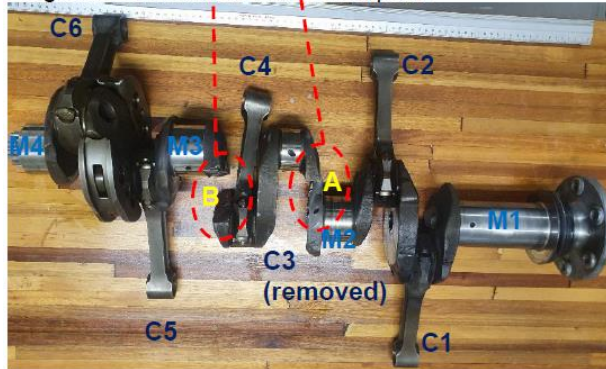
Photo 6: Position of primary fractures A and B and other parts (Digital)

2.2.5 Investigation results of the supplied components revealed two primary fractures, A and B (see photo 6), which initiated and progressed due to predominant fatigue in the web sections of the crankshaft during operation. A qualitative Non-destructive Testing (NDT) Dye-Penetrant Inspection (DPI) revealed extensive micro-fracture initiations around the

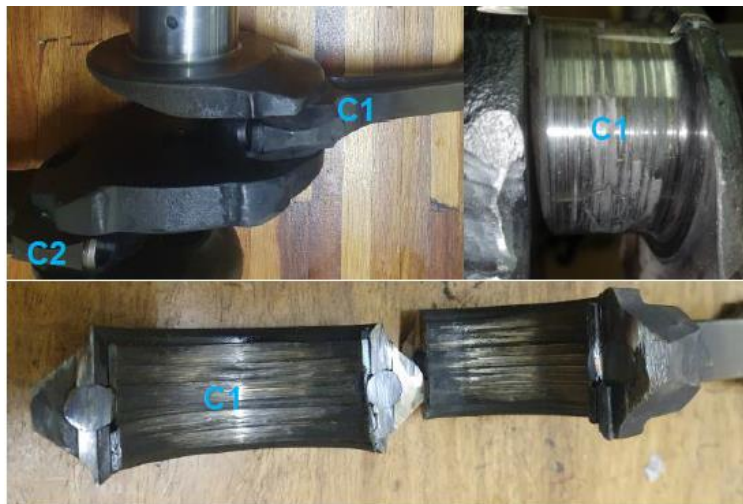
The big-end connecting rods C1 and C2 (Diagram 1; Photo 6) and bearings revealed signs of high temperature exposures, excessive wear and imminent seizure (Photo 9). This could be considered as collateral damages induced during the failure sequence of the crankshaft due to the blockage of the oil feed lines.

Photo 9: Connecting rod C1 condition (Digital)

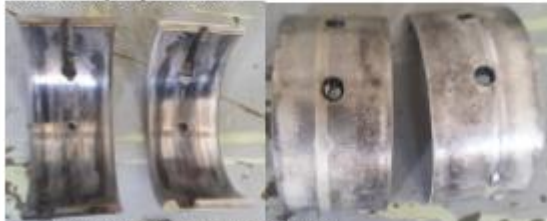
Photo 5: Main bearing condition (Digital)

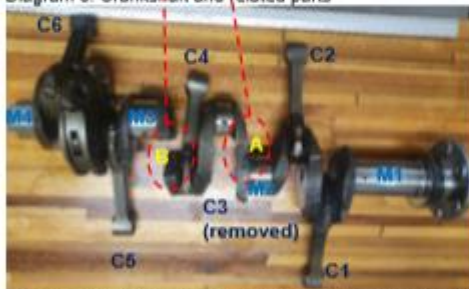
Photo 6: Position of primary fractures A and B and other parts (Digital)

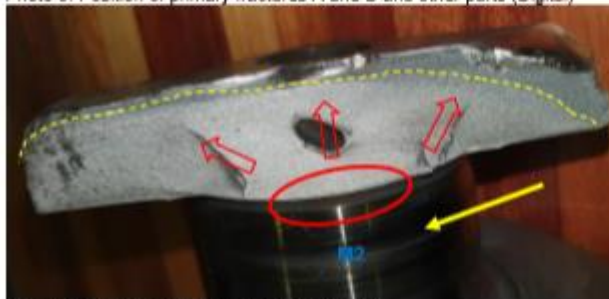
Photo 7: Fracture A, surface geometry (Digital)

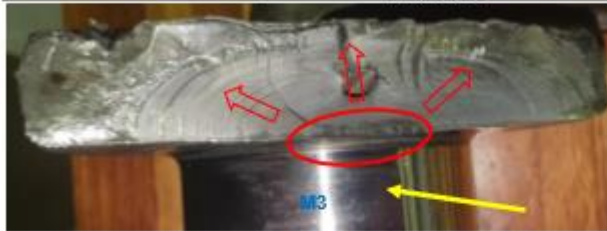
Photo 8: Fracture B, surface geometry (Digital)

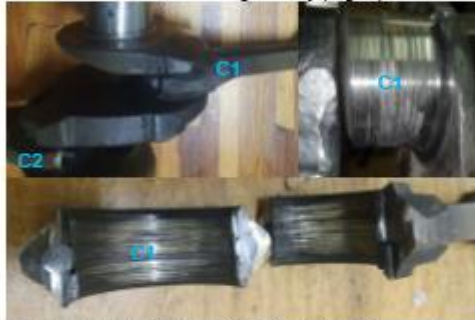
The big-end connecting rods C1 and C2 (Diagram 1; Photo 6) and bearings revealed signs of high temperature exposures, excessive wear and imminent seizure (Photo 9). This could be considered as collateral damages induced during the failure sequence of the crankshaft due to the blockage of the oil feed lines.

Photo 9: Connecting rod C1 condition (Digital)

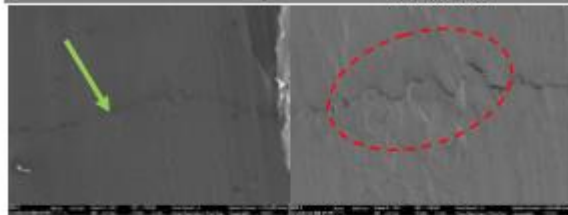
Smearing damages surrounding the micro-fractures (Fractograph 8, red dashed circle) support the notion that these fractures were exposed to an operating environment for an undetermined period.

Fractograph 8: Fracture B, surface morphology (SE, 20kV, FEGSEM)

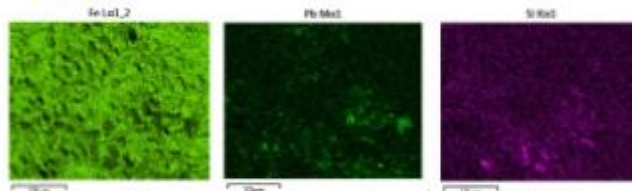
The EDS MAP results confirmed the presence of lead (Pb) impregnated onto the fracture surfaces (EDS MAP Result 1). Lead originates from the sleeve bearing material and supports the notion that the fractures were exposed to the operating environment for an undetermined period.

EDS MAP result 1: Fracture B, Surface smearing composition (Oxford Aztec, 20kV, SE)
