**AIRCRAFT ACCIDENT REPORT AND EXECUTIVE SUMMARY**

<b>Reference:</b>	CA18/2/3/10007			
<b>Aircraft Registration</b>	ZU-FXE	<b>Date of Accident</b>	26 May 2021		<b>Time of Accident</b>	1451Z		
<b>Type of Aircraft</b>	Bushbaby Explorer		<b>Type of Operation</b>	Private (Part 94)				
<b>Pilot-in-command Licence Type</b>	National Pilot Licence (NPL)		<b>Age</b>	69	<b>Licence Valid</b>	Yes		
<b>Pilot-in-command Flying Experience</b>	<b>Total Flying Hours</b>		63.6	<b>Hours on Type</b>	31.2			
<b>Last Point of Departure</b>	Polokwane Civil Aerodrome (FAPI), Limpopo Province							
<b>Next Point of Intended Landing</b>	Polokwane Civil Aerodrome (FAPI), Limpopo Province							
<b>Damage to Aircraft</b>	Destroyed							
<b>Location of the accident site with reference to easily defined geographical points (GPS readings if possible)</b>								
Approximately 200m from Polokwane Civil Aerodrome perimeter fence at GPS: S 23°55'54.19" E 029°28'40.86" and at a field elevation of 4250 feet (ft)

**Reference Number** : CA18/2/3/10007  
**Occurrence Category** : Category 1  
**Type of Operation** : Private (Part 94) Experimental  
**Name of Operator** : Fire Creek Investments 59 CC  
**Aircraft Reg

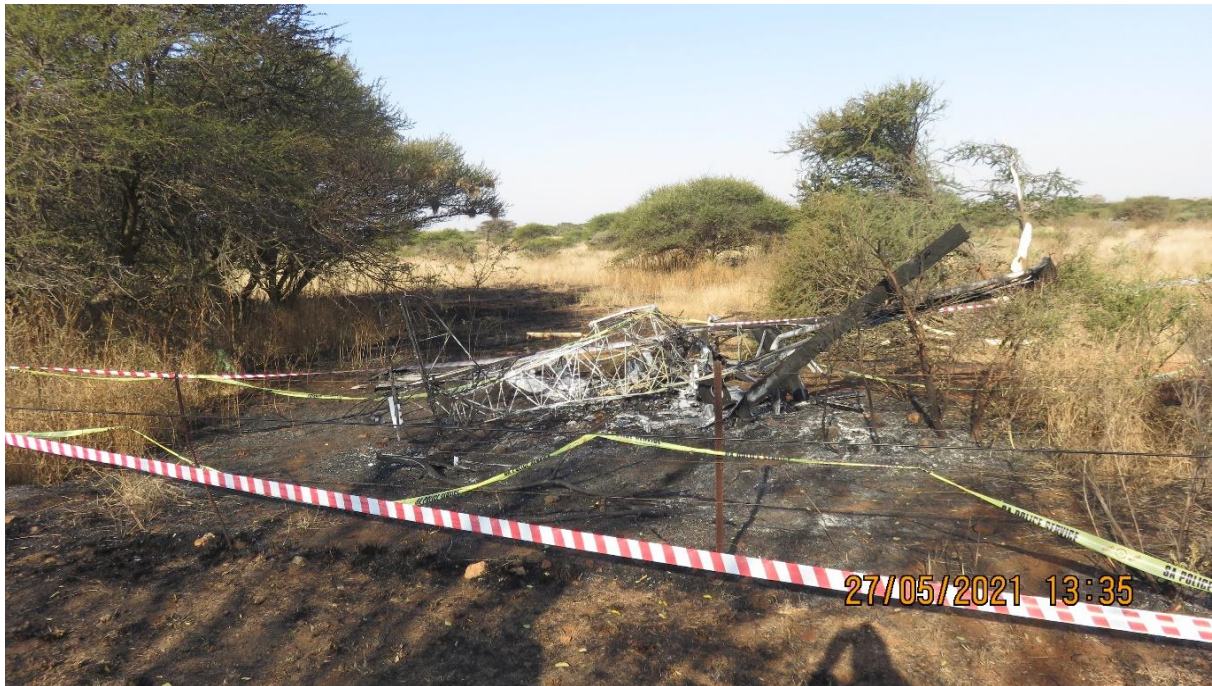
1.3.1. The aircraft was destroyed by ground impact force and the post-impact fire.

Figure 2: The wreckage after the fire was extinguished at the accident site.

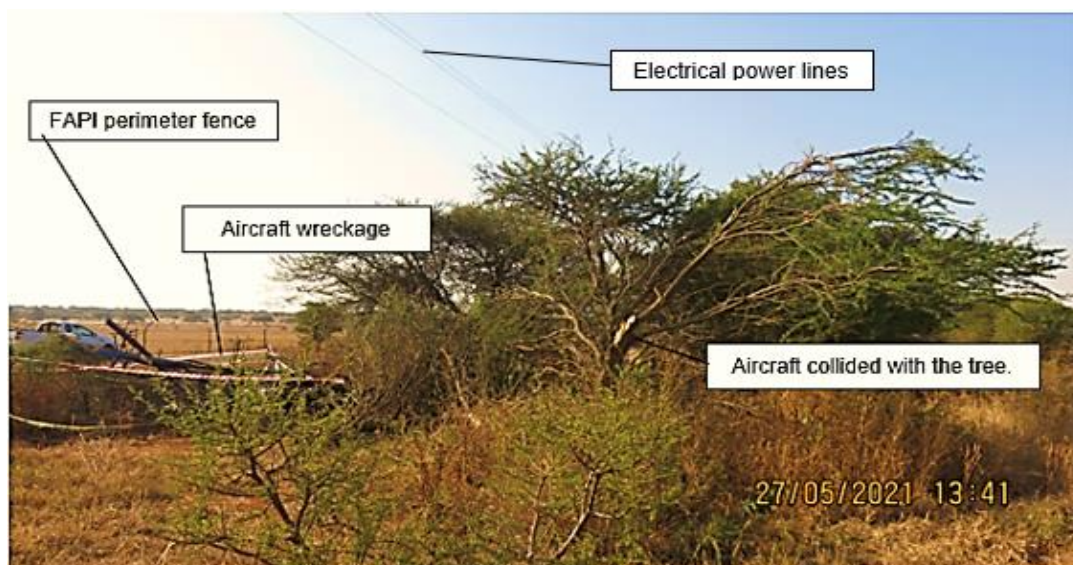
**Figure 3:** The accident site and obstacles in the area.

1.12.1 The aircraft crashed on a bushy terrain, close to the electrical power lines. The aircraft collided with a tree and swung around approximately 180 degrees to face the opposite direction of the approach path before coming to a stop; thereafter, a post-impact fire ensued.

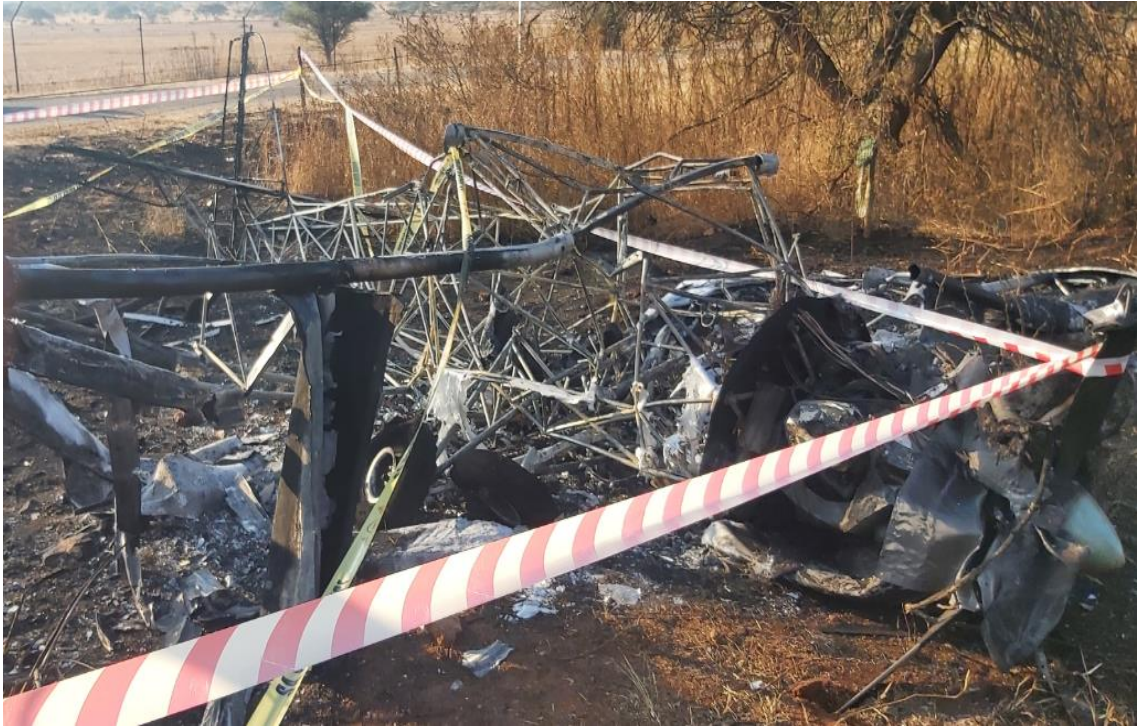
**Figure 4:** The main landing gear wheels were found on the right-side of the wreckage.

1.12.2 The left-side main gear was observed near the right-side main landing gear; whilst the left-side landing gear strut was bent towards the right-side main landing gear.

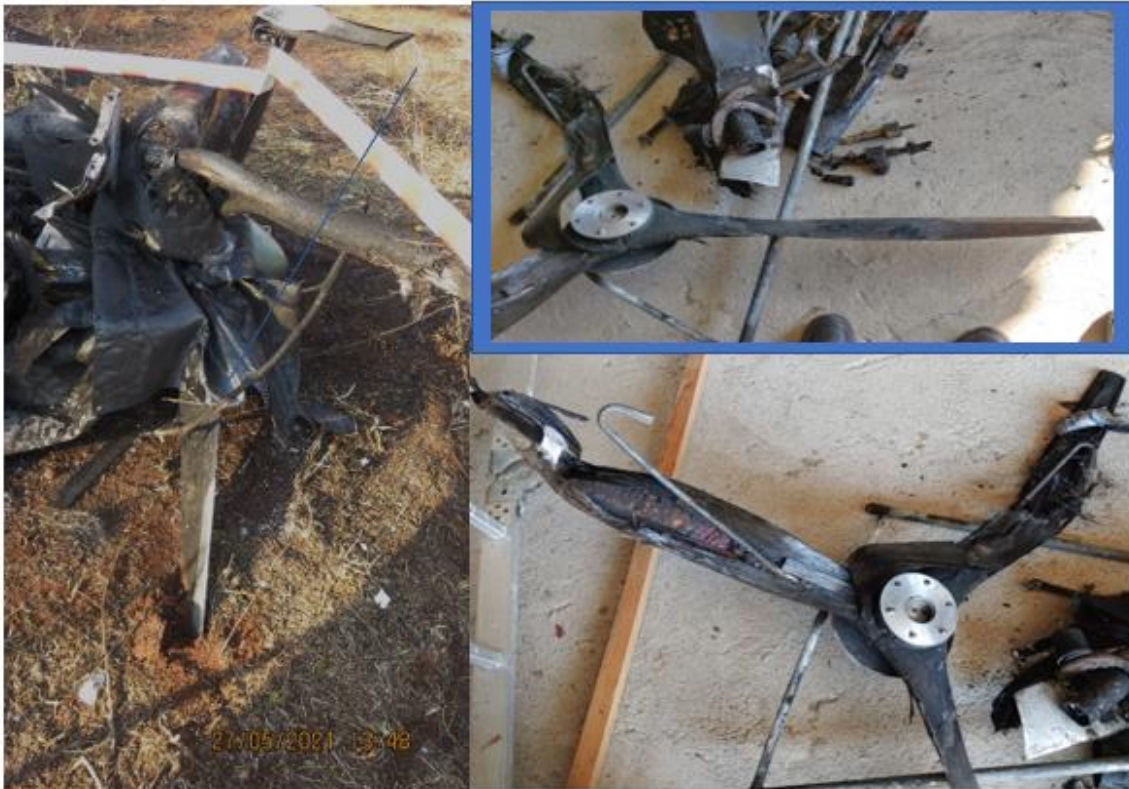
**Figure 5:** The damage on the propeller blades.

1.12.3 The aircraft was equipped with a three-bladed propeller, and two of the propeller blades were damaged by post-impact fire. One of the propeller blades was found with no damage. The damage to the composite propeller blades was indicative of an engine that was not turning during collision with the tree.
