LIMITED ACCIDENT INVESTIGATION REPORT

Reference Number	CA18/2/3/10008						
Classification	Accident	Date	24 May 2021	Time	1100Z		
Type of Operation	Aerial Work (Part 137)						
Location							
Place	Offshore, Table Bay, about 4km south of Robben Island						
GPS Co-ordinates	Latitude	S33°51'40"	Longitude	E018°25'43"	Elevation	25m	
Aircraft Information							
Registration	ZT-UTG						
Model/Make	DJI Phantom 4 Pro						
Damage to Aircraft	Drone not recovered		Total Aircraft Hours	21.20			
Pilot-in-command							
Licence Type	Remote Pilot Licence		Gender	Male	Age	48	
Licence Valid	Yes						
Total Hours on Type	103.58		Total Flying Hours	103.58			
People On-board	0	Injuries	0	Fatalities	0	Other (on Ground)	0
What Happened							
<p>On 24 May 2021, a pilot was conducting aerial work using a DJI Phantom 4 Pro drone with registration mark ZT-UTG, less than 2 nautical miles (about 4km) south of Robben Island when the accident occurred. The drone flight was a commercial operation.</p> <p>After taking aerial pictures of a ship in the sea at around 1100Z, the drone was piloted back to base, however, it lost communication with the controller/pilot en route. According to the pilot, there were

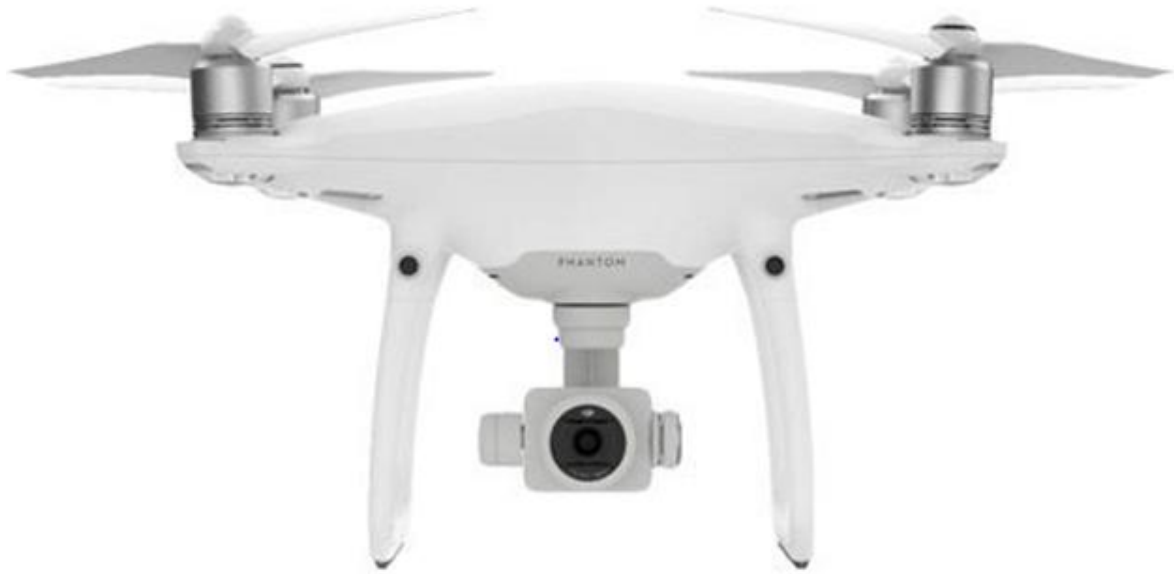
Figure 1: DJI Phantom 4 Pro (source: Google)

Drone pilots operating within line of sight should ensure that conditions around their area of operation are conducive for a safe flight and that there are no obstructions in their line of sight.
