LIMITED ACCIDENT INVESTIGATION REPORT

Reference Number	CA18/2/3/10009						
Classification	Accident	Date	1 June 2021	Time	0945Z		
Type of Operation	Helicopter Aerial Work (Part 128)						
Location							
Place of Departure	Farm Middelwater in the Brandfort District, Free State Province			Place of Intended Landing	Same Farm		
Place of Accident	Farm Middelwater in the Brandfort District, Free State Province						
GPS Co-ordinates	Latitude	28°54'21.60"S	Longitude	2618'48.73"E	Elevation	4346 feet	
Aircraft Information							
Registration	ZS-RVD						
Make / Model	Schweizer 269C (Serial No. S1849)						
Damage to Aircraft	None		Total Aircraft Hours	2 319.4			
Pilot-in-command							
Licence Valid	Yes	Gender	Male		Age 33		
Licence Type	Commercial Pilot						
Total Hours on Type	1 943.9		Total Flying Hours	5 098.0			
People On-board	1 + 1	Injuries	1	Fatalities	0	Other (On Ground)	0
What Happened							
<p>On Tuesday morning, 1 June 2021, the pilot on-board a Schweizer 269C helicopter with registration ZS-RVD took off from New Tempe Aerodrome (FATP), just outside Bloemfontein, and landed on the game farm Middelwater in the Brandfort District.</p> <p>After the two doors were removed from t

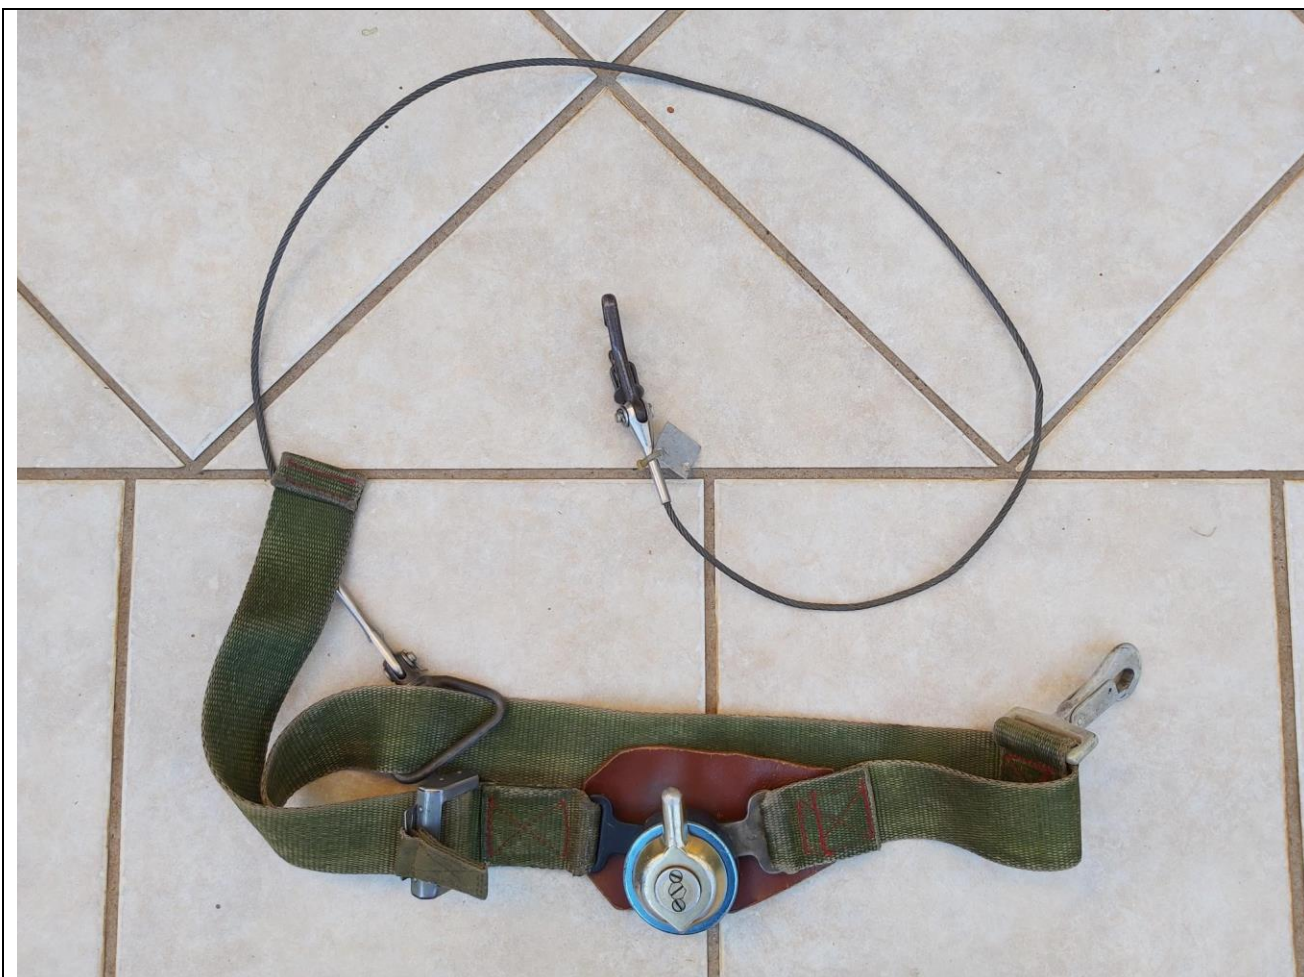
The safety harness (lap strap) was inspected after the accident and was found to be intact and serviceable. The passenger did not make use of an additional safety harness (see Figure 1).

Figure 1: Additional safety harness.

The passenger most probably inadvertently unlatched his safety harness while manoeuvring in the helicopter to dart the buffalos and, during the right turn, lost his seating and fell out of the helicopter.

The passenger did not make use of an additional safety harness as a backup to the helicopter-equipped safety harness.

Safety Message and/or Safety Recommendation/s	
<p>Safety Recommendation: It is recommended that the Director of Civil Aviation mandates the use of an additional safety harness for all operations in which a crew member or a person exposes any part of their body outside of the helicopter.</p> <p>Safety Message: All operators involve in game work and associated helicopter operations should ensure that crew members and/or passengers on-board with a specific function (i.e., game darting, game culling, hoisting) be equipped with an alternate safety harness to avoid such persons from falling out of the helicopter and suffering a serious injury and/or loss of life. The adjustable safety harness should be attached to a hard point in the helicopter.</p>	
Purpose of the Investigation	
<p><i>In terms of Part 12.03.1 of the Civil Aviation Regulations (CAR) 2011, this report was compiled in the interest of the promotion of aviation safety and the reduction of the risk of aviation accidents or incidents and not to apportion blame or liability.</i></p>
