<b>AIRCRAFT ACCIDENT REPORT AND EXECUTIVE SUMMARY</b>
---

<b>Reference:</b>		CA18/2/3/10010	
<b>Aircraft Registration</b>	ZU-BJY	<b>Date of Accident</b>	2 June 2021		<b>Time of Accident</b>	1428Z	
<b>Type of Aircraft</b>	Tecnam P92 Echo			<b>Type of Operation</b>	Training (Part 141)		
<b>Pilot-in-command Licence Type</b>	Commercial Pilot Licence (CPL) (Aeroplane)		<b>Age</b>	21	<b>Licence Valid</b>	Yes	
<b>Pilot-in-command Flying Experience</b>	<b>Total Flying Hours</b>		252.2		<b>Hours on Type</b>	17.1	
<b>Last Point of Departure</b>	Grand Central Airport (FAGC), Gauteng Province						
<b>Next Point of Intended Landing</b>	Grand Central Airport (FAGC), Gauteng Province						
<b>Damage to Aircraft (Substantial/Destroyed)</b>	Substantial						
<b>Location of the accident site with reference to easily defined geographical points (GPS readings if possible)</b>							
Runway 17 at Grand Central Airport at GPS co-ordinates determined to be S25°59'13" E028°8'26" at an elevation of 5289 feet

**Reference Number** : CA18/2/3/10010  
**Name of Owner/Operator** : Appelo Aviation  
**Manufacturer** : Tecnam C, Aeronautiche SRL  
**Model** : P92 Echo  
**Nationality** : South African  
**Regi

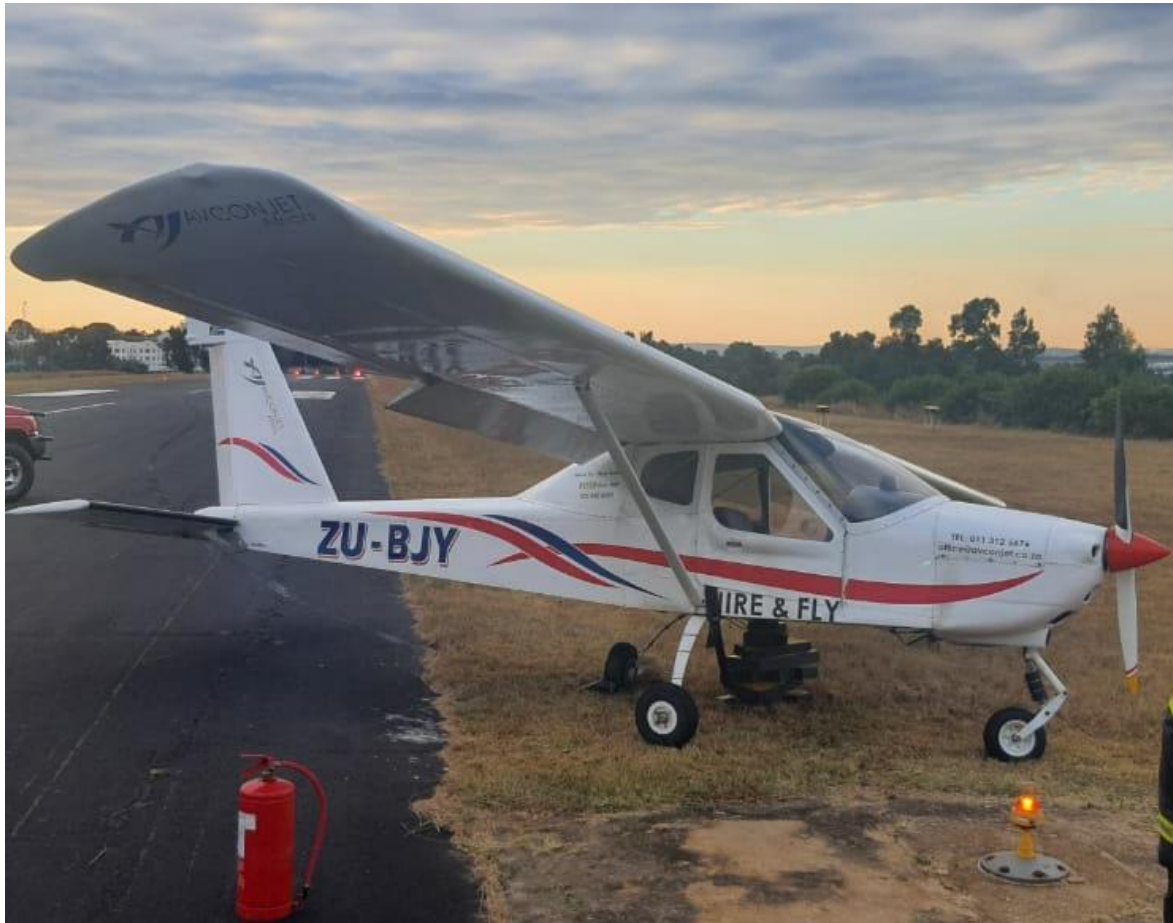
1.3.1 The aircraft sustained substantial damage during the accident sequence.

Figure 2: The aircraft post-accident with the damaged left gear.

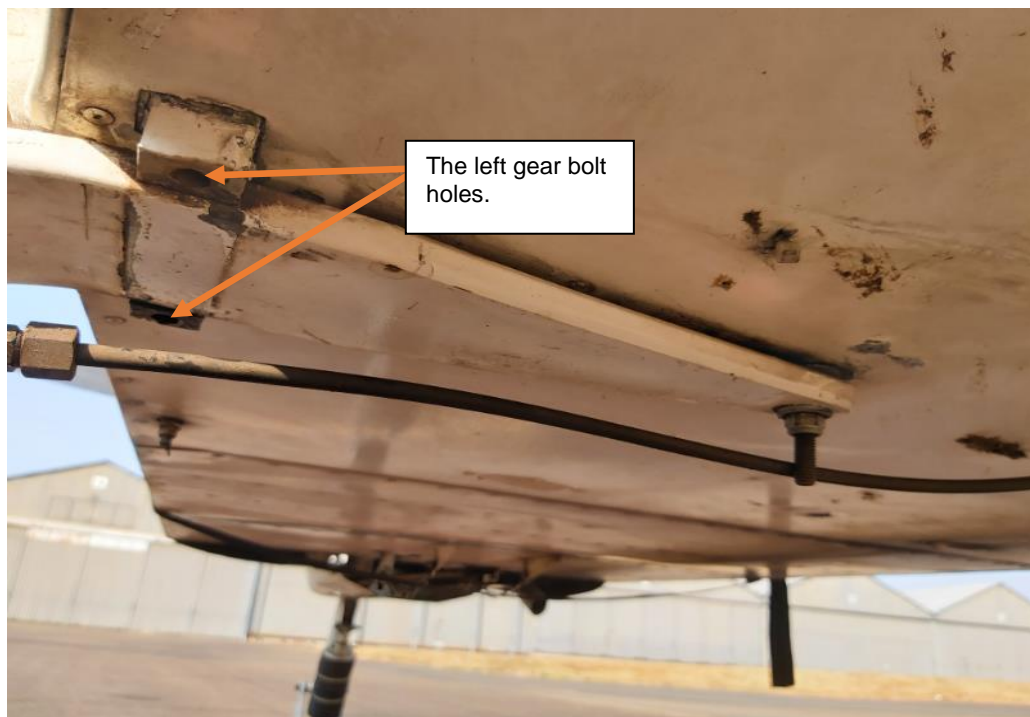
1.12.1 During landing on Runway 17, the left main landing gear attachment bolts failed. This resulted in the aircraft veering uncontrollably to the left-side of Runway 17. The right main landing gear had all three bolts intact, while the left main landing gear had only one bolt intact; two left gear attachment bolts and nuts were missing. When the student pilot and the instructor disembarked the aircraft, they noted that the aircraft was leaning to the left-side.

**Figure 4:** The left landing gear attachment area.

- 1.12.3 The instructor reported that there was ample fuel (approximately 50 litres) remaining inside the tanks at the time of landing.
- 1.12.4 Further investigation of the failed undercarriage at the maintenance facility revealed that whilst the spring appeared undamaged, the bolts and nuts failed (the structure is shown in Figure 4). The undercarriage leaf spring is attached to the airframe by three bolts and nuts, with the outer two holding the clamp; together with the inner bolt and nut they secure the spring in place against the airframe structural beam. The left gear inner bolt and nut were the only one remaining following the failure of the outer left gear attachment bolts and nuts. This resulted in the left gear rolling backwards during the landing roll. The Approved Person (AP) and aerodrome fire and rescue services personnel reported that they could not locate the two failed bolts and nuts following the runway inspection.

1.16.1 After the aircraft was recovered to a hangar at FAGC, the aircraft maintenance organisation (AMO) reported that they inspected the aircraft and found that the gear had collapsed due to shear force, shearing off the two attachment bolts that held the gear in position (part number [P/N] MS20005-24 internal wrenching bolt 5/16-24). Therefore, they had to replace the bottom skin, all left-side gear attachment hardware and landing gear bracket. Moreover, a 4130 brace .250 had to be replaced on the welded airframe structure.

was carried out on 21 February 2021. It is, thus, probable that the failure of the two attachment bolts was a result of a fatigue crack which propagated over time until the accident date during landing at FAGC. The failure of the two outer bolts and nuts resulted in the left gear swinging backwards during the landing roll; the pilot was unable to control the aircraft and, subsequently, the aircraft veered off to the left-side of the runway.

4.2.1 (1) It is recommended that the manufacturer considers the inclusion of the NDT inspection on the landing gear attachment bolts and nuts; as well as determine the timeframes on which these inspections should be carried out.

(2) It is recommended that the Director of Civil Aviation (DCA) issues a mandatory Airworthiness Directive (AD) which will mandate the inspection of landing gear attachment bolts and nuts for cracks using a NDT on all aircraft type similar to the accident aircraft prior to their next flight.

4.2.2 Safety message: All owners/operators of the aircraft type similar to the accident aircraft are to inspect the landing gear attachment bolts and nuts for cracks using the NDT prior to their next flight.

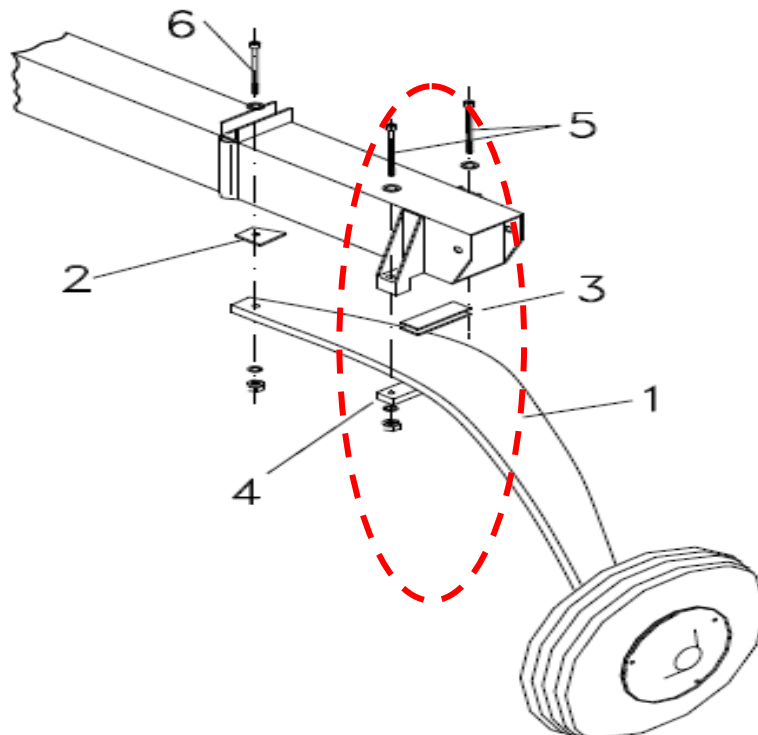
*The main landing gear consists of two special steel spring-leaf strut positioned crossways to the fuselage for elastic cushioning of landing loads. The two steel spring-leaf struts are attached to the fuselage underside via the main girder. Two rawhide liners are inserted between each spring-leaf and the girder. Two nuts secure the individual spring-leaf to the edge of the girder via a light alloy clamp while a single bolt and nut secures the inboard end of the leaf-spring to the girder. On ZU-BJY aircraft, the bolts and nuts illustrated by number 5 in (Diagram 1) below were missing.*

**Diagram 1:** Main landing gear showing attachment bolts and nuts. (Source: AMM)
