LIMITED ACCIDENT INVESTIGATION REPORT

Reference Number		CA18/2/3/10012																						
Classification	Accident	Date	16 June 2021	Time	0730Z																			
Type of Operation		Private (Part 94)																						
Location																								
Place of Departure		Eagles Creek, Gauteng Province	Place of Intended Landing		Parys Airfield (FAPY), Free State Province																			
Place of Incident		Parys Airfield (FAPY) Runway 06, Free State Province																						
GPS Co-ordinates	Latitude	S26°53'13.9"	Longitude	E027°30'19.1"	Elevation	4740ft																		
Aircraft Information																								
Registration		ZU-KGV																						
Model/Make		Composite Technology Short Wing (CTSW)																						
Damage to Aircraft		Substantial	Total Aircraft Hours		525.76																			
Pilot-in-command																								
Licence Valid		Yes	Gender	Male	Age	63																		
Licence Type		National Pilot Licence (Aeroplane)																						
Total Hours on Type		74.53	Total Flying Hours		427.31																			
People On-board	1+1	Injuries	0	Fatalities	0	Other (On Ground)	0																	
What Happened																								
<p>On 16

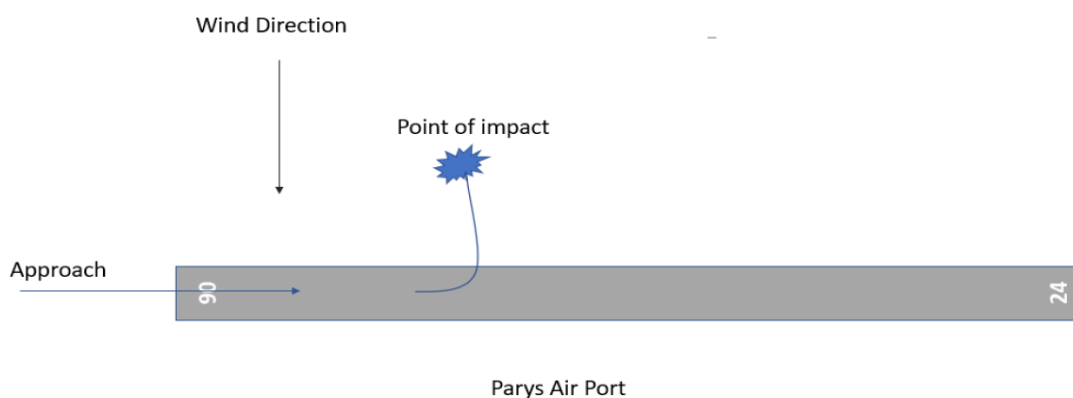
Wind shear, by definition, is a variation of wind velocity along a direction at right angles to the wind's direction and tending to exert a turning force. The aircraft may have been subjected to a wind shear from the left as the pilot was in the process of landing the aircraft.

Diagram 1: Illustration of the accident area. (Source: Pilot)
