LIMITED ACCIDENT INVESTIGATION REPORT
--

Reference Number		CA18/2/3/10013					
Classification	Accident	Date	16 June 2021	Time	1230Z		
Type of Operation	Private (Part 91)						
Location							
Place of Departure	Virginia Aerodrome (FAVG), KwaZulu-Natal Province	Place of Intended Landing	Rand Aerodrome (FAGM), Gauteng Province				
Place of Accident	End of Runway 23 at Virginia Aerodrome, KwaZulu-Natal Province						
GPS Co-ordinates	Latitude	S29°46'15"	Longitude	E031°03'37.0"	Elevation	20 feet	
Aircraft Information							
Registration	ZS-OIK						
Model/Make	Piper PA-46-350P (Malibu Mirage)						
Damage to Aircraft	Substantial		Total Aircraft Hours	1429.2			
Pilot-in-command							
Licence Type	Commercial Pilot Licence (CPL)	Gender	Male	Age	64		
Licence Valid	Yes						
Total Hours on Type	68.2		Total Flying Hours	994.3			
People On-board	1 + 1	Injuries	0	Fatalities	0	Other (on ground)	0
What Happened							
<p>On Wednesday, 16 June 2021, the pilot accompanied by a passenger on-board a Piper PA-46-350P with registration ZS-OIK intended to conduct a private flight from Virginia Aerodrome (FAVG) to Rand Aerodrome (FAGM). The flight plan was filed, and the flight was conducted in visual

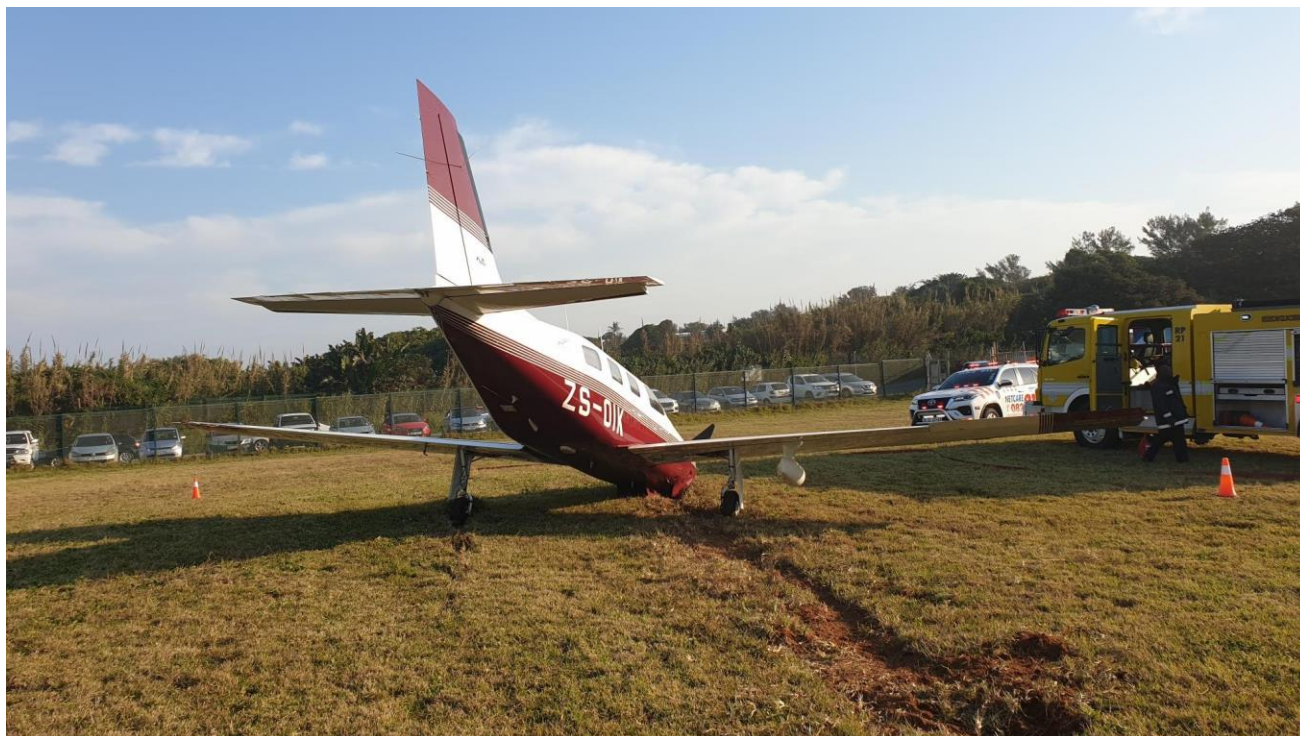
Figure 1: The aircraft as it came to rest. (Source: Pilot)

The pilot lifted off before reaching the recommended take-off speed and when he decided to abort take-off, it was too late. The aircraft overshot the runway and came to a stop on the grass (beyond the runway).

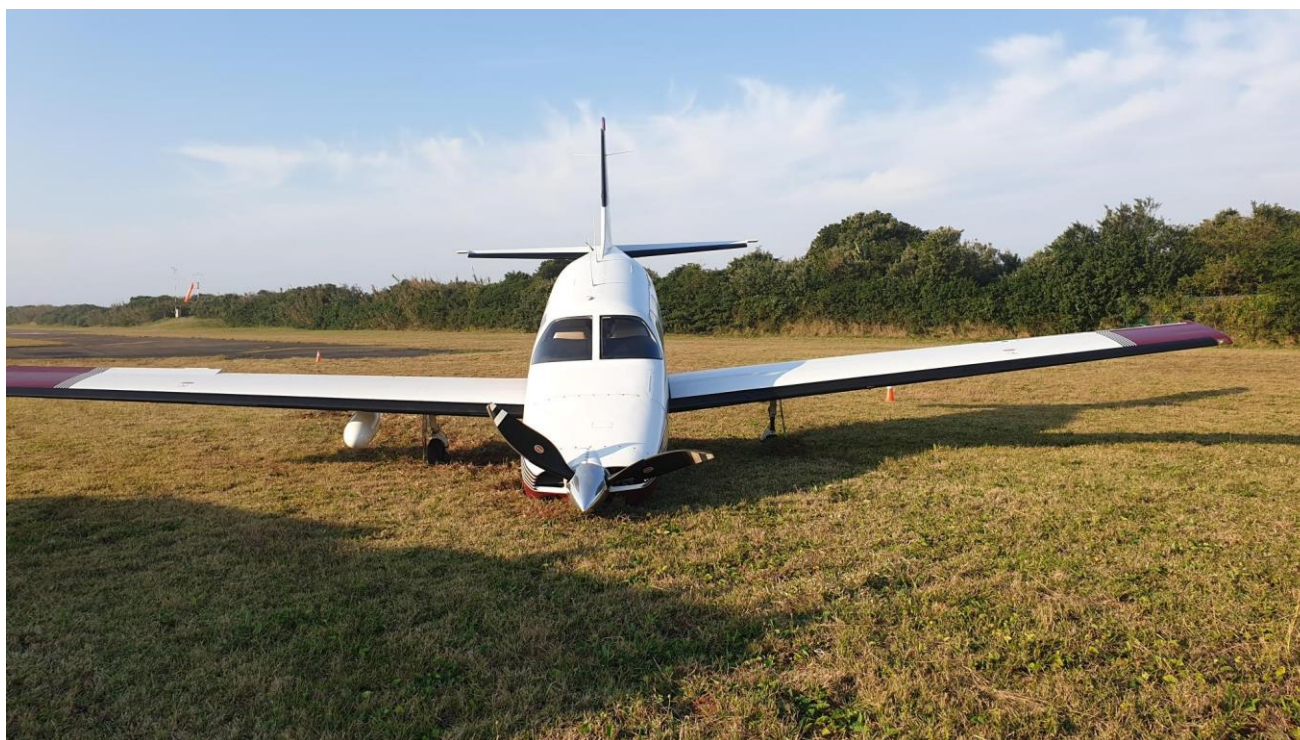
Figure 2: The resting position of the aircraft taken from the front. (Source: Pilot)

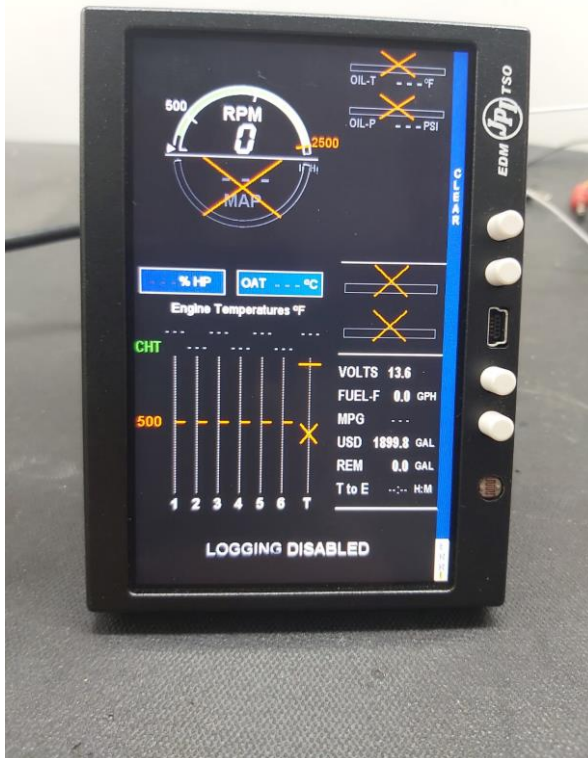
The aircraft was fitted with the JPI instrument, which is used to monitor engine parameters. It gives warning to the pilot if any parameters exceed the programmed limit. The instrument also collects data. The instrument was removed from the aircraft and was taken to an avionics shop for downloading. The JPI did not record the accident flight and the only data retrieved was for the flight which took place on 30 October 2020.

Figure 3: Picture of the JPI instrument which monitors engine parameters. (Source: Pilot)

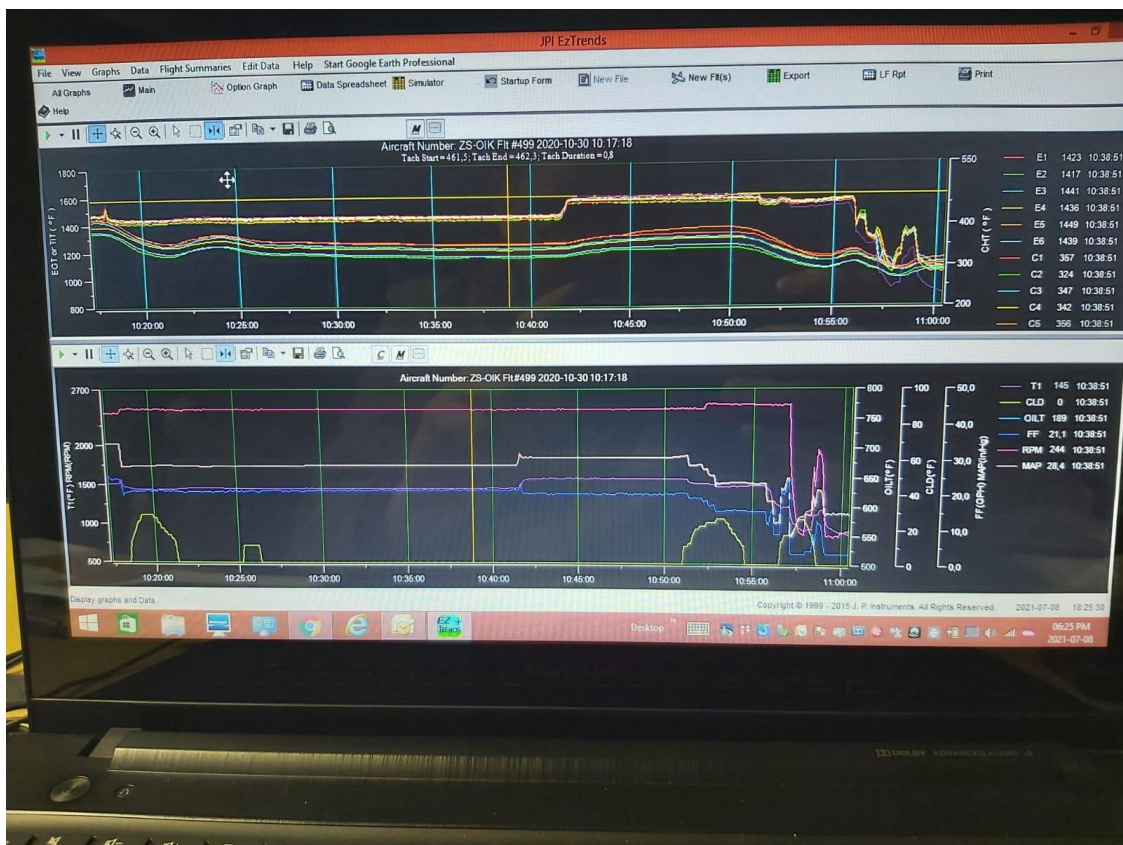
Figure 4: The last reading on the JPI instrument. (Source: Pilot)

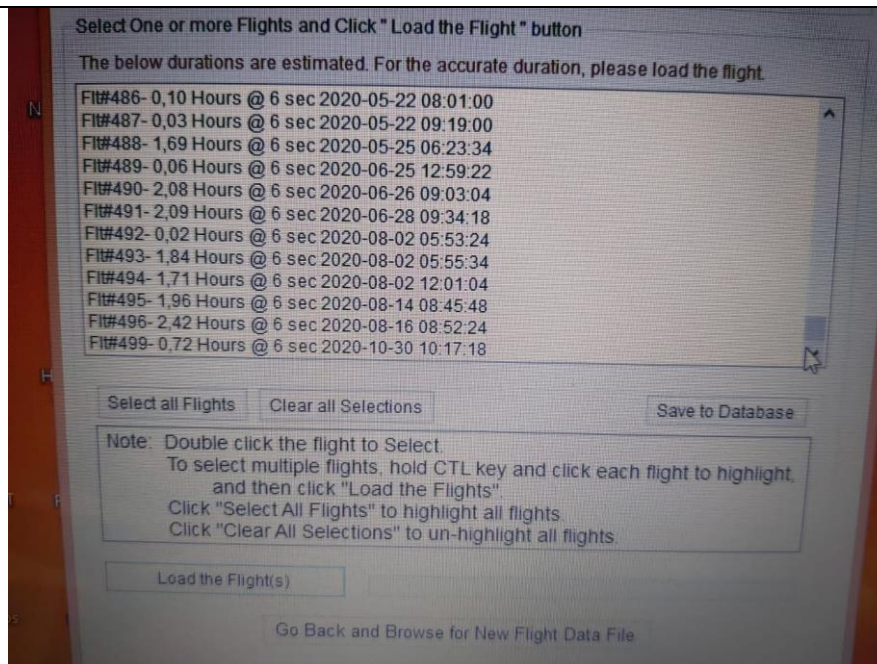
Figure 5: The last recording on JPI instrument. (Source: Pilot)
