Section/division Accident and Incident Investigations Division

LIMITED ACCIDENT INVESTIGATION REPORT

Reference Num	nber	CA1	8/2/3/10015									
Classification	Accident		Date		19 June 2021		Ti	Time		1445Z		
Type of Operation	Private (Part 94)						•		-			
Location												
Place of	Ste	Stellenbosch Aerodrome			Place of Intended Mo			Morr	orning Star Aerodrome			
Departure	(FA	SH)		L	Landing							
Place of Accide	ent											
GPS	Latitude		33°58'44.15" S		ongitude	018°49'18.28" E		Elevation	295 feet			
Co-ordinates												
Aircraft Information												
Registration	egistration Z			ZU-RBM								
Make / Model		Auto-Gyro Cavalon (Serial No. Y00196)										
Damage to Aircraft		Substantial			Total Aircraft Hours		1	188.7				
Pilot-in-command												
Licence Type		National Pilot Licence			ender	Male			Age 65			
Licence Valid	alid Yes											
Total Hours on Type		141.3			Total Flying Hours			4	411.8			
People On-board	1+	0 Ir	njuries	0	Fatalities		0	_	Other On Ground)	0		
What Happen	ed	l						1 (<u> </u>

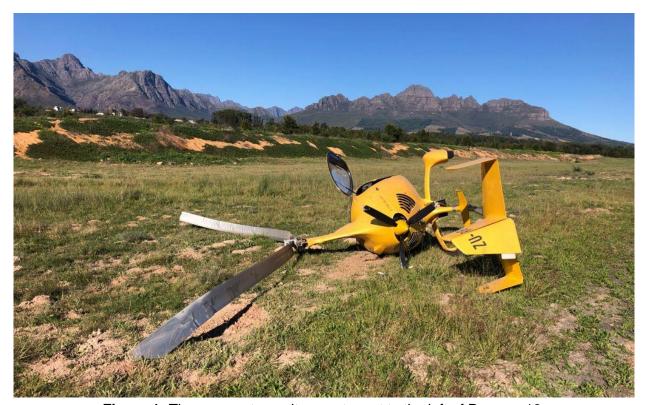
Before the control stick was fully back, he released the brakes, resulting in the gyrocopter accelerating too fast and the nose wheel becoming unstable. The gyrocopter rolled over to the left before skidding. It came to a halt on the grass surface next to the runway.

lower tail plane strikes the ground before the gyrocopter rolls to the left and the main rotor blades impact the grass surface next to the runway.

The pilot was not injured during the accident sequence, but the gyrocopter was substantially damaged.

Figure 1: The gyrocopter as it came to rest to the left of Runway 19.

Loss of control during take-off following the release of brakes prematurely prior to application of a full back pressure on the control stick.
