| LIMITED ACCIDENT INVESTIGATION REPORT |

| Reference Number | CA18/2/3/10016 | | | | | |
| Registration | ZS-NFI | | | | | |
| Model/Make | Beech 36 (Bonanza), Beech Aircraft (Serial Number: E 2712) | | | | | |

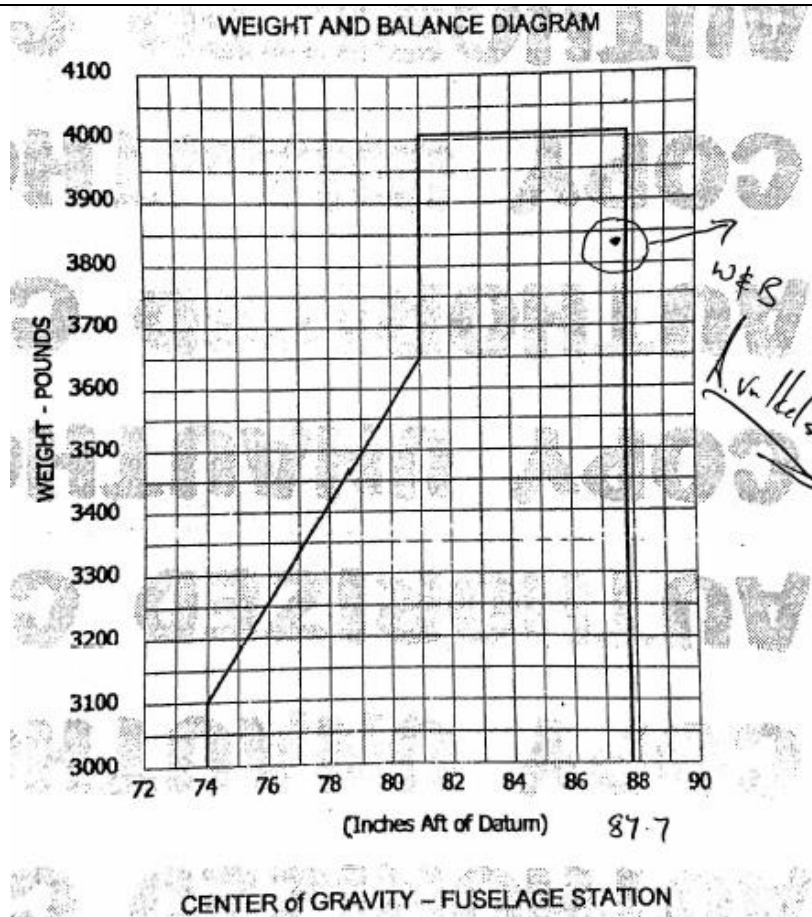
Figure 1: The centre of gravity (CoG) is close to the aft limit. (Source: Pilot)

The aircraft's left wing impacted a tree due to failure to climb since the centre of gravity (CoG) was too close to the aft limit. This resulted in the aircraft ground-looping 180° before coming to a stop facing the direction of take-off.

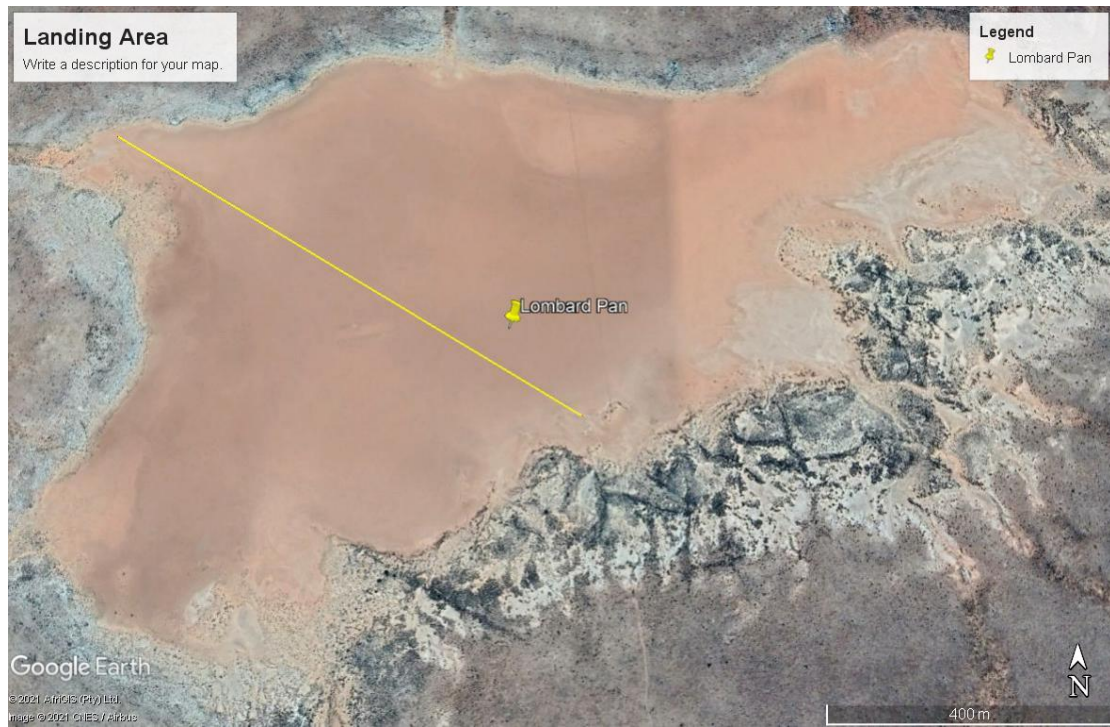
The pilot did not consider the resistance caused by gravel surface of the pan during his flight planning.

Figure 2: The Lombard pan used as a runway. (Source: Pilot)
