AIRCRAFT ACCIDENT REPORT AND EXECUTIVE SUMMARY

Reference:		CA18/2/3/10017	
Aircraft Registration	ZS-MZV	Date of Accident	28 June 2021		Time of Accident	0925Z	
Type of Aircraft	Cessna 182P (Serial No. 182-61343)		Type of Operation		Private (Part 91)		
Pilot-in-command Licence Type	Private Pilot Licence		Age	31	Licence Valid	Yes	
Pilot-in-command Flying Experience	Total Flying Hours		115.5		Hours on Type	42.7	
Last Point of Departure	Hoedspruit Civil Aerodrome (FAHT), Limpopo Province						
Next Point of Intended Landing	Rand Aerodrome (FAGM), Gauteng Province						
Damage to Aircraft	Substantial						
Location of the accident site with reference to easily defined geographical points (GPS readings if possible)							
Swampland in Wadeville (GPS position: 26°17'18.20" South 028°10'19.40" East), elevation 5 047 feet (ft)							
Meteorological Information	Surface wind; 350°/16kts, temperature; 17°C, dew point; -1°, CAVOK						
Number of People On-board	1 + 3	Number of People Injured	0	Number of People Killed	0	Other (On Ground)	0

Probable Cause							
The pilot's fuel management practise resulted in a complete loss of engine power due to fuel exhaustion; the pilot had no choice but to

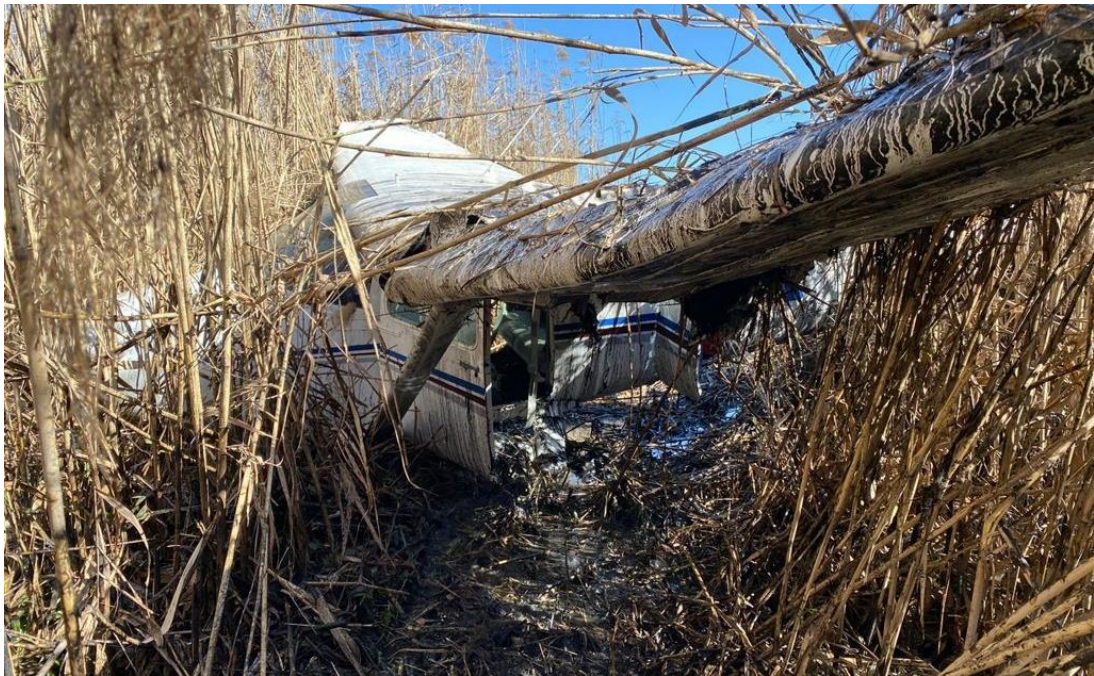
1.3.1 The aircraft was substantially damaged during the accident sequence.

Figure 3: The aircraft as it came to rest in a swampland.

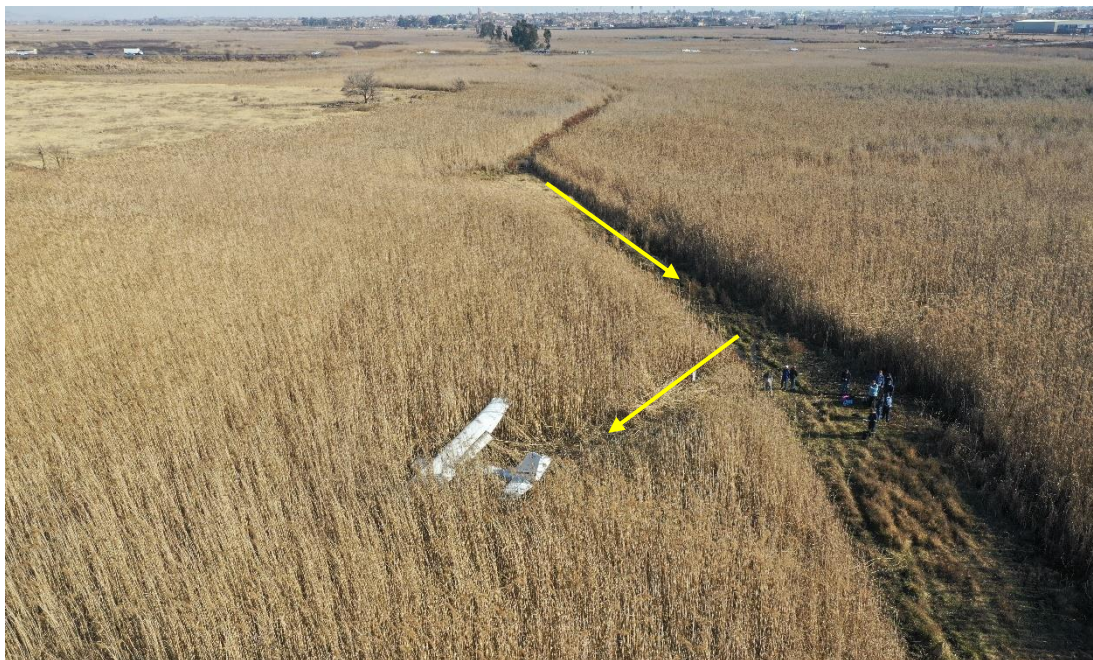
1.12.1 The pilot landed in a swampland on an open area between dense reed facing a north-easterly direction. The pilot was unable to maintain directional control and the aircraft veered off to the right, approximately 80 metres (m) after touchdown, and came to rest in a left-wing low attitude facing a southerly direction.

Figure 5: Aerial view of the terrain and the aircraft. (Source: AAS)

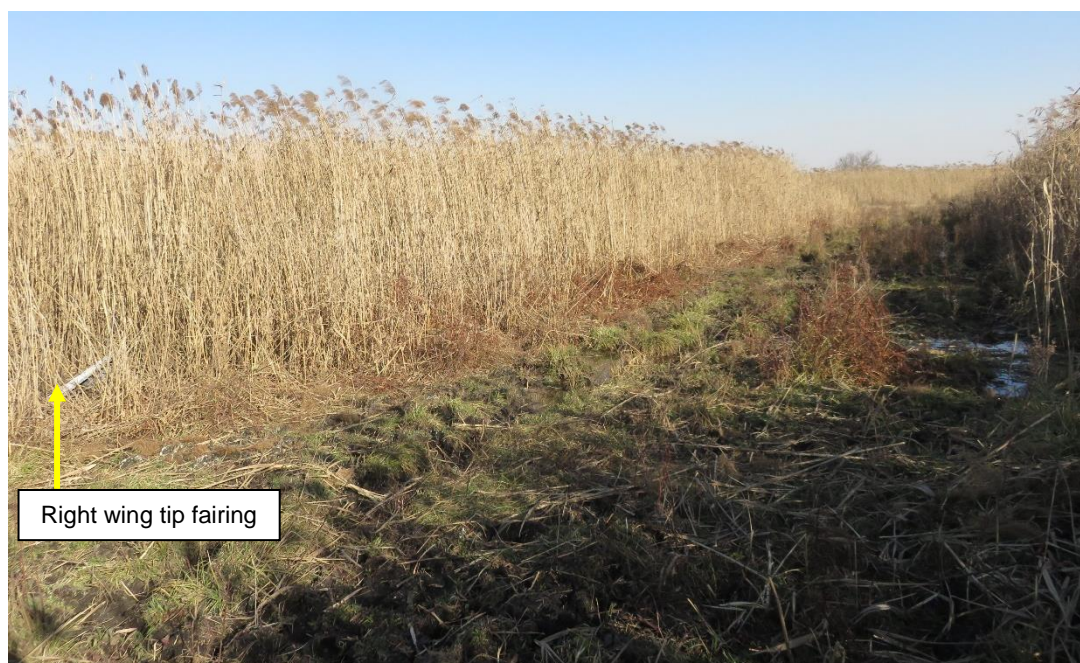
Figure 6: The open area that the pilot landed on.

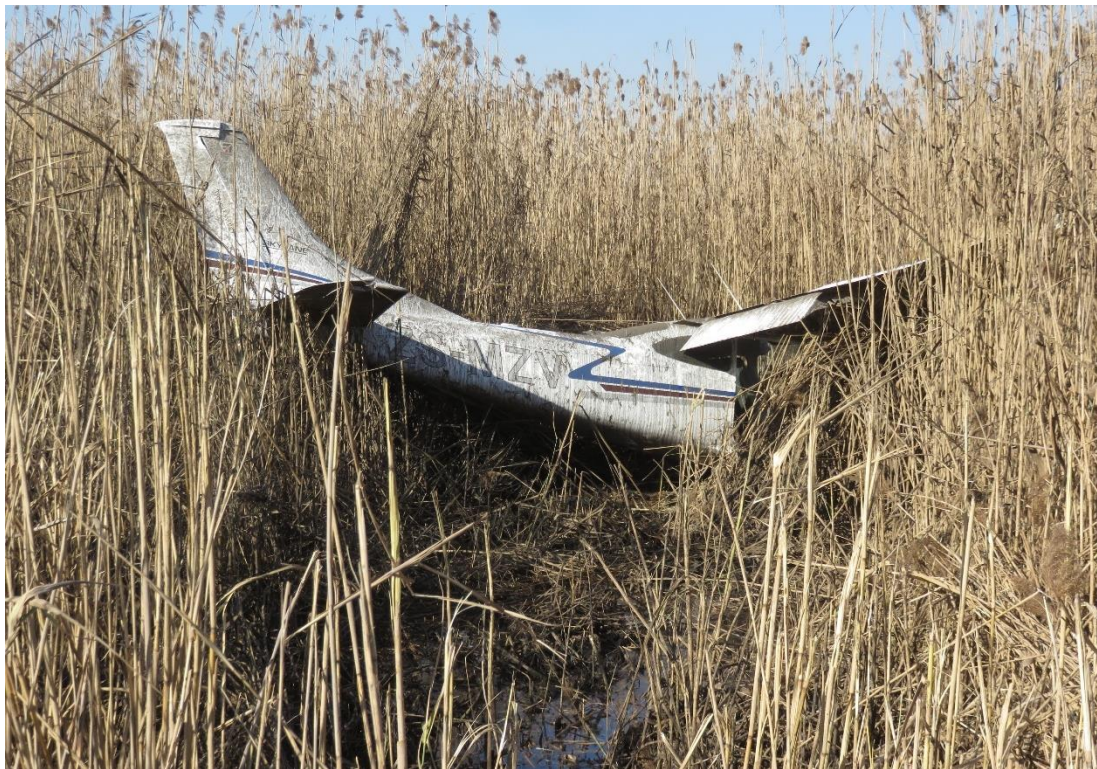
Figure 8: The aircraft as it came to rest.

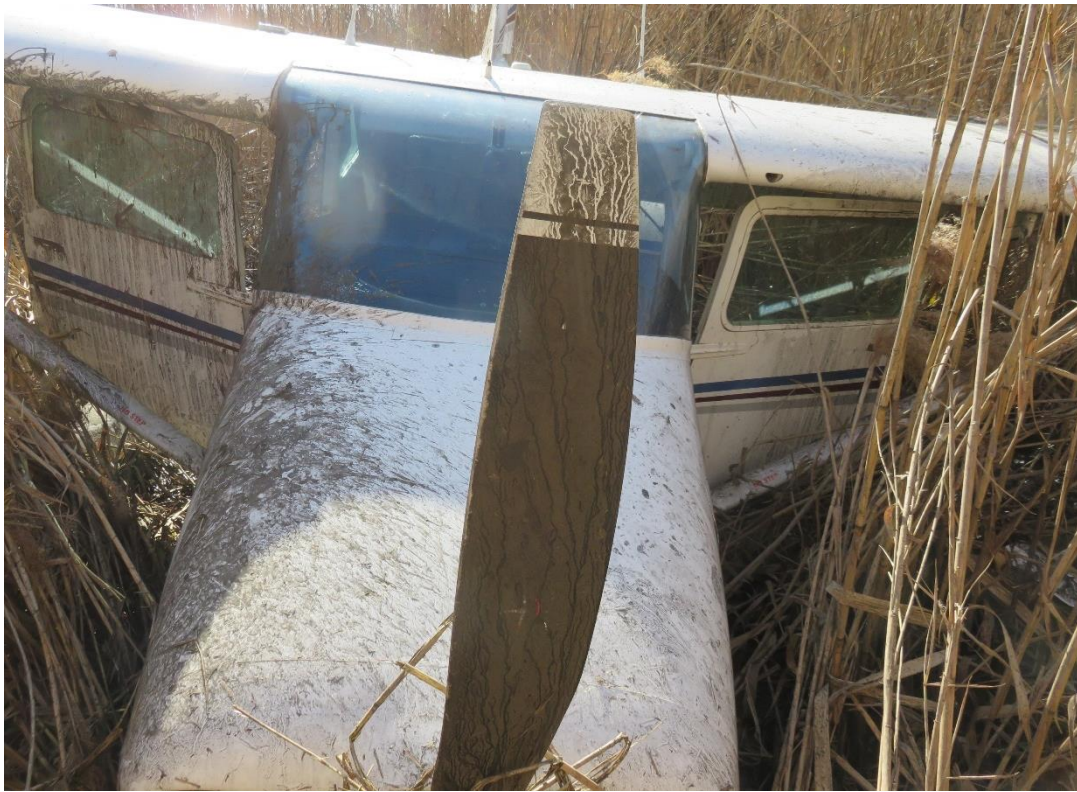
Figure 9: The front view of the aircraft with one of the propeller blades slightly bent.

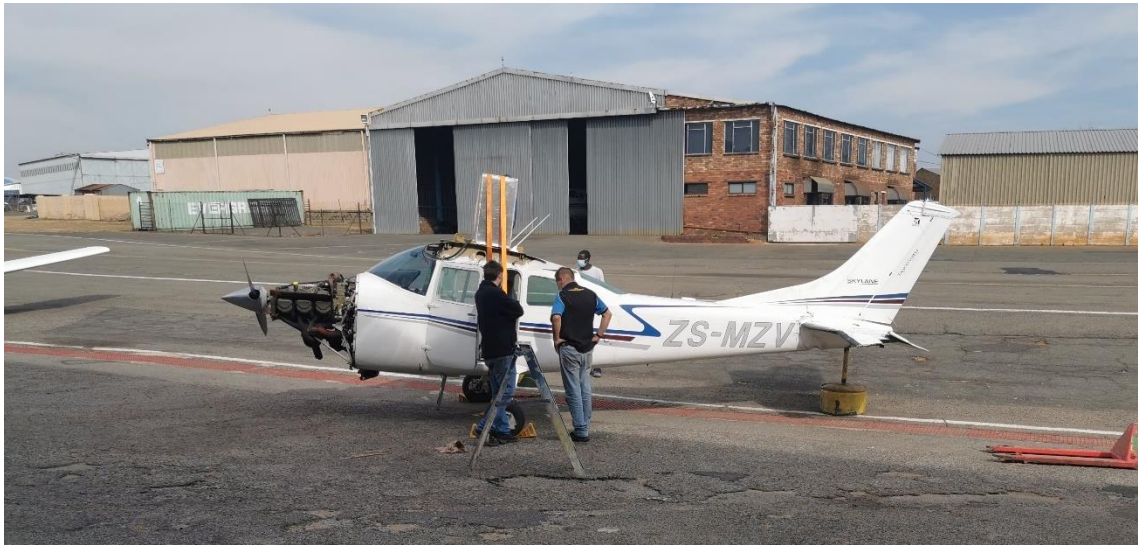
Figure 10: The engine ground run following recovery of the aircraft.

The engine stoppage was attributed to fuel exhaustion, which required the pilot to perform a forced landing. The post-recovery engine ground run confirmed that the engine was mechanically in working condition.

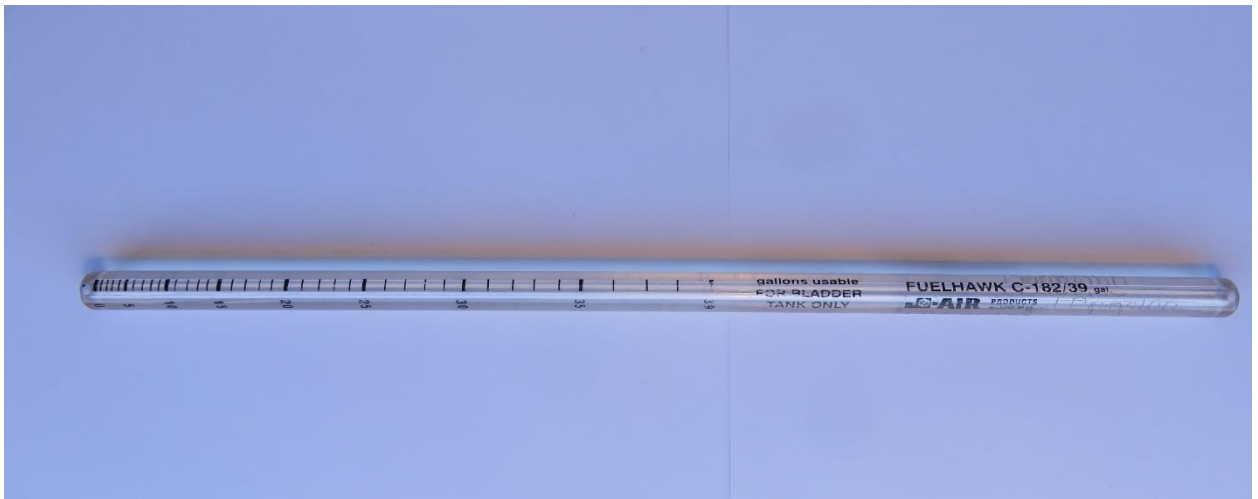
A transparent plastic tubular dipstick (see Figure 11) was used by the pilot for measuring the aircraft's fuel levels. This device is used by: *dipping it into the tank and holding the thumb over the end part/side, and then lifting it out.* Fuel level is read on the calibrated scale on the side of the tube.

Figure 11: The dipstick that was used by the pilot.

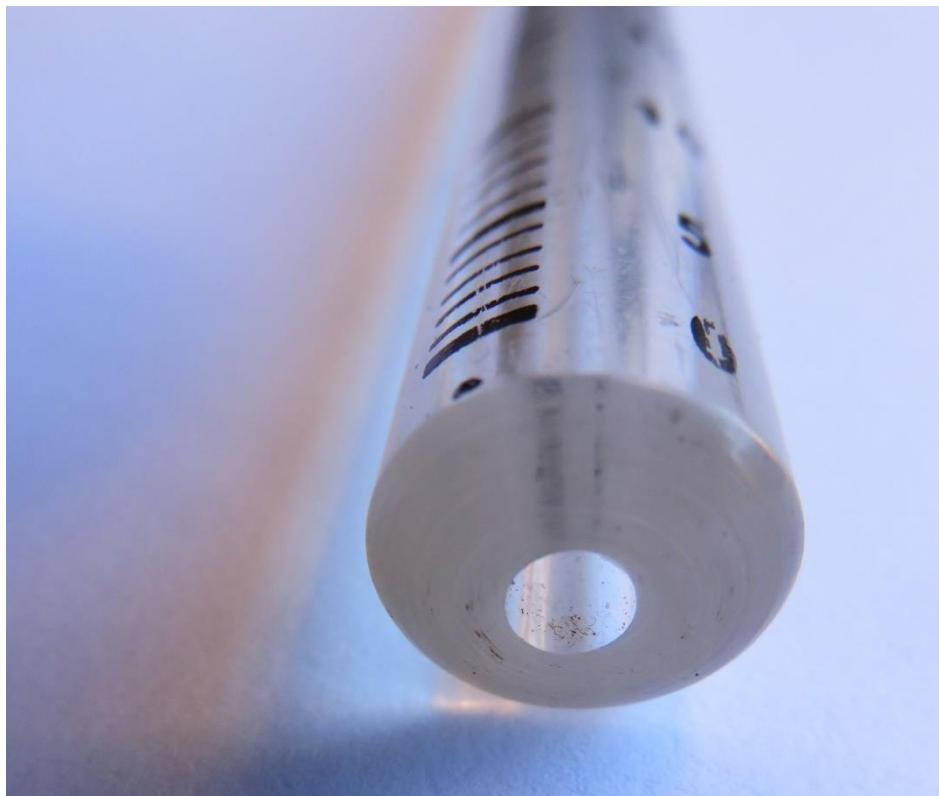
Figure 12: The dipstick viewed from the bottom end.
