<b>LIMITED ACCIDENT INVESTIGATION REPORT</b>
--

<b>Reference Number</b>		CA18/2/3/10018									
<b>Classification</b>		Accident	<b>Date</b>		27 June 2021	<b>Time</b>		1032Z			
<b>Type of Operation</b>		Private (Part 94)									
<b>Location</b>											
<b>Place of Departure</b>		Nelspruit Aerodrome (FANS), Mpumalanga Province		<b>Place of Intended Landing</b>			Geelbos farm, Standerton, Mpumalanga Province				
<b>Place of Accident</b>		Geelbos farm airstrip on a gravel runway in Standerton, Mpumalanga Province									
<b>GPS Co-ordinates</b>		<b>Latitude</b>		S27°03'.094	<b>Longitude</b>		E029°16'.957	<b>Elevation</b>		5 052 feet	
<b>Aircraft Information</b>											
<b>Registration</b>		ZU-NKC									
<b>Make / Model</b>		Flamingo VL 3A1									
<b>Damage to Aircraft</b>		Substantial		<b>Total Aircraft Hours</b>			603				
<b>Pilot-in-command</b>											
<b>Licence Valid</b>		Yes		<b>Gender</b>		Male		<b>Age: 59</b>			
<b>Licence Type</b>		National Pilot Licence (NPL)

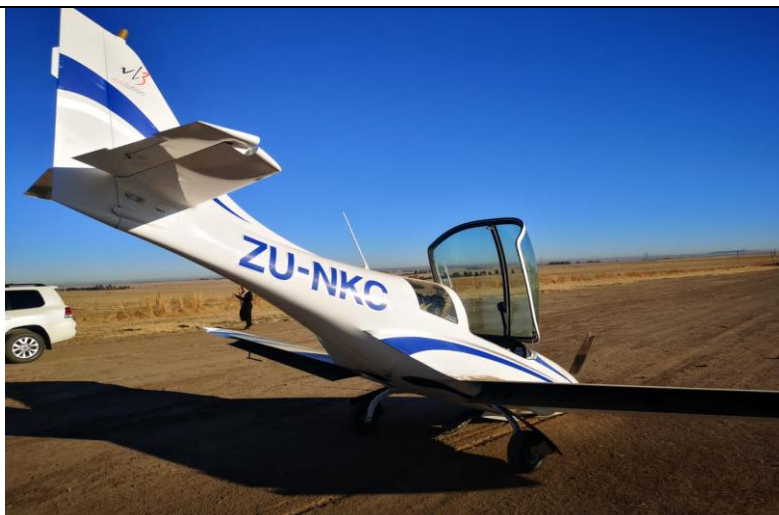
<b>Total Hours on Type</b>		31		<b>Total Flying Hours</b>			1 189				
<b>People On-board</b>		1 + 0		<b>Injuries</b>		0		<b>Fatalities</b>		0	
<b>Other (On Ground)</b>		0									
<b>What Happened</b>											
<p>On Sunday, 27 June 2021, the pilot being the sole occupant on-board a two-seat Flamingo VL 3A1 aircraft with registration ZU-NKC was on a private flight from Nelspruit Aerodrome (FANS) destined for Geelbos farm airstrip situated in Standerton, Mpumalanga province, when the accident occurred. The flight was conducted under Visual Meteorological Conditions (VMC) by day and no flight plan was filed. The pilot reported that the combined aircraft fuel tanks had a total of 100 litres of Avgas LL100 fuel. The aircraft took off uneventfully from FANS and climbed to 6500 feet at 135 knots indicated air speed (IAS). After one hour of flight time, the pilot approached the farm's airstrip for a full stop landing; and all was normal. He then extended the landing gear and executed an uneventful landing on the gravel runway at 60 knots IAS. However, during the landing roll as the aircraft's speed decreased, the nose gear collapsed, and the propeller blades struck the ground.</p>

**Figure 1:** The aircraft on the gravel runway post-accident. (Source: Pilot)

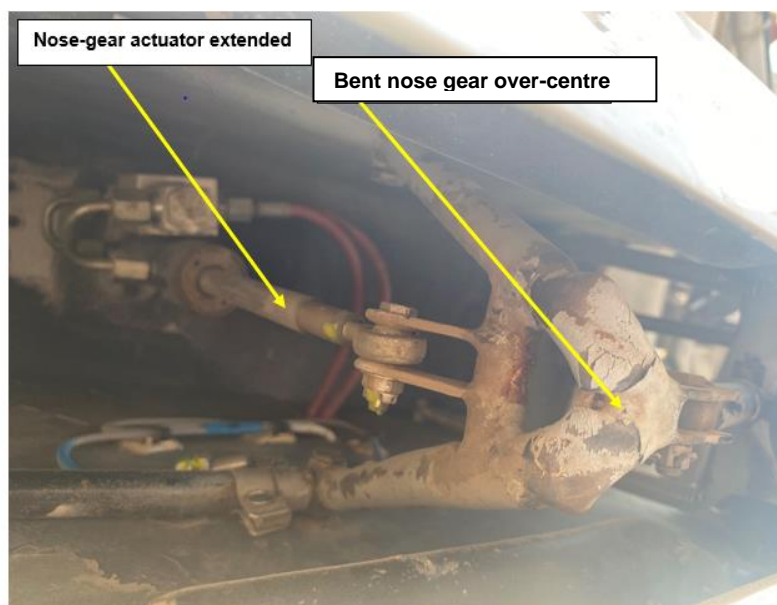
The aircraft was substantially damaged during the accident sequence; however, the pilot was not injured. The pilot switched off the master before disembarking the aircraft. Post-accident examination of the nose gear indicated that the strut had broken off (the fork and the top section separated). Examination of the landing gear indicated that it was in a down and locked position and the nose gear over-centre had bent and folded rearward after collapsing, causing the engine bottom cowling to skid on the runway surface. All available Service Bulletins (SBs) and applicable maintenance procedures were reviewed and none of them mandated a non-destructive testing (NDT) on the nose gear strut.

**Figure 2:** The nose-gear actuator and the bent gear over-centre.

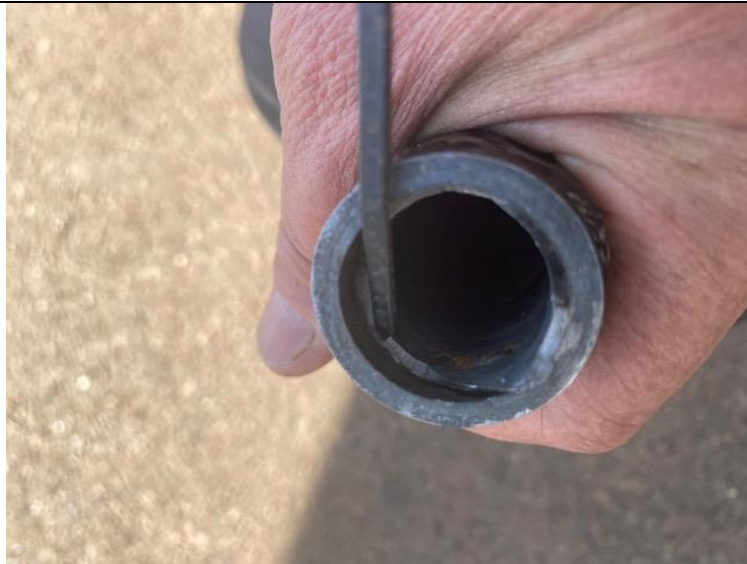
The investigation concluded that the nose gear strut broke off because of the presence of an existing fatigue crack (rusted area observed) most probably caused by previous hard landings. The fatigue crack gradually grew in service undetected until the nose gear broke off due to overload.

**Figure 3:** The area on the front-side of the nose gear strut where the crack initiated.

1. The Flamingo VL 3A1 aircraft nose gear strut had shown a susceptibility to fatigue cracking on the nose gear strut during operation. None on the Service Bulletins (SBs) issued by the aircraft manufacturer, AVEKO S.R.O, mandates or addresses a non-destructive testing (NDT) on the nose gear strut. It is recommended to the Director of Civil Aviation that he/she informs the manufacturer of the identified failure and to request that a study be conducted which would then give birth to the NDT inspection procedure, and that would be communicated through a mandatory Service Bulletin (SB).

2. It is recommended to the Director of Civil Aviation to mandate operators/owners of a Flamingo VL 3A1 aircraft type to conduct a non-destructive testing (NDT) inspection on nose gear struts during their next scheduled inspections and each time a hard landing is reported. Should cracks be detected, then the nose gear strut should be replaced.
