<b>LIMITED ACCIDENT INVESTIGATION REPORT</b>
--

<b>Reference Number</b>		CA18/2/3/10019					
<b>Classification</b>	Accident	<b>Date</b>	2 July 2021		<b>Time</b>	0930Z	
<b>Type of Operation</b>	Private (Part 94)						
<b>Location</b>							
Place of Departure		Syringa Sands Airstrip, Limpopo Province		Place of Intended Landing		Eagles Creek Aerodrome, Gauteng Province	
Place of Occurrence		Syringa Sands Airstrip, Limpopo Province					
GPS Co-ordinates		Latitude	24° 29' 19.47" S	Longitude	027° 48' 24.60" E	Elevation	4 750ft
<b>Aircraft Information</b>							
Registration		ZU-EPT					
Model/Make		Tecnam P-2004 Bravo					
Damage to Aircraft		Substantial		Total Aircraft Hours		950.1	
<b>Pilot-in-command</b>							
Licence Valid		Yes		Gender		Male      Age      30	
Licence Type		National Pilot Licence (NPL)					
Total Hours on Type		168.2		Total Flying Hours		201.4	
People On-board		1 + 1	Injuries	0	Fatalities	0	Other (on ground)      0
<b>What Happened</b>

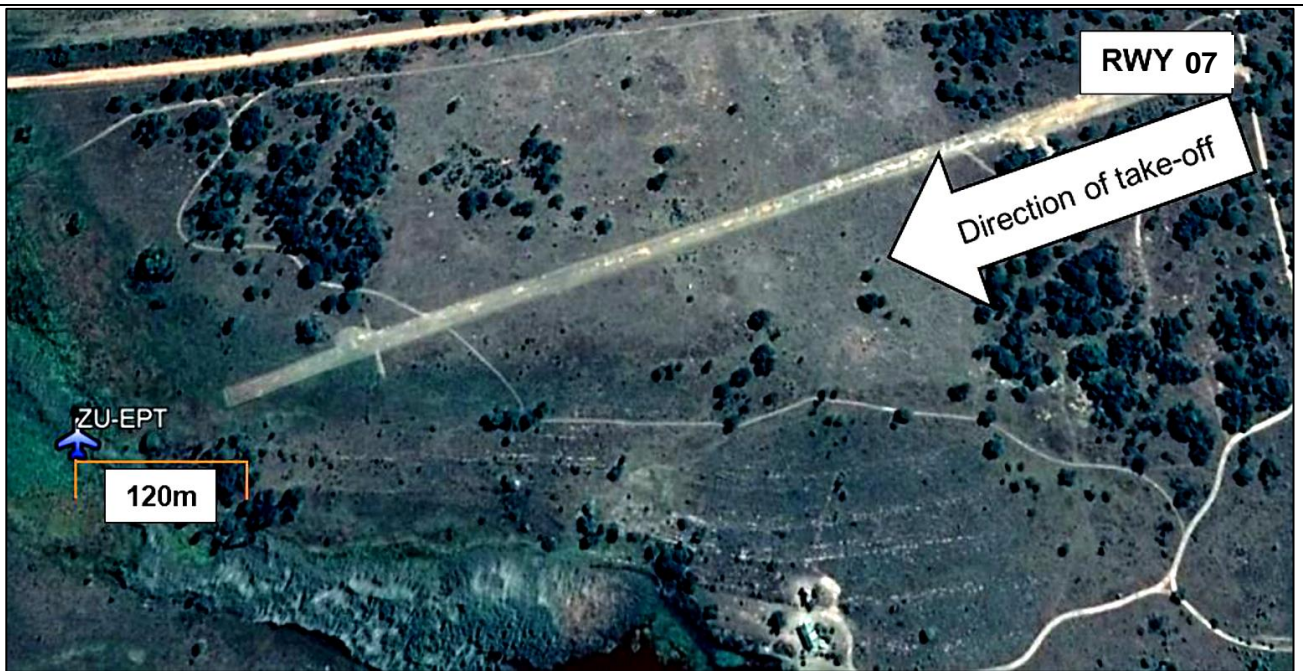
**Figure 1:** An aerial view of the accident site. (Source: Google Earth)

During landing, the pilot instructed the passenger to assume brace position; the aircraft overran the runway surface and came to a stop in a wetland in an upright position, about 120m from the end of RWY 07. The aircraft sustained substantial damage to its left wing as well as upper and bottom fuselage (due to the rugged thick grass terrain the aircraft skidded over on its path), and all three landing gears broke off.

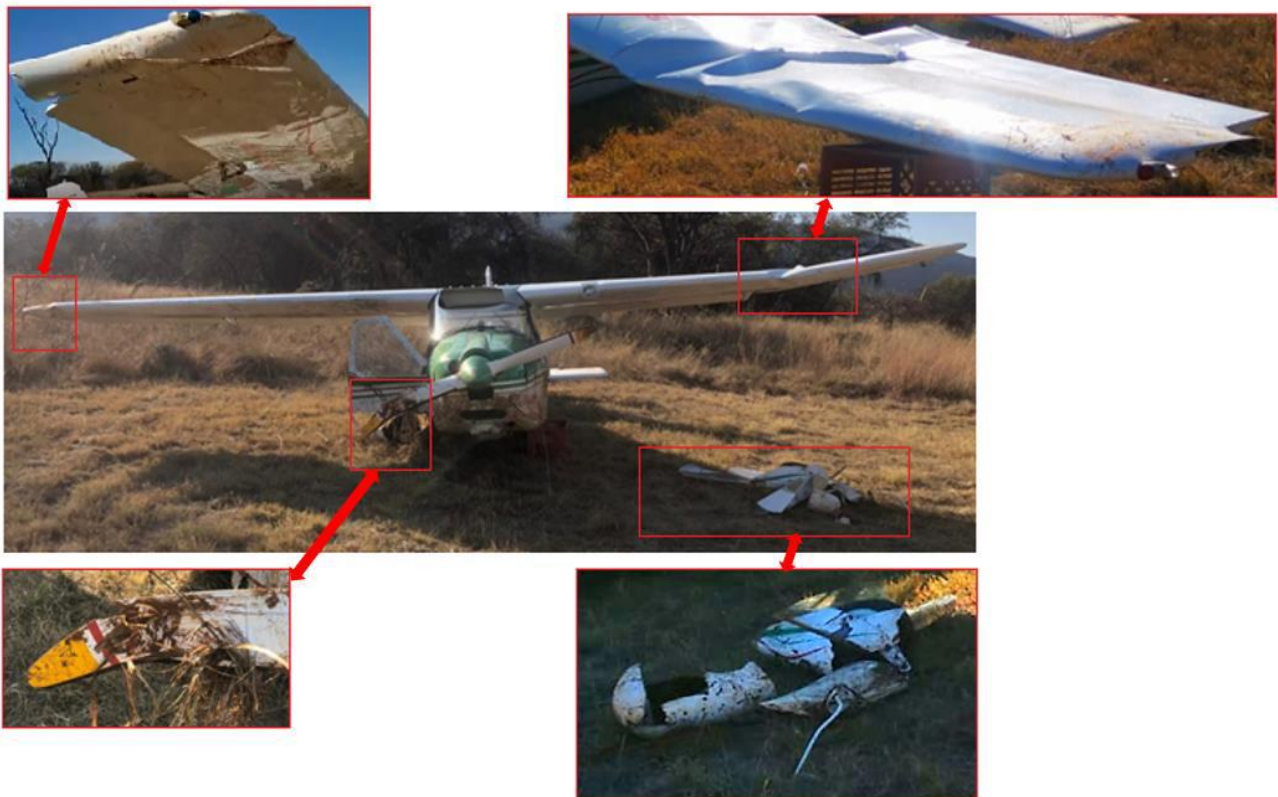
**Figure 2:** A collage showing post-impact damage to aircraft. (Source: Pilot)
