LIMITED ACCIDENT INVESTIGATION REPORT
--

Reference Number		CA18/2/3/10020					
Classification	Accident	Date	3 July 2021	Time	0848Z		
Type of Operation	Commercial (Part 135)						
Location							
Place of Departure	O.R. Tambo International Airport (FAOR)			Place of Intended Landing	Lapalala Private Airstrip, Limpopo Province		
Place of Accident	Lapalala Private Airstrip, Limpopo Province						
GPS Co-ordinates	Latitude	23°53'8" S	Longitude	28°18'16" E	Elevation	3923 ft	
Aircraft Information							
Registration	ZS-JEM						
Model/Make	Cessna 208B						
Damage to Aircraft	Substantial			Total Aircraft Hours	14010.8		
Pilot-in-command							
Licence Valid	Yes	Gender	Female		Age	32	
Licence Type	Commercial Pilot Licence (Aeroplane)						
Total Hours on Type	±643.9			Total Flying Hours	2362.2		
People On-board	2+1	Injuries	0	Fatalities	0	Other (on ground)	0
What Happened							
<p>On Saturday morning, 3 July 2021, two pilots and a third crew member on-board a Cessna 208B aircraft with registration marking ZS-JEM took off from Runway 03L at O.R. Tambo International Airport (FAOR), Gauteng province, to Lapalala private airstrip in Limpopo province. The flight was conducted under instrument

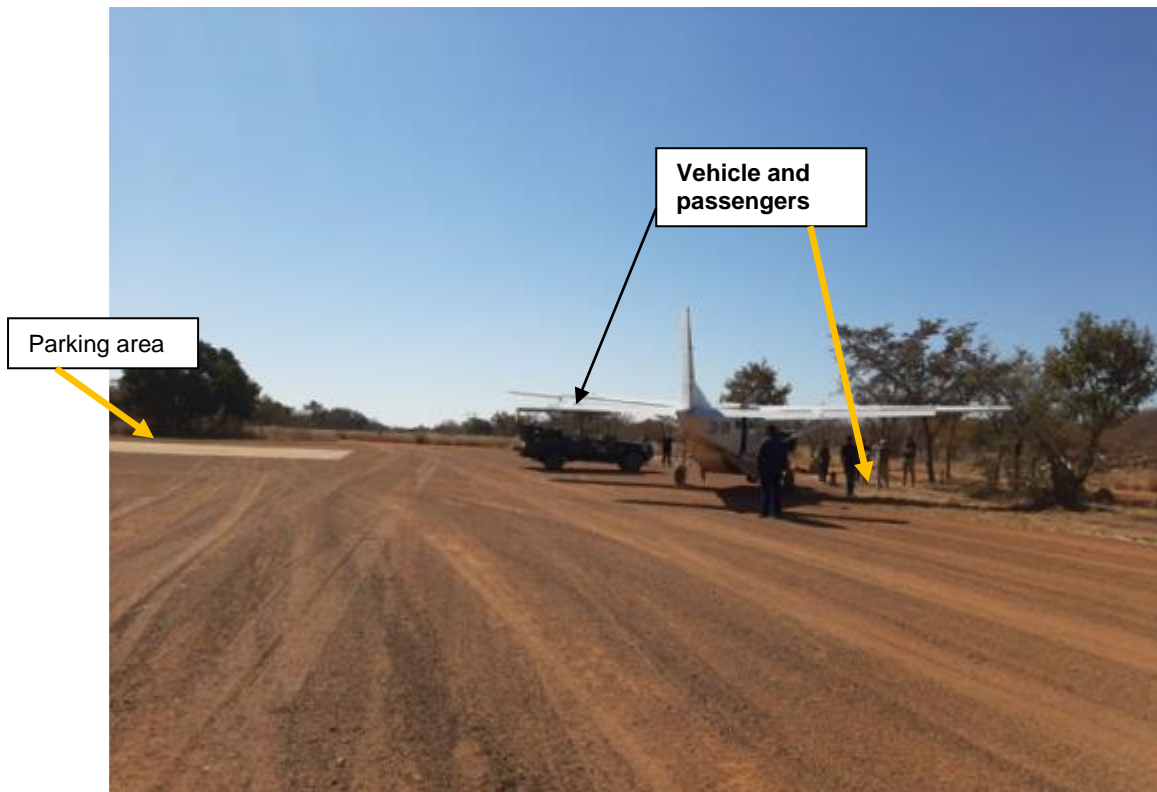
standing in the parking area, as well as two vehicles parked to the north-west side of the aircraft parking area. Both the PM and PF were concerned about the proximity of the passengers and vehicles to the aircraft as it approached the parking area. To reduce risk of incident with the vehicles and/or the passengers, the PF made a wide left turn to position the aircraft away from the vehicles. During the execution of the left turn, the right-side wing tip impacted a tree on the runway edge, causing damage to the aircraft. The occupants were not injured.

Figure 1: Position of the aircraft after collision with the tree. (Source: Operator)

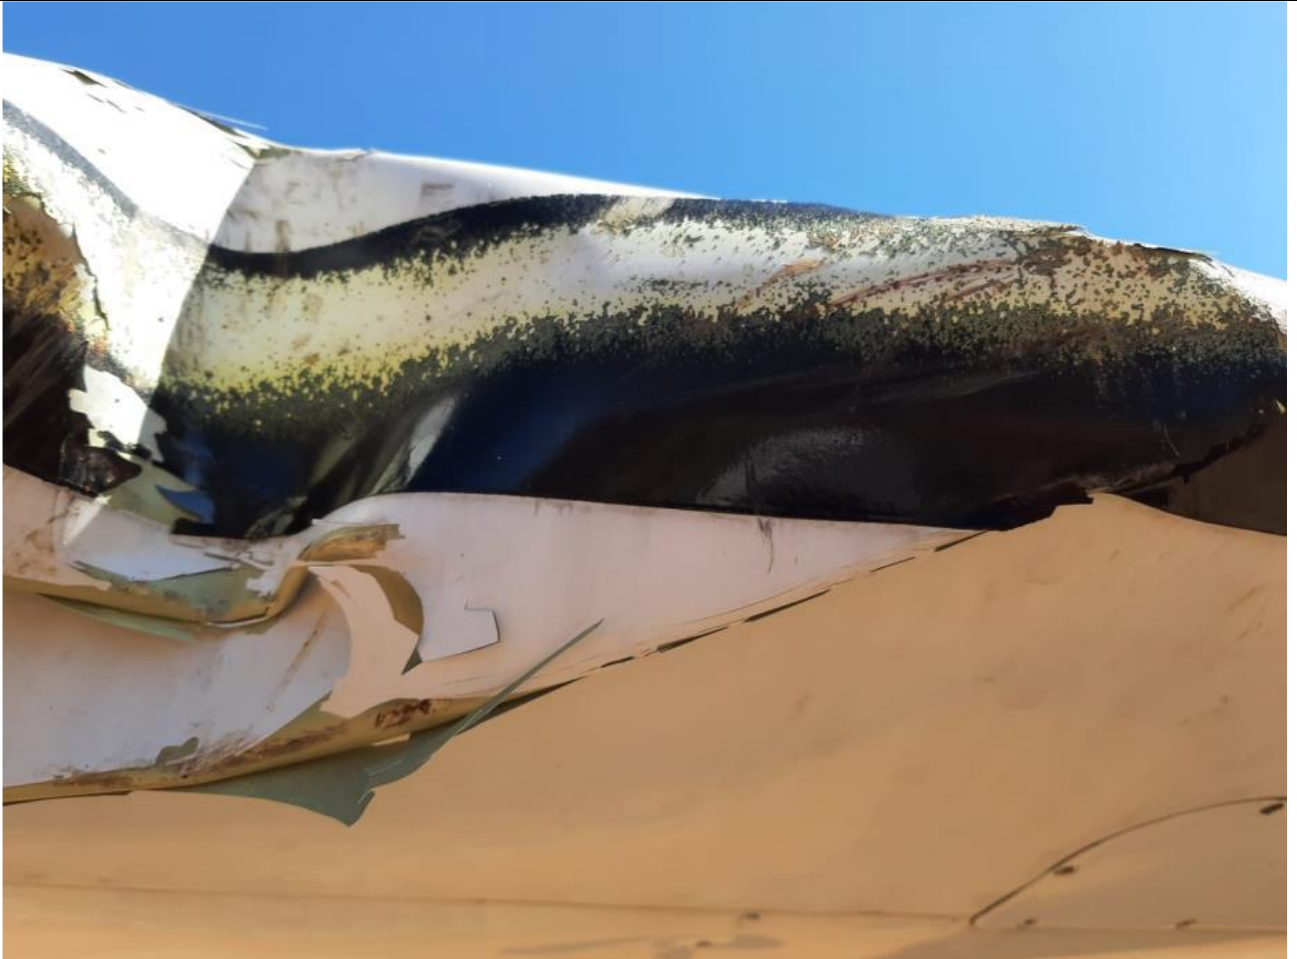
Figure 2: Damage on the right wing tip. (Source: Operator)

The co-pilot misjudged the aircraft’s proximity to the trees, resulting in the right-wing tip colliding with a tree during execution of a wide left turn whilst taxiing to the aircraft parking area.

Airport operator to remove the trees as they are very close to the runway.
