LIMITED ACCIDENT INVESTIGATION REPORT

Reference Number	CA18/3/2/10021						
Classification	Accident	Date	4 July 2021	Time	0800Z		
Type of Operation	Private (Part 91)						
Location							
Place of Departure	Wonderboom Airport (FAWB), Gauteng Province		Place of Intended Landing	Mountain View Game Ranch private airstrip, Limpopo Province			
Place of Occurrence	Mountain View Game Ranch Private Airstrip, Limpopo Province						
GPS Co-ordinates	Latitude	S 24°26'53"	Longitude	E 028°26'02"	Elevation	4770 ft	
Aircraft Information							
Registration	ZS-MVM						
Model/Make	Mooney M20M						
Damage to Aircraft	Minor		Total Aircraft Hours	2064.1			
Pilot-in-command							
Licence Type	Private Pilot Licence		Gender	Male	Age	32	
Licence Valid	Yes						
Total Hours on Type	231		Total Flying Hours	516.5			
People On-board	2 + 1	Injuries	0	Fatalities	0	Other	0
What Happened							
<p>On Sunday 4 July 2021, a Mooney M20 aircraft with registration ZS-MVM took off on a private flight from Wonderboom Airport (FAWB) with two pilots on-board, accompanied by a passenger, (who was seated on the rear seat). The flight, which was destined for Mountain View Game Ranch private airstrip in Limpopo province,

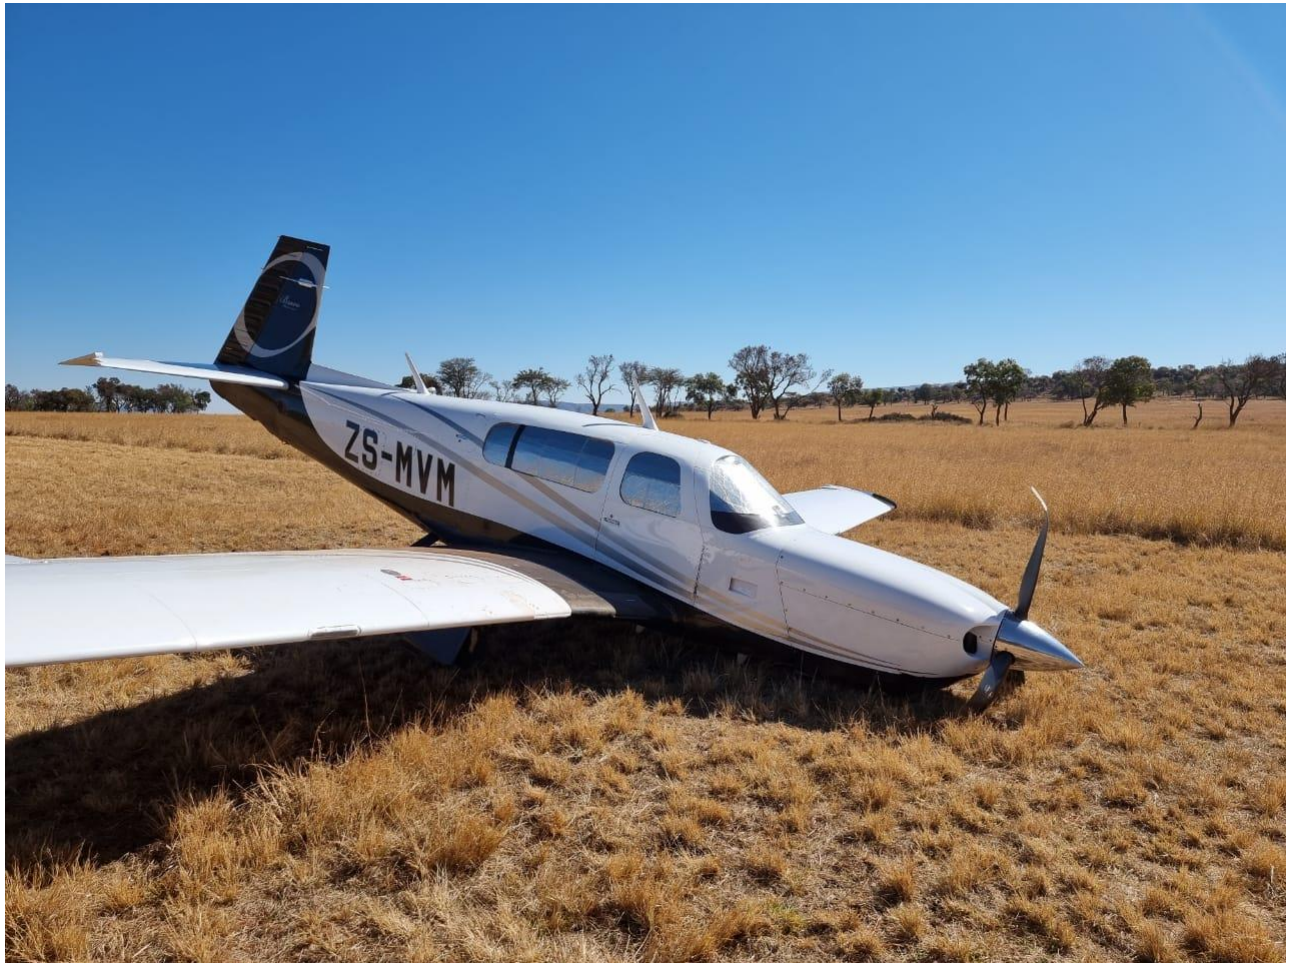
The PF stated that during the ground roll, the nose gear wheel ran over a sinkhole that was concealed by grass. Thereafter, the nose gear collapsed and the propeller struck the ground. The damage to the aircraft was limited to the nose landing gear and the propeller. There were no reported injuries of the occupants on-board the aircraft.

Figure 1: The aircraft with damaged propeller post-accident. (Source: Pilot)

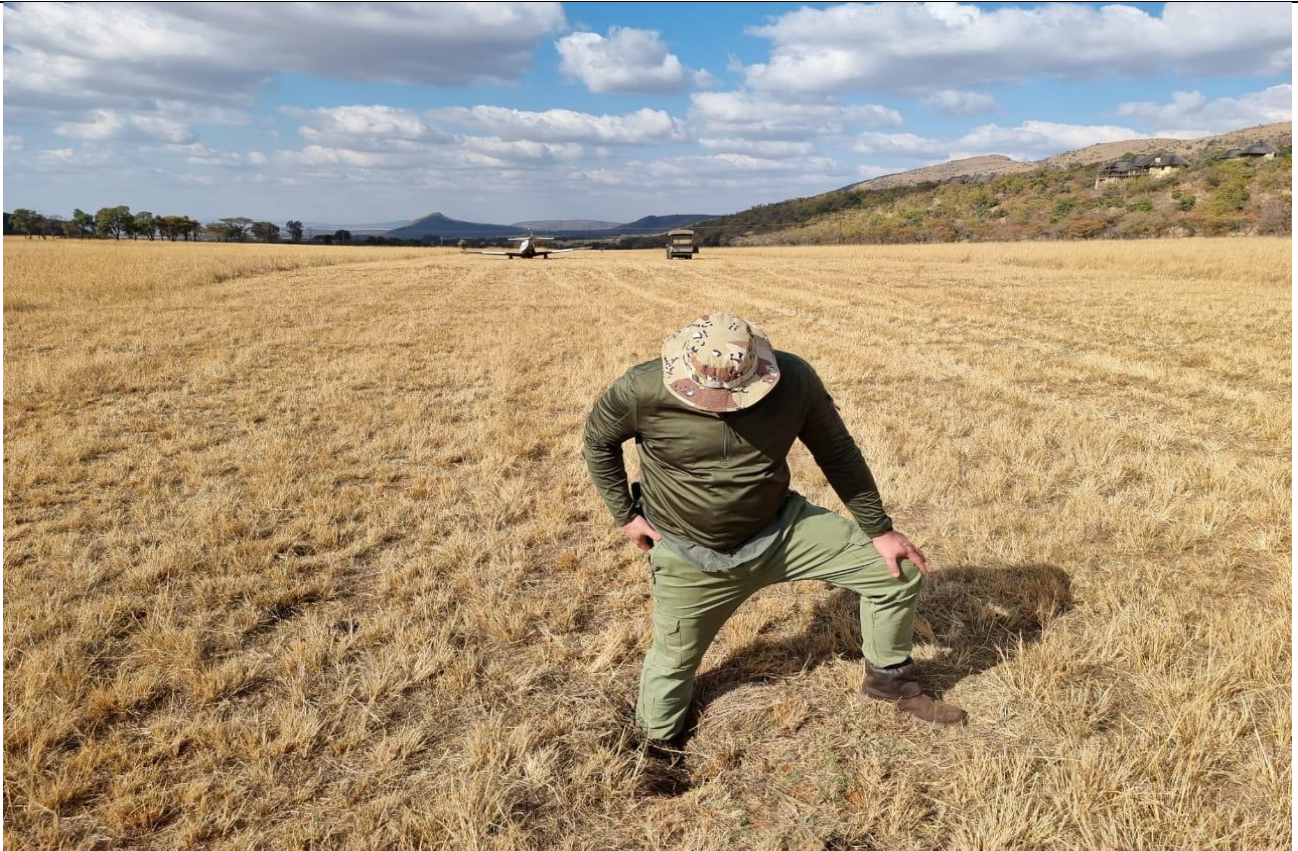
Figure 2: The pilot with his foot in the sinkhole over which the aircraft ran over. (Source: Pilot)

The aircraft’s nose gear assembly ran over a sinkhole concealed by grass during the landing roll, which resulted in the collapse of the nose landing gear strut, causing damage to the propeller blades.

Safety message: Pilots are encouraged to always conduct a thorough flight planning and enquire about the condition/s of the destination airport or airfield so as to be aware or take necessary precautions.
