**AIRCRAFT ACCIDENT REPORT AND EXECUTIVE SUMMARY**

| | | | | <b>Reference:</b> | | CA18/2/3/10022 | |
| <b>Aircraft Registration</b> | ZU-FZZ | <b>Date of Accident</b> | 9 July 2021 | | <b>Time of Accident</b> | 0720Z | |
| <b>Type of Aircraft</b> | Sling 2 | | | <b>Type of Operation</b> | Training (Part 141) | | |

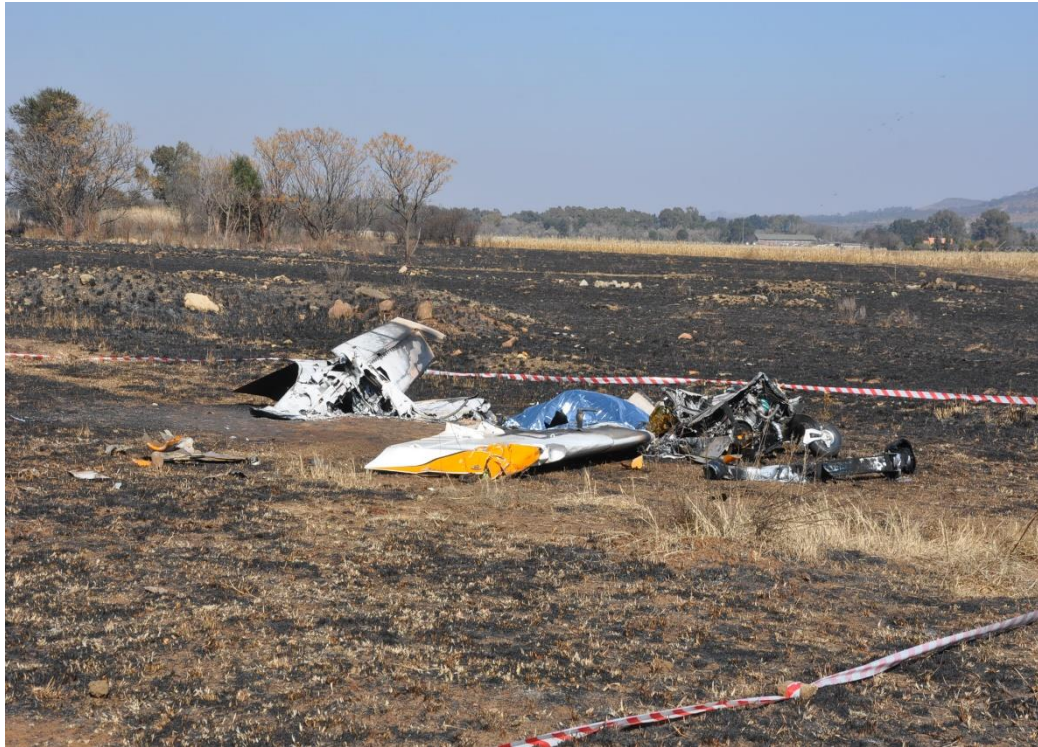
1.3.1. The aircraft was destroyed by impact forces as well as fuel-fed post-impact fire.

**Figure 3:** The aircraft at the accident scene post-accident.

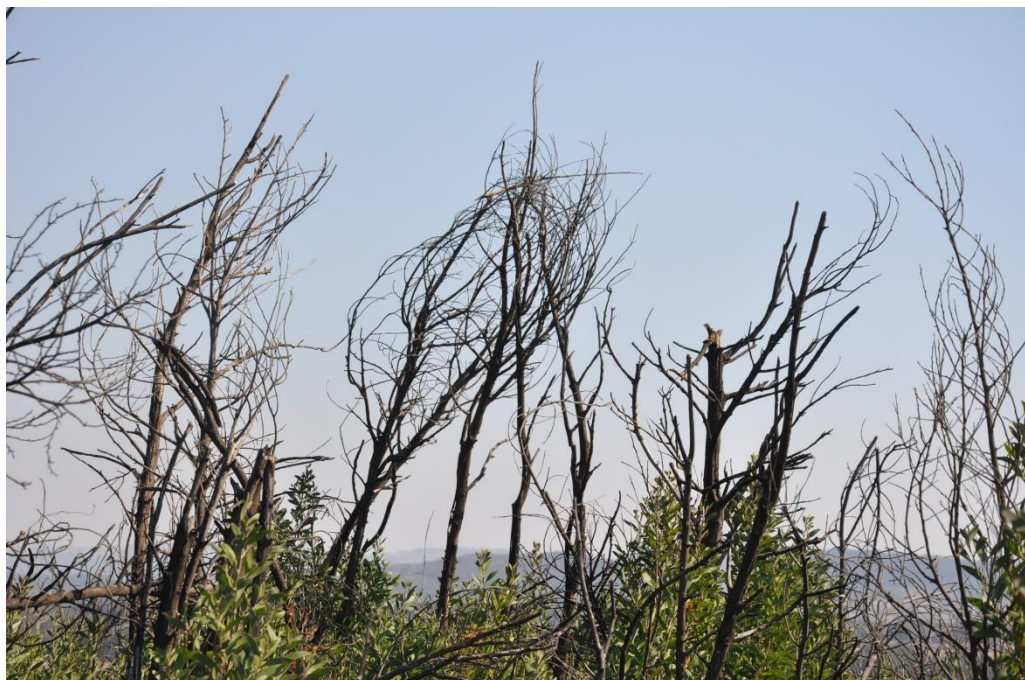
1.4.1. Several shrubs were clipped by the aircraft prior to ground impact.

**Figure 4:** Shrubs on the left-side of Runway 02 that were clipped by the aircraft.

- 4.2.1 It is recommended that the vegetation growing close to the runway be removed to reduce obstacles that pilots could possibly encounter in an event of unstable landings or approaches.
- 4.2.2 It is recommended that at uncontrolled/unlicensed aerodromes – where flight training takes place – instructors maintain constant contact with their student pilots through the use of two-way radios to minimise student pilots making complex decisions on their own without their guidance.

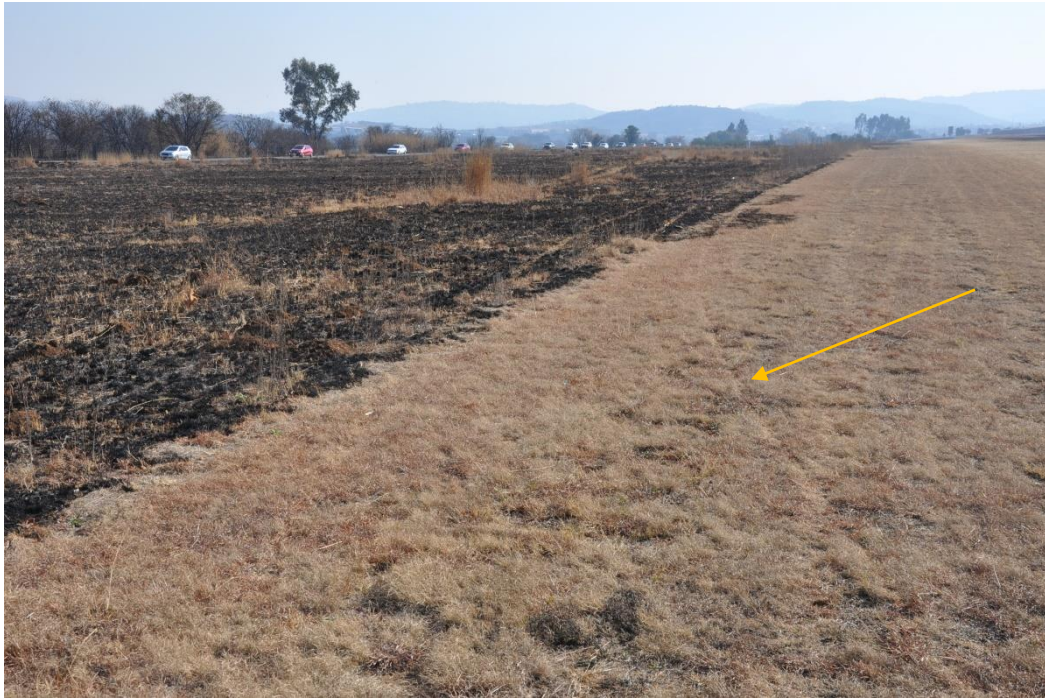
1.12.1. The first ground markings which were caused by the landing gear wheels were observed towards the left of RWY 02 at approximately 287m from the threshold, and again at approximately 407m; this is evident that the aircraft started to veer off to the left-side of RWY 02 (see Figure 8). The ground markings stopped a few metres before the vegetation (shrubs), therefore, evidence indicates that the aircraft became airborne again and made contact with the top of the shrubs (see Figure 9).

**Figure 8:** Wheel markings of where the aircraft started to veer off to the left.

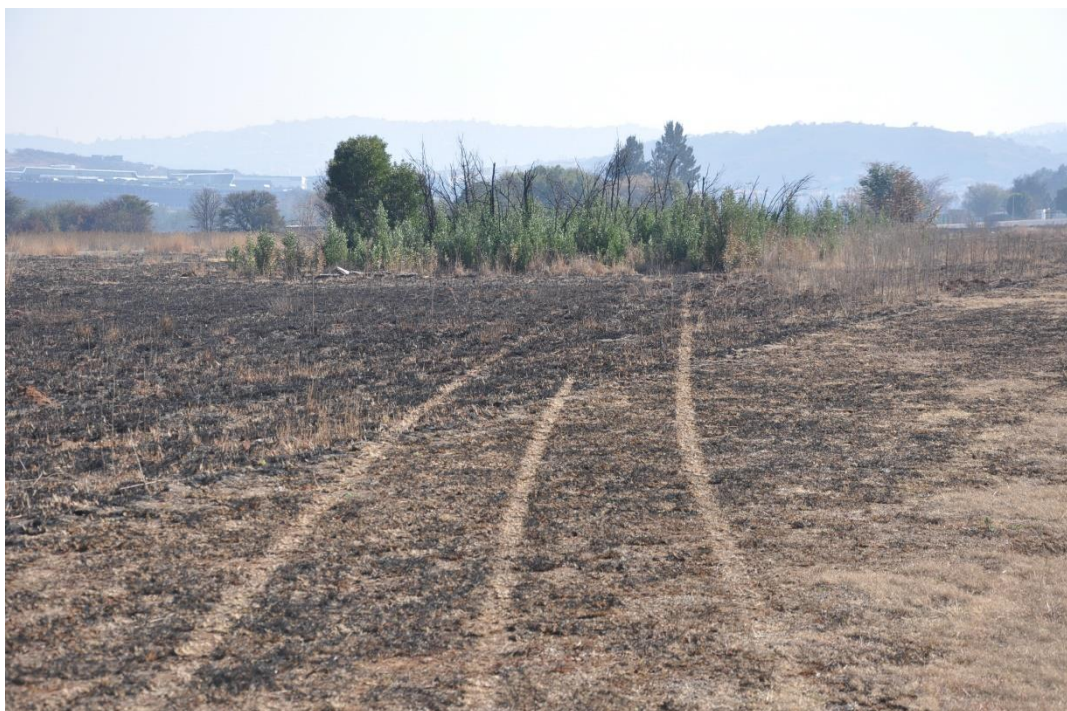
**Figure 9:** Wheel markings of the aircraft heading towards the vegetation.

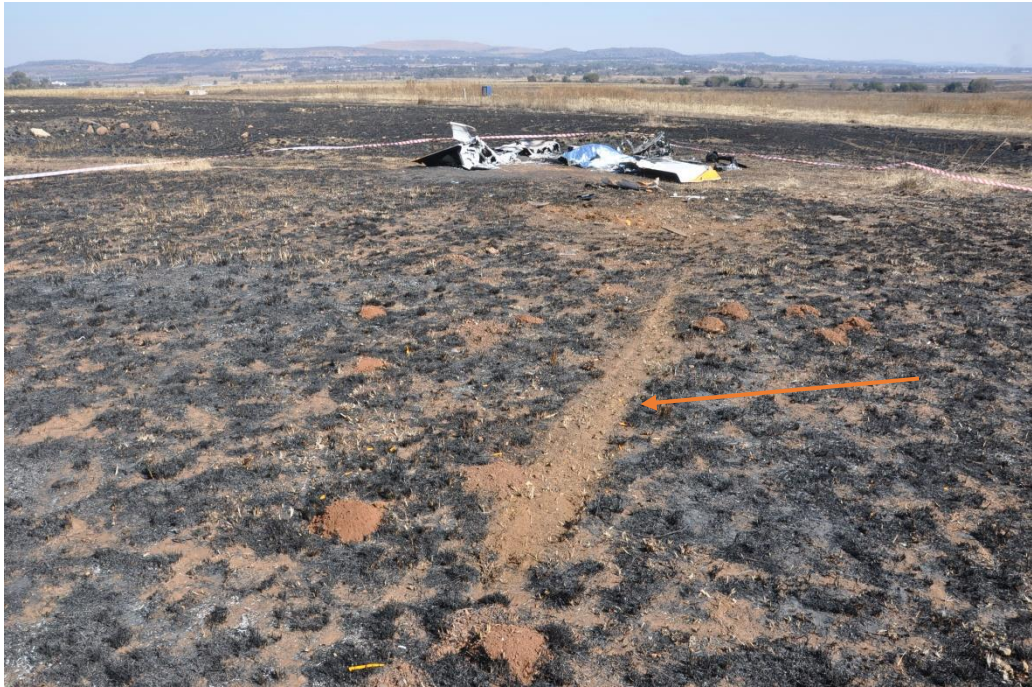
1.12.2 The aircraft impacted the ground in a left-wing low attitude (see Figure 10). Figure 12 displays some debris from the nose cone of the aircraft, as well as one of the propeller blades, about 8m from the first point of impact. The aircraft came to rest in an inverted attitude before it caught alight (see Figure 11). The control cables were visible and there was continuity in the control cables. The landing gear wheels trail was first seen from the threshold of RWY 02 (approximately 287m from the threshold) and again at approximately 407m from the threshold of RWY 02.

**Figure 10:** First ground marking after the left wing contacted the ground.

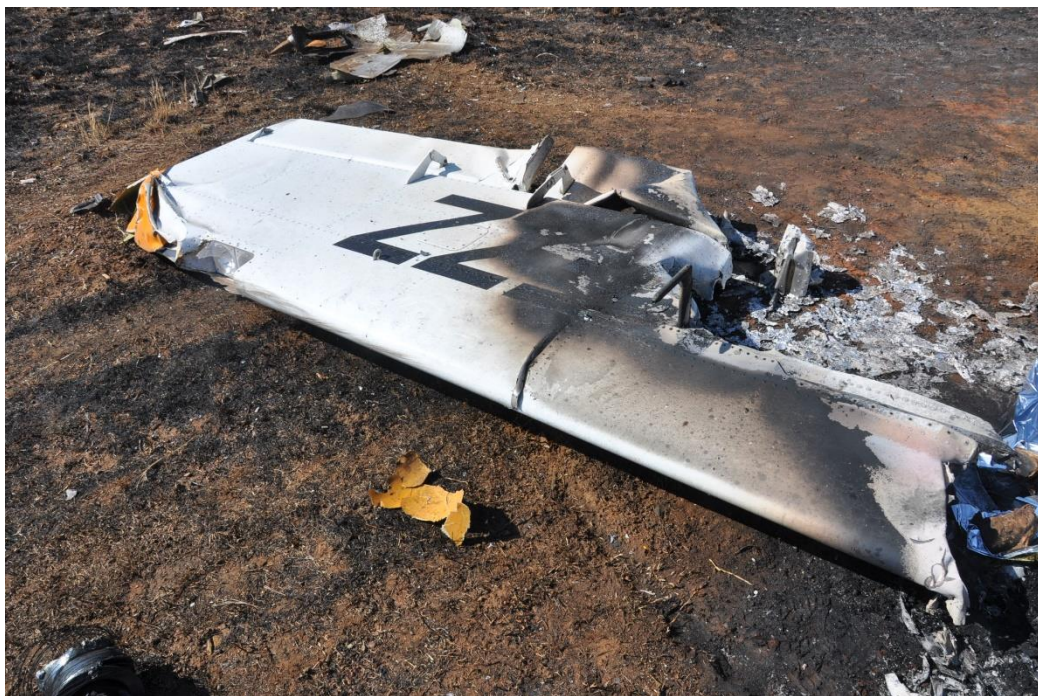
**Figure 11:** The left-wing with impact damage on the wing tip.

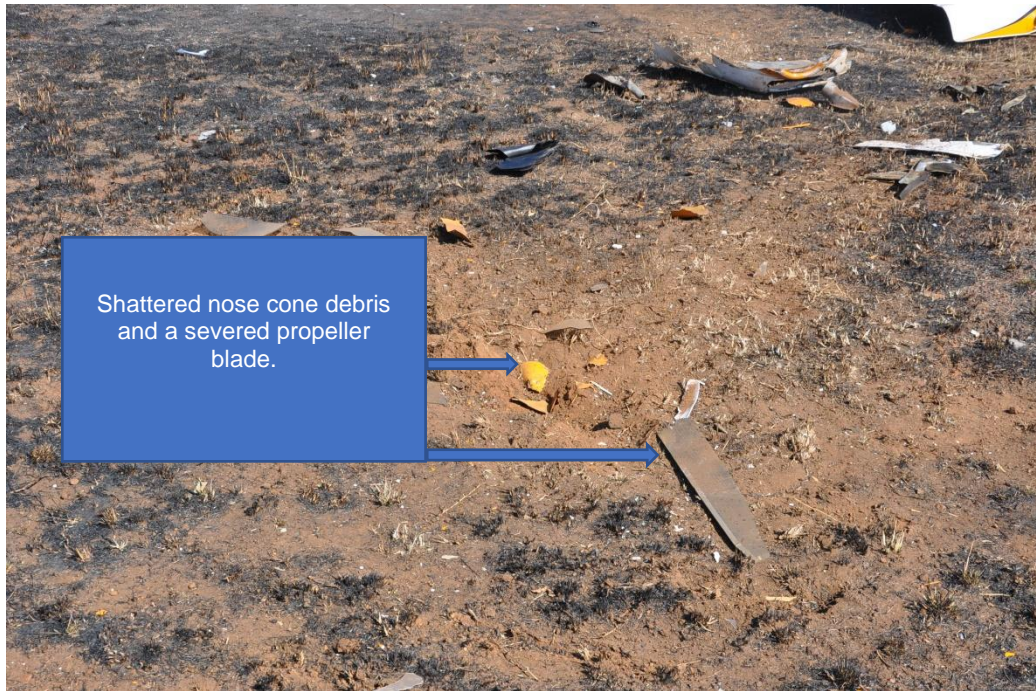
**Figure 12:** Debris from the propeller and nose cone.

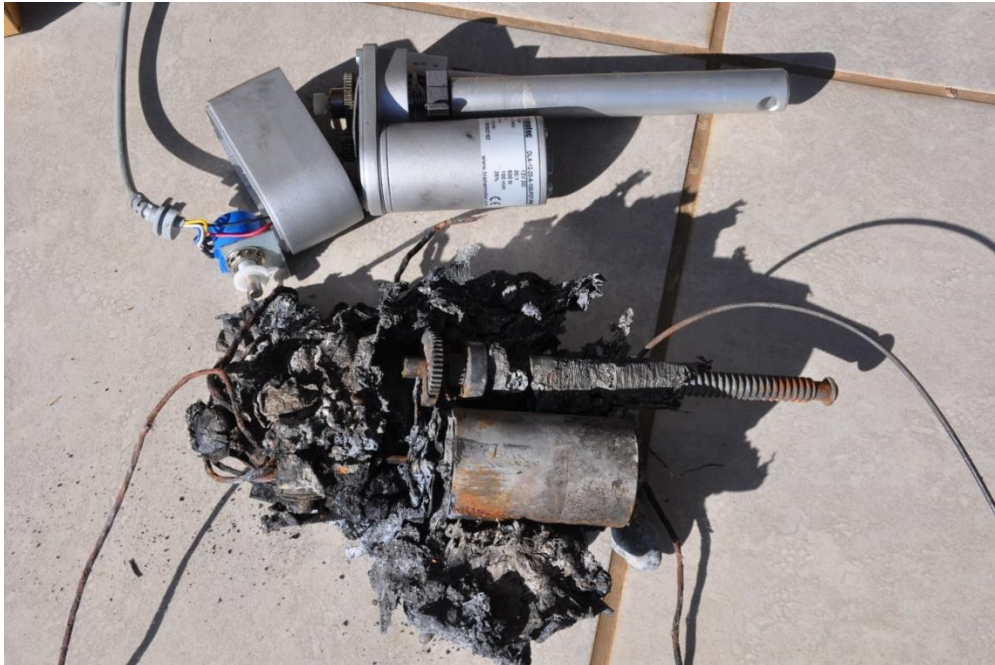
1.16.1. The components that remained post-accident were inspected. Other than being degraded by fire, the flap motor was found in the configuration of 'flaps up'.

**Figure 13:** A serviceable flap motor in the retracted configuration (top); and a fire damaged flap motor in the retracted configuration (bottom).
