LIMITED ACCIDENT INVESTIGATION REPORT

Reference Number		CA18/2/3/10023					
Classification	Accident	Date	16 July 2021	Time	1454Z		
Type of Operation		Private (Part 94)					
Location							
Place of Departure	Vrischgewaagol private farm, Mpumalanga Province		Place of Intended Landing	Vrischgewaagol private farm, Mpumalanga Province			
Place of Occurrence		Vrischgewaagol private farm, Mpumalanga Province					
GPS Co-ordinates	Latitude	S 26°11'46.7"	Longitude	E029°39'22.3"	Elevation	5300 ft	
Aircraft Information							
Registration		ZU-DDX					
Model/Make		Z194 Cheetah					
Damage to Aircraft		Substantial damage		Total Aircraft Hours	1246.6		
Pilot-in-command							
Licence Valid	Yes		Gender	Male		Age	32
Licence Type		National Pilot Licence					
Total Hours on Type		38.7		Total Flying Hours	38.7		
People On-board	1 + 1	Injuries	0	Fatalities	0	Other	0
What Happened							
<p>On 16 July 2021, a pilot accompanied by a passenger on-board the Z194 Cheetah aircraft registered ZU-DDX took off from Vrischgewaagol private farm airstrip, Mpumalanga province, on a local private scenic flight in the area. A pre-flight inspection was conducted, and the aircraft was set for take-off with 45 litres

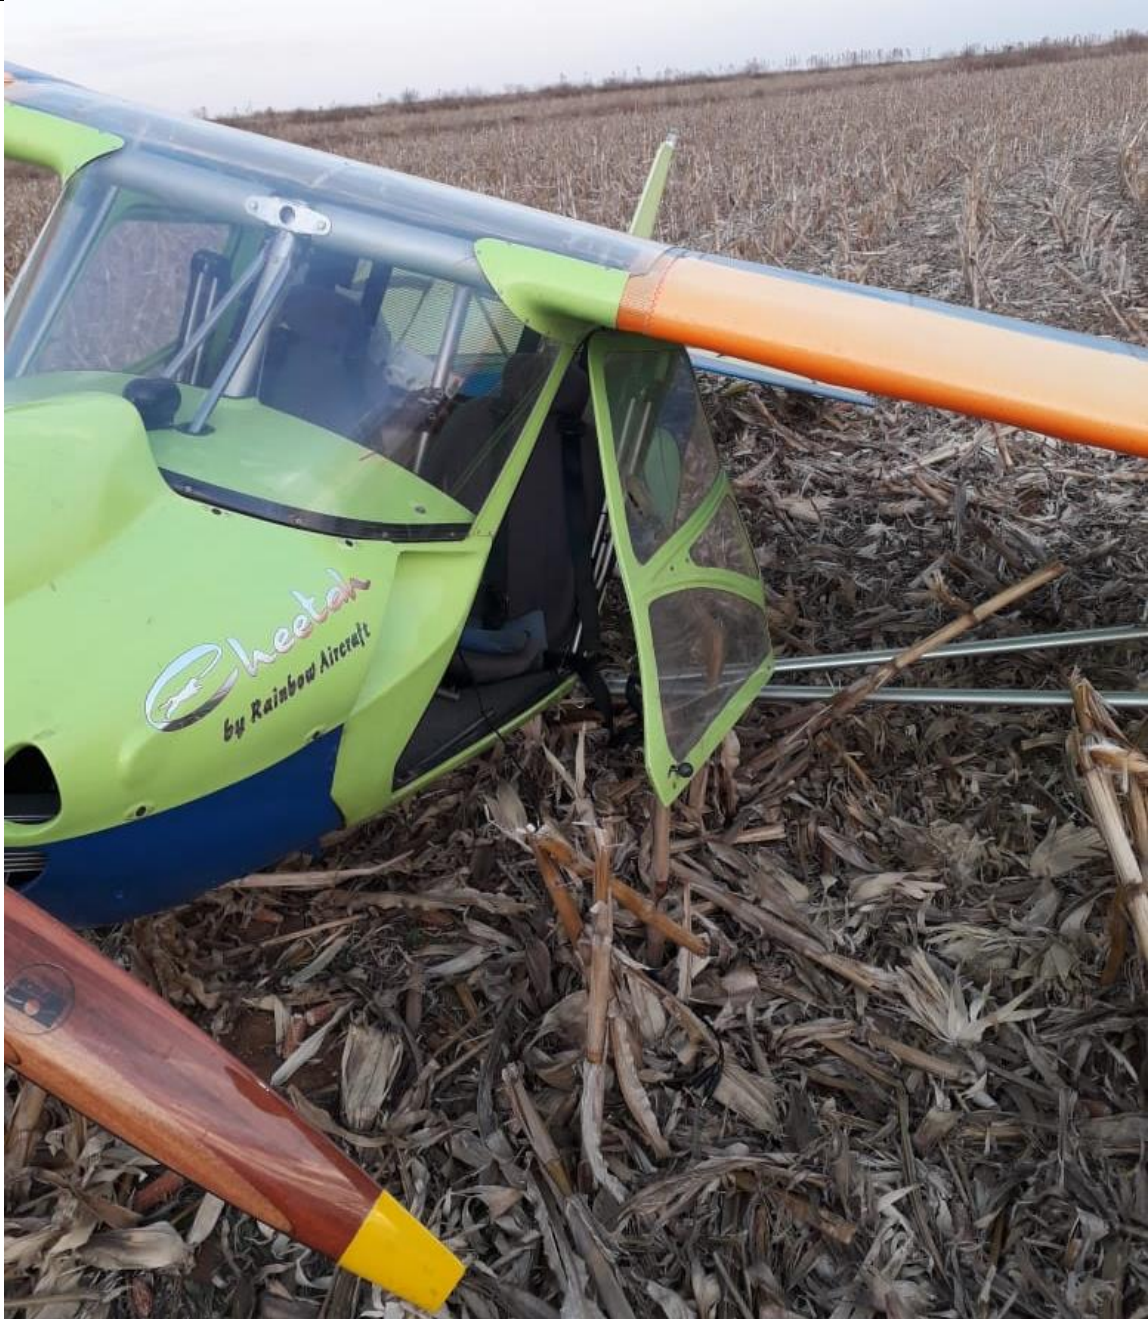
Figure 1: The aircraft as it came to rest.

Unsuccessful forced landing after an engine failure by not choosing a landing field ahead or to the left or right of the nose (of the aircraft). The cause of engine stoppage after take-off was due to fuel starvation because of the failed mechanical fuel pump.

Pilots are encouraged to always inspect drums visually for contaminants prior to refuelling; regularly inspect fuel pump filters; and conduct fuel drains from the aircraft to visually check for contaminants.

Pilots must make sure that they choose a field directly ahead or slightly to either side of the take-off path in case of engine failure after take-off.
