LIMITED ACCIDENT INVESTIGATION REPORT
--

Reference Number		CA18/2/3/10024					
Classification	Accident	Date	25 July 2021		Time	1245Z	
Type of Operation	Operation of Non-type Certified Aircraft (Part 94)						
Location							
Place of Departure		Fochville Aerodrome, Gauteng Province		Place of Intended Landing		Wingfield Private Airstrip, Gauteng Province	
Place of Accident		Wingfield Private Airstrip, Loch Vaal, Gauteng Province					
GPS Co-ordinates	Latitude	S 29° 22' 29.5"	Longitude	E 031° 19' 07.3"	Elevation	4744ft	
Aircraft Information							
Registration		ZU-FCP					
Model/Make		Quad City Challenger II					
Damage to Aircraft		Destroyed		Total Aircraft Hours		451 hours	
Pilot-in-command							
Licence Valid		No		Gender		Male	
				Age		45	
Licence Type		Not licensed					
Total Hours on Type		Unknown		Total Flying Hours		Unknown	
People On-board		1 + 1		Injuries		2	
				Fatalities		0	
				Other (on ground)		0	
What Happened							
<p>On Sunday, 25 July 2021, a pilot and a passenger (the pilot's wife) on-board a Quad City Challenger II aircraft with registration ZU-FCP took off on a private flight from Fochville Aerodrome, Gauteng province, with the intention to land at Wingfield

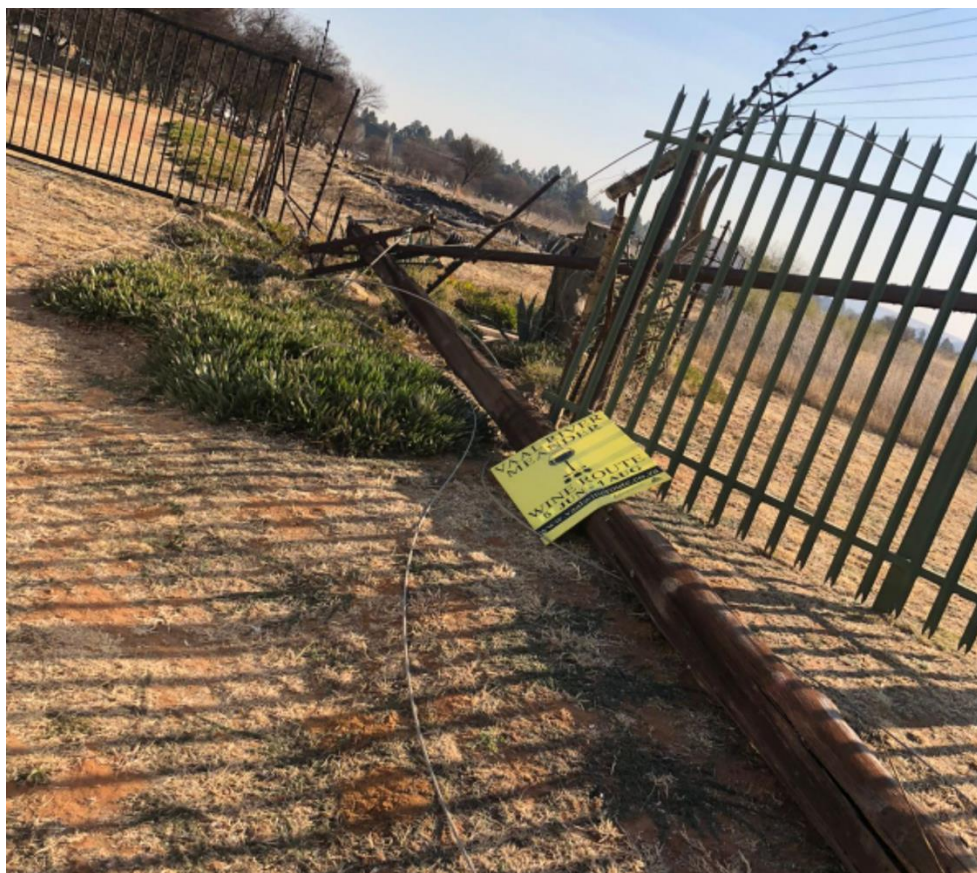
Figure 1: Broken electric pole and damaged palisade fence caused by the collision of the aircraft with the powerlines. (Source: Airstrip owner)

- The engine was turned by hand, and it turned freely without obstruction.
- The aircraft had approximately 5 gallons of fuel in the 10-gallon fuel tank.
- The aircraft's hydraulic system was still intact and a quarter ($\frac{1}{4}$) of hydraulic fluid was found in the system.
- All flight control surfaces were found still attached to the aircraft.
- All damage observed was attributed to impact forces because of collision with powerlines and hard landing of the aircraft during the accident sequence (see Figure 1).

The owner of Wingfield Private Airstrip indicated that an order was placed for overhead wire marker spheres through ESKOM months before the accident took place, however, there has been a delay in the delivery of the spheres.

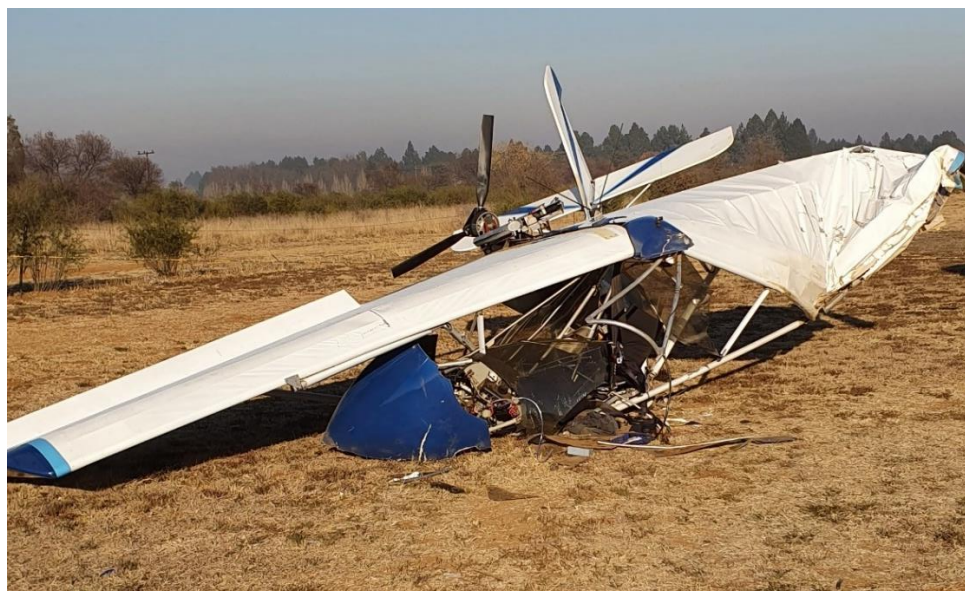
Figure 2: The aircraft post-accident.

Post-accident on-site investigation confirmed that the aircraft collided with the electric powerlines before it crashed near the threshold of RWY 28. The wreckage damage observed indicated that the aircraft's belly was scrapped by the powerlines, and the left and right landing gears got entangled with the powerlines, which was exhibited by the wire striation marks. The aircraft impacted the ground hard and was destroyed by impact forces; as a result, both occupants on-board were seriously injured.

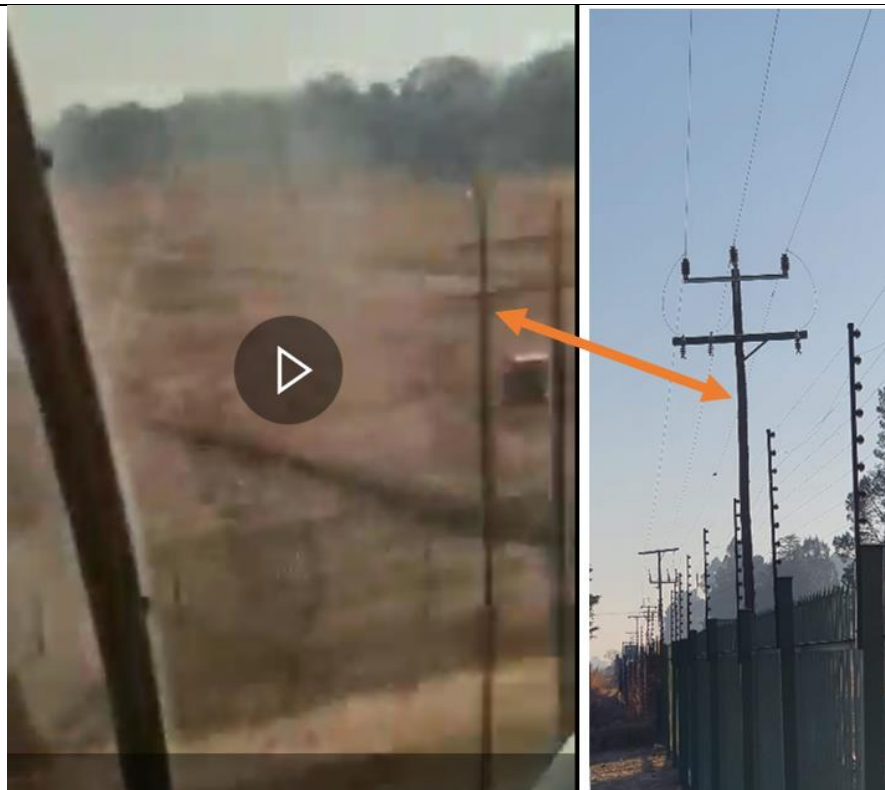
In the video footage taken by the passenger, a powerline wooden pole is located to the right of the aircraft's path. The powerline wooden poles are 12 metres (m) high and are placed 30m apart along the road. There are two powerline wooden poles in the airstrip's yard, the other one (powerline wooden pole) would have been to the immediate left of the aircraft's path.

Figure 3: **Left:** Powerline supporting pole as seen from the video taken on-board the aircraft (Source: Pilot's friend). **Right:** Image of powerlines supporting poles taken on the ground.

Collision with powerlines during landing due to the pilot's lack of situational awareness as he did not look out for powerline poles. This was exacerbated by poor visual scan of the area due to the sun's glare on the Perspex windscreen.
