<b>LIMITED ACCIDENT INVESTIGATION REPORT</b>
--

<b>Reference Number</b>		CA18/2/3/10025					
<b>Classification</b>	Accident	<b>Date</b>	28 July 2021		<b>Time</b>	0900Z	
<b>Type of Operation</b>		Private (Part 94)					
<b>Location</b>							
Place of Departure	Eva's Airfield in Hilton, KwaZulu-Natal Province			Place of Intended Landing	Eva's Airfield, KwaZulu-Natal		
Place of Accident		Mondi Plantation near Craigie Burn Dam in KwaZulu-Natal Province					
GPS Co-ordinates	Latitude	29°08'27.3" S	Longitude	030°23'27.7" E	Elevation	4368ft	
<b>Aircraft Information</b>							
Registration		ZU-IMX					
Model/Make		Zlin Savage Cub (X279)					
Damage to Aircraft		Destroyed	Total Aircraft Hours		368.0		
Registration		ZU-IPZ					
Model/Make		Zlin Savage Cub (X279)					
Damage to Aircraft		Substantial	Total Aircraft Hours		144		
<b>Pilot-in-command ZU-IMX</b>							
Licence Valid		Yes	Gender	Male		Age	49
Licence Type		Commercial Pilot Licence (Aeroplane)					
Total Hours on Type		500		Total Flying Hours		1688.2

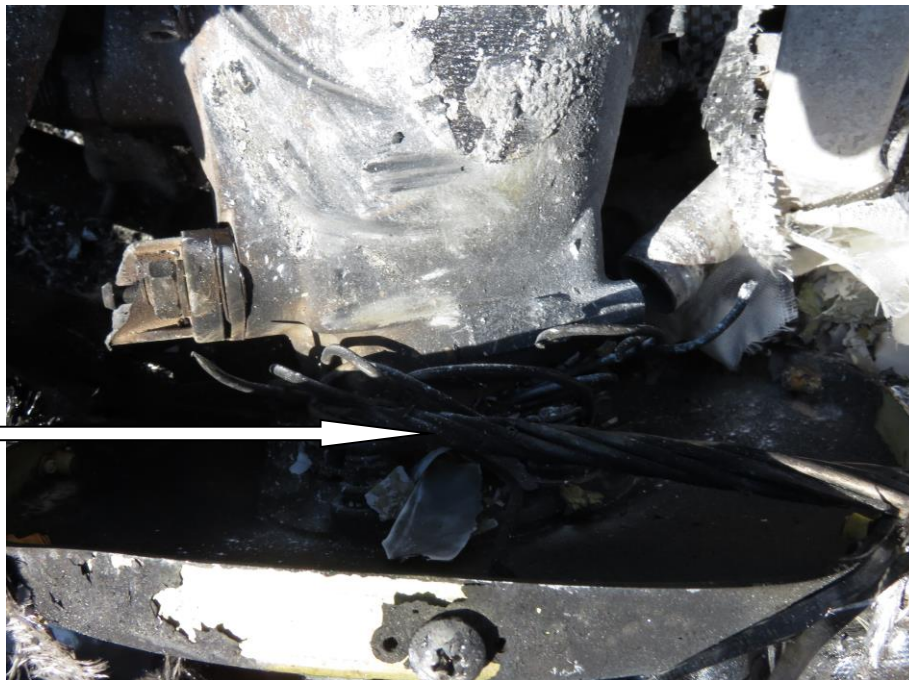
Moments later, the ZU-IMX aircraft collided with Eskom powerlines secured by wooden poles that were 11 metres in height which spanned along its flight path; thereafter, the aircraft continued on its flight path for approximately 110 metres before crashing onto a rocky terrain in the valley near Craigie Burn Dam. Post-impact fire ensued afterwards. The pilot sustained burn injuries, however, he was able to free himself from the wreckage. The aircraft was destroyed by post-impact fire. The ZU-IMX aircraft flight lasted approximately 0.4 hours. Post-accident examination of the ZU-IMX aircraft indicated that the powerline cable got entangled around the propeller flange.

Powerline cable entangled around the propeller flange.

**Figure 1:** Powerline cable entangled around the propeller flange.

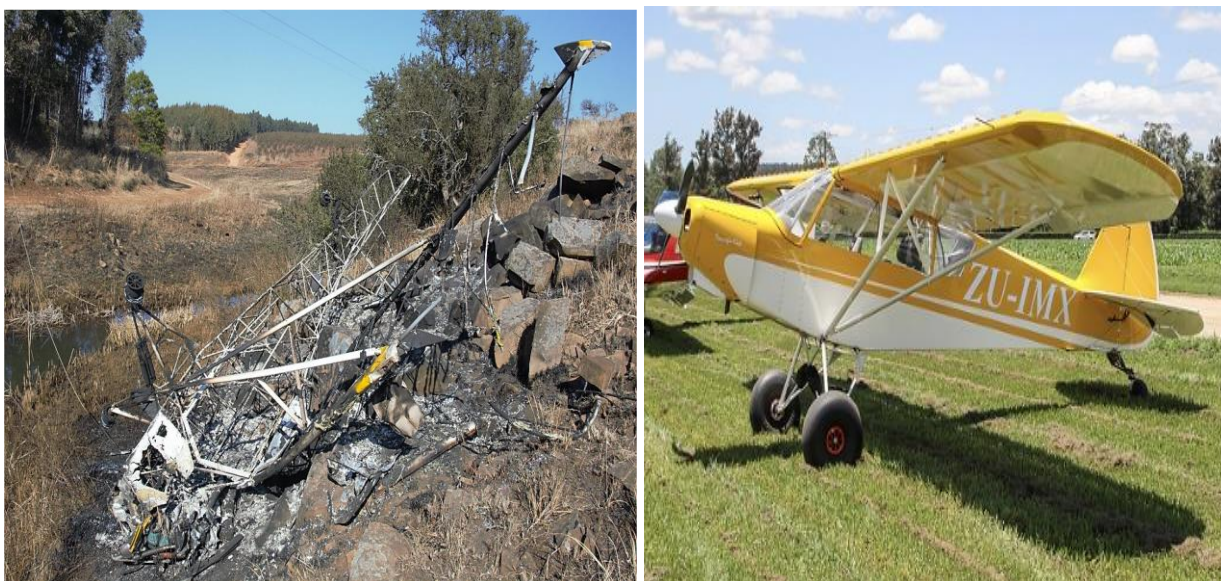
**Figures 2 and 3:** The ZU-IMX aircraft at the accident site (left picture). A picture of ZU-IMX (right picture), a Savage Cub aircraft, taken a while before the accident. (Source: (<http://defenceweb.co.za>))

The ZU-IMX aircraft was flying low, where after, it collided with the powerlines that spanned along its flight path, and as a result, the pilot lost control before the aircraft crashed.

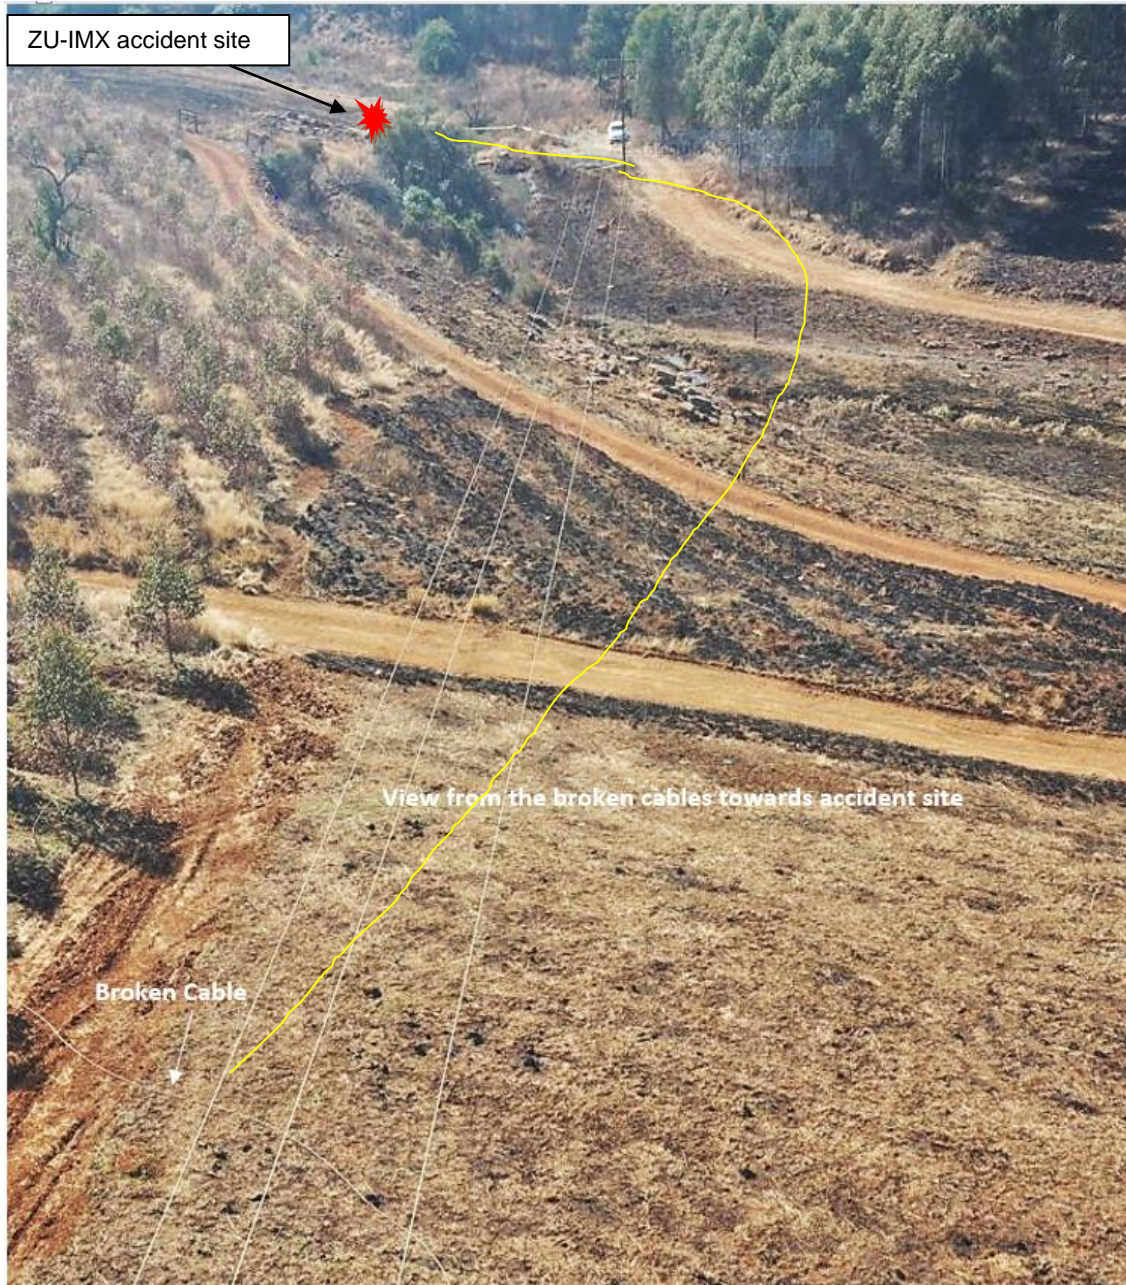
**Figure 4:** Aerial view of ZU-IMX flight path in yellow; as well as the severed powerline cable the aircraft collided with, and view of the accident site.
