LIMITED ACCIDENT INVESTIGATION REPORT
--

Reference Number		CA18/2/3/10026					
Classification	Accident	Date	29 July 2021	Time	0842Z		
Type of Operation		Training (Part 141)					
Location							
Place of Departure		Grand Central Airport (FAGC), Gauteng Province		Place of Intended Landing		Grand Central Airport (FAGC), Gauteng Province	
Place of Accident		Runway 17 at Grand Central Airport (FAGC), Gauteng Province					
GPS Co-ordinates	Latitude	S 25° 59' 13.20"	Longitude	E 028° 08' 5.80"	Elevation	5280ft	
Aircraft Information							
Registration		ZS-EWX					
Model/Make		Cessna C172I					
Damage to Aircraft		Substantial		Total Aircraft Hours		14 986.3	
Pilot-in-command							
Licence Valid		Yes		Gender		Male	
Licence Type		Student Pilot Licence					
Total Hours on Type		47.8		Total Flying Hours		47.8	
People On-board		1+0		Injuries		0	
				Fatalities		0	
				Other (on ground)		0	
What Happened							
<p>On 29 July 2021 at approximately 0842Z, a Cessna C172I aircraft with registration ZS-EWX was engaged in a training flight at Grand Central Airport (FAGC), Gauteng Province. On-board the aircraft was a student pilot conducting a solo circuit training on Runway 17. The flight was conduc

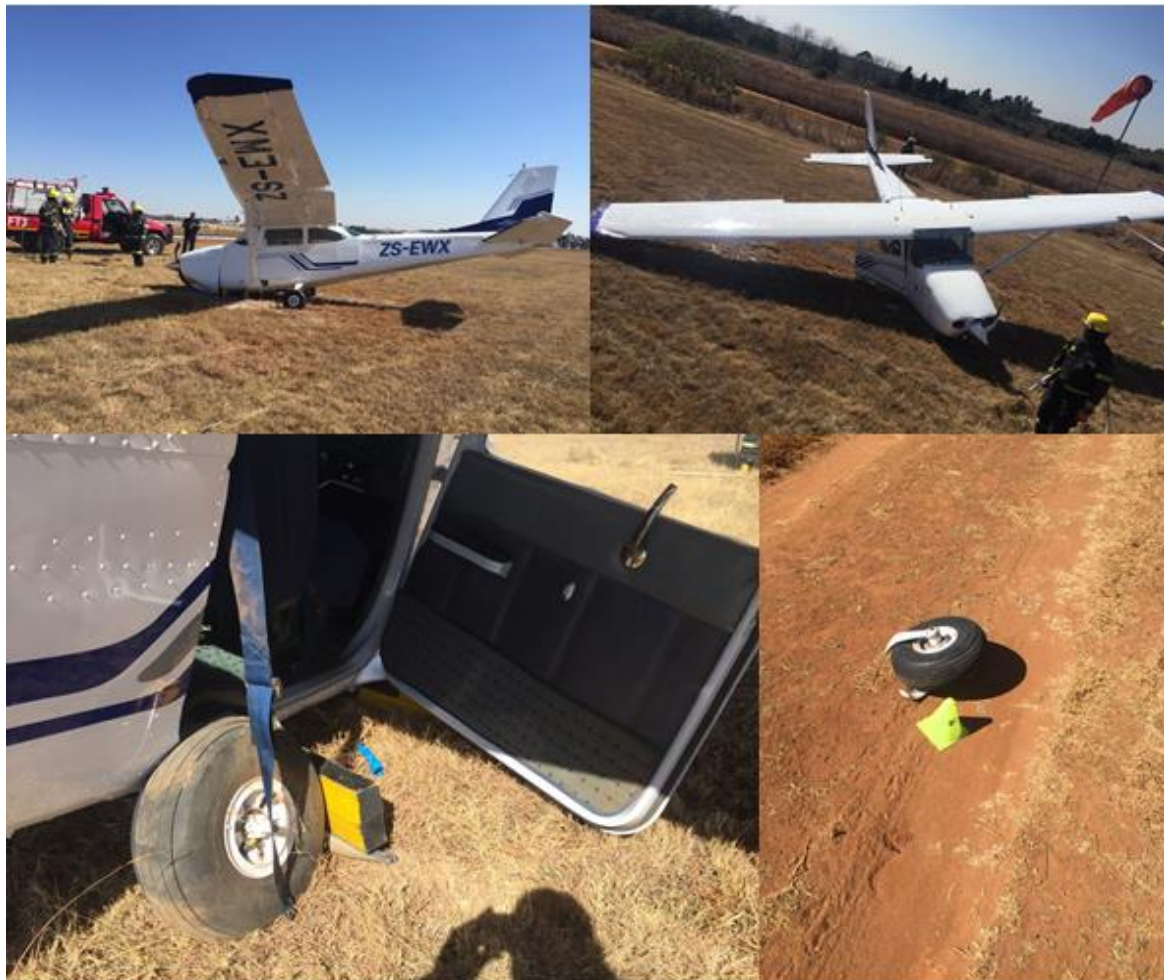
Figure 1: The accident aircraft with damages sustained during the accident sequence.

The student pilot did not sustain any injuries during the accident sequence. The aircraft sustained damage to the nose landing gear (which broke off), the propeller, the fuselage (multiple structural fractures), both wings, both main landing gears, and the horizontal stabiliser.

<p>Probable Cause:</p> <p>The aircraft approached at high speed, resulting in a hard landing on the left edge of the runway and the aircraft bounced before the pilot lost directional control of the aircraft as the crosswind lifted the right wing, causing it to veer off to the left of the runway.</p>	
<p>Safety Action/s</p> <p>None.</p>	
<p>Safety Message and/or Safety Recommendation/s</p> <p>None.</p>	
<p>Purpose of the Investigation</p> <p><i>In terms of Regulation 12.03.1 of the Civil Aviation Regulations (CAR) 2011, this report was compiled in the interest of the promotion of aviation safety and the reduction of the risk of aviation accidents or incidents and not to apportion blame or liability.</i></p>	
<p>About this Report</p> <p><i>Decisions regarding whether to investigate, and the scope of an investigation are based on many factors, including the level of safety benefit likely to be obtained from an investigation. For this occurrence, no investigation has been conducted, and the Accident and Incident Investigations Division (AIID) has relied on the information submitted by the affected person/s and organisation/s to compile this brief report. The report has been compiled using information supplied in the initial notification, as well as follow-up information to bring awareness of potential safety issues to the industry in respect of this occurrence, as well as possible safety action/s that the industry might want to consider in preventing a recurrence of a similar accident.</i></p> <p><i>This report provides an opportunity to share safety message/s in the absence of an investigation.</i></p> <p><i>All times given in this report are Co-ordinated Universal Time (UTC) and will be denoted by (Z). South African Standard Time is UTC plus 2 hours.</i></p>
