LIMITED ACCIDENT INVESTIGATION REPORT

Reference Number	CA18/2/3/10027						
Classification	Accident	Date	4 August 2021	Time	1230Z		
Type of Operation	Private (Part 127) Helicopter aerial work and other air service operations						
Location							
Place of Departure	Brakpan Airfield (FABB)		Place of Intended Landing		Elim Game Farm Hertzogville, Free State Province		
Place of Accident	Elim Game farm, near Hertzogville Free State Province						
GPS Co-ordinates	Latitude	S 29°08'27.3"	Longitude	E 30°23'27.7"	Elevation	5400ft	
Aircraft Information							
Registration	ZS-RHD						
Model/Make	Robinson 44 (Serial Number: 0242)						
Damage to Aircraft	Destroyed		Total Aircraft Hours		3999.0		
Pilot-in-command							
Licence Valid	Yes	Gender	Male		Age	50	
Licence Type	Commercial Pilot Licence (Helicopter)						
Total Hours on Type	642.2		Total Flying Hours		773.1		
People On-board	1+0	Injuries	0	Fatalities	0	Other (On Ground)	0
What Happened							
<p>On 4 August 2021, a Robinson 44 helicopter with registration ZS-RHD was engaged in game capture operation at Elim Game Farm in the Free State. The pilot was the sole occupant on-board the helicopter. The pilot stated that during game capture

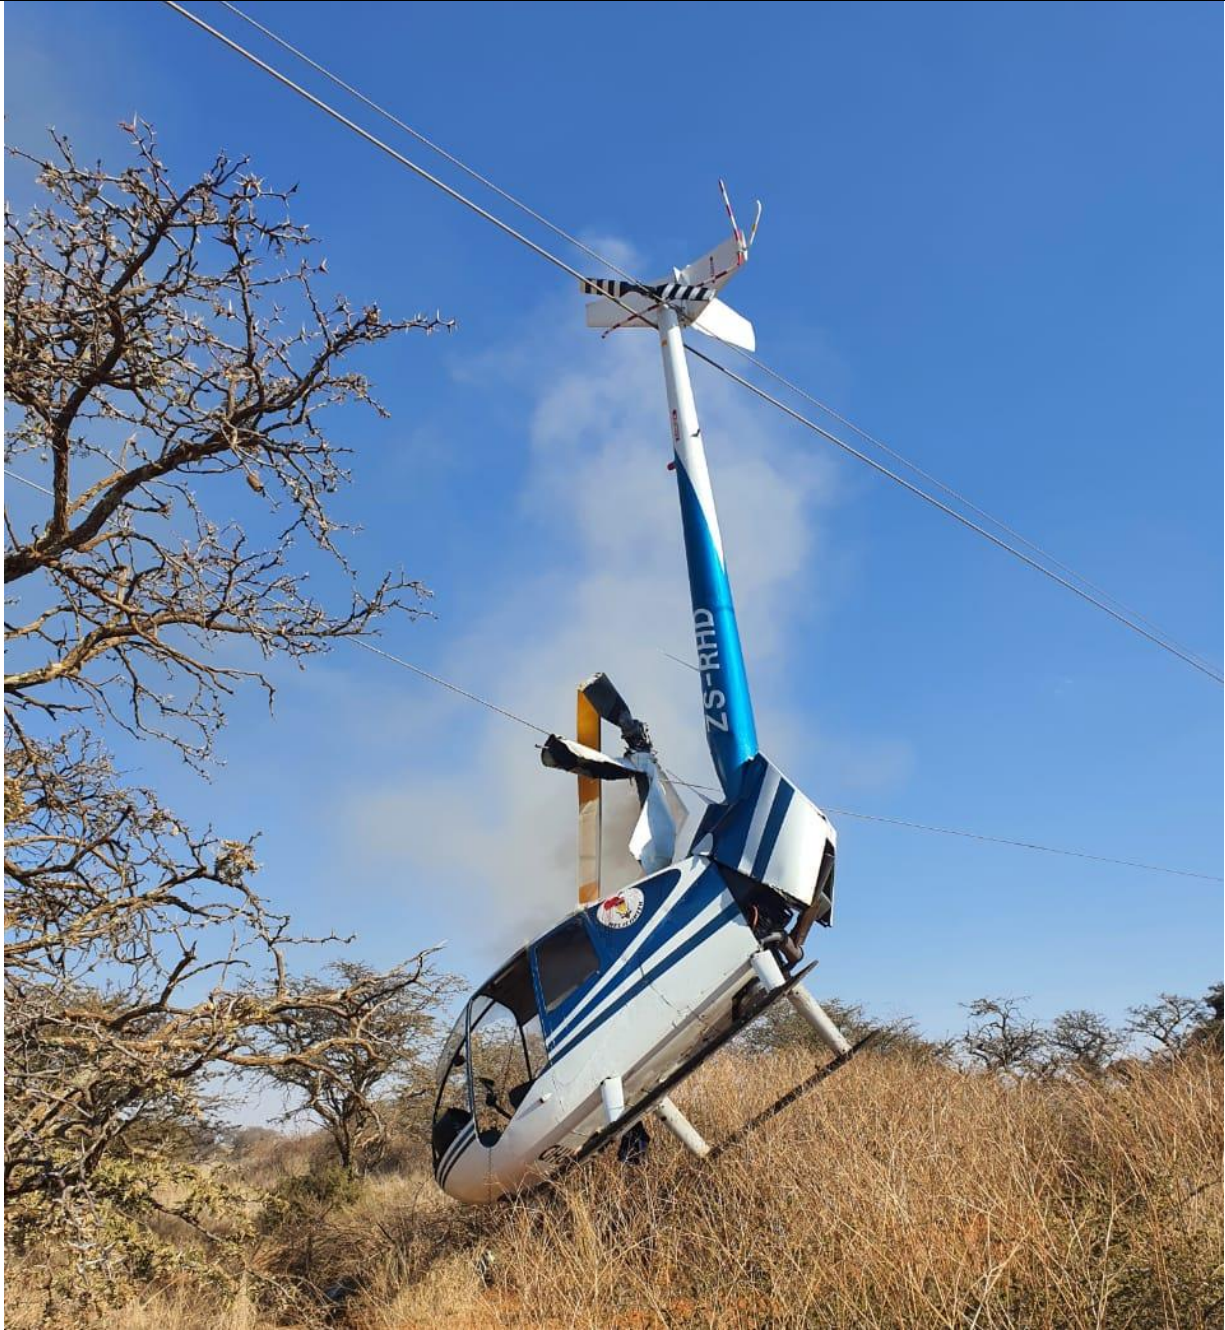
Figure 1: The helicopter suspended by live electrical wires before it caught fire.

The helicopter was being flown at a low height and it collided with the powerlines that spanned along its flight path during a left bank. The helicopter was suspended on the powerlines before it caught alight.

Pilot's failure to look out (for obstacles) during a low-level flight.

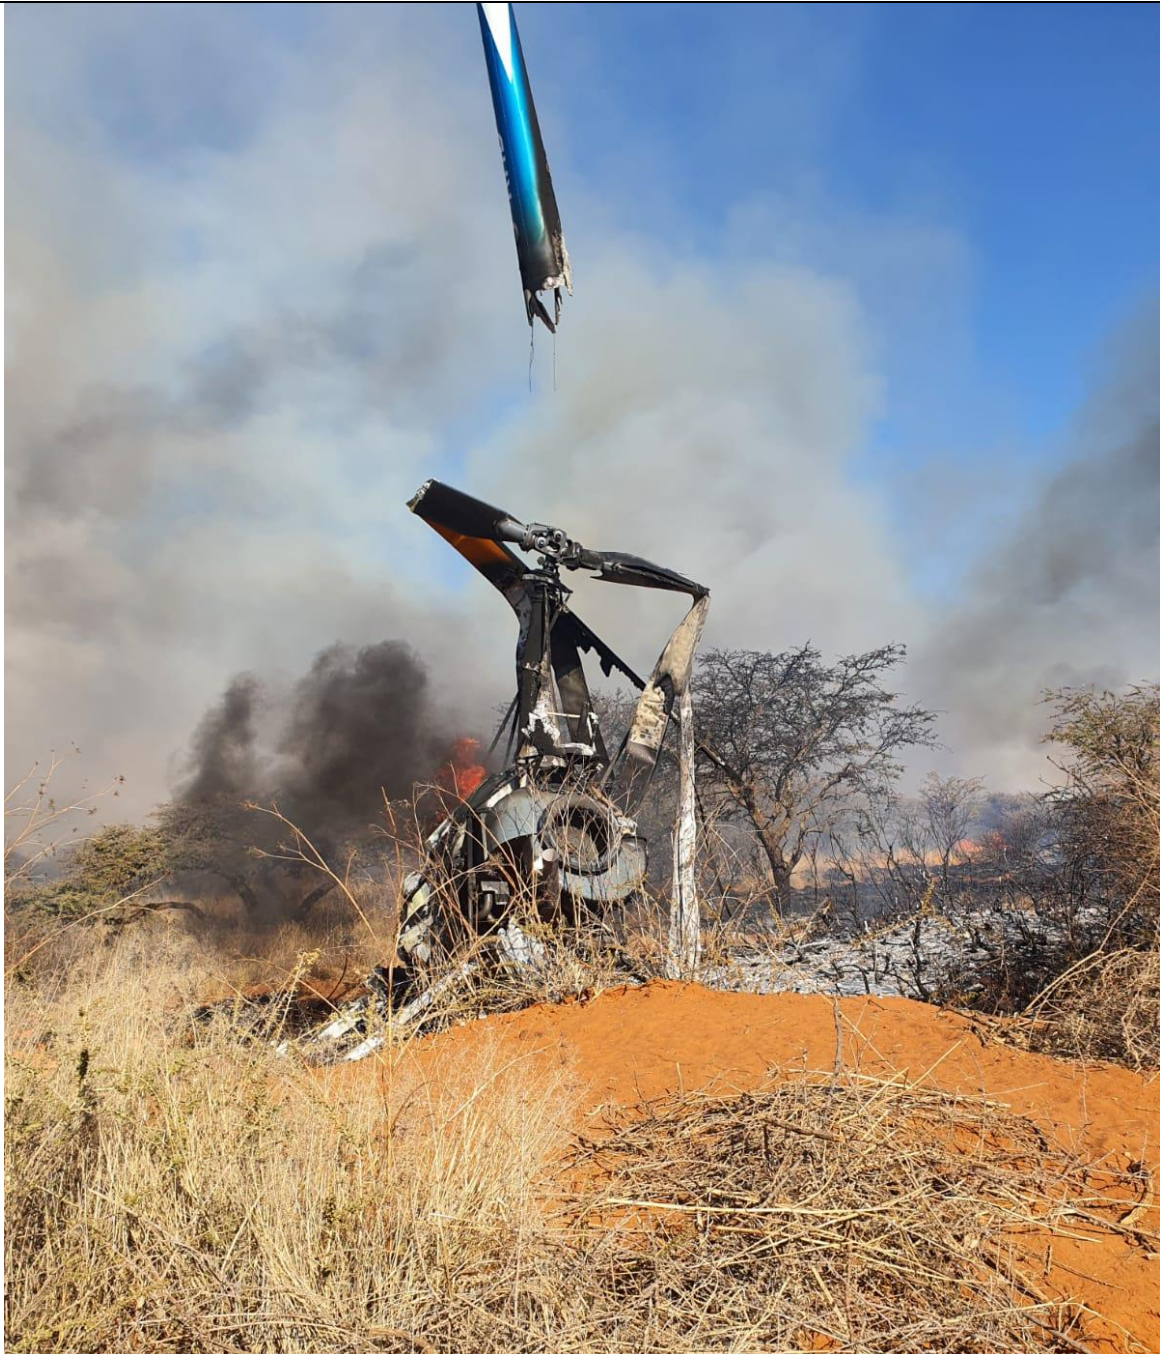
Figure 2: The helicopter engulfed in flames during the accident.
