LIMITED ACCIDENT INVESTIGATION REPORT

Reference Number	CA18/3/2/10028						
Classification	Accident	Date	26 July 2021	Time	1120Z		
Type of Operation	Training (Part 141)						
Location							
Place of Departure	Morning Star Airfield, Western Cape Province			Place of Intended Landing	Wintervogel Airfield, Western Cape Province		
Place of occurrence	Wintervogel Airfield, Western Cape province						
GPS Co-ordinates	Latitude	S 33°37' 674"	Longitude	E18°40'947"	Elevation	350 ft	
Aircraft Information							
Registration	ZS-MDF						
Model/Make	Cessna 172M Skyhawk II (Serial Number: 172-63912)						
Damage to Aircraft	Substantial			Total Aircraft Hours	6608.6		
Pilot-in-command							
Licence Type	Student Pilot Licence (SPL)			Gender	Male	Age	43
Licence Valid	Yes						
Total Hours on Type	705.1			Total Flying Hours	1172		
People On-board	1 + 1	Injuries	0	Fatalities	0	Other	0
What Happened							
<p>On Monday, 26 July 2021, a flight instructor and a student pilot on-board a Cessna 172M Skyhawk II aircraft with registration ZS-MDF were on a training flight from Morning Star Airfield situated in Cape Town, Western Cape province, destined for Wintervogel Airfield situated north of Cape Town.

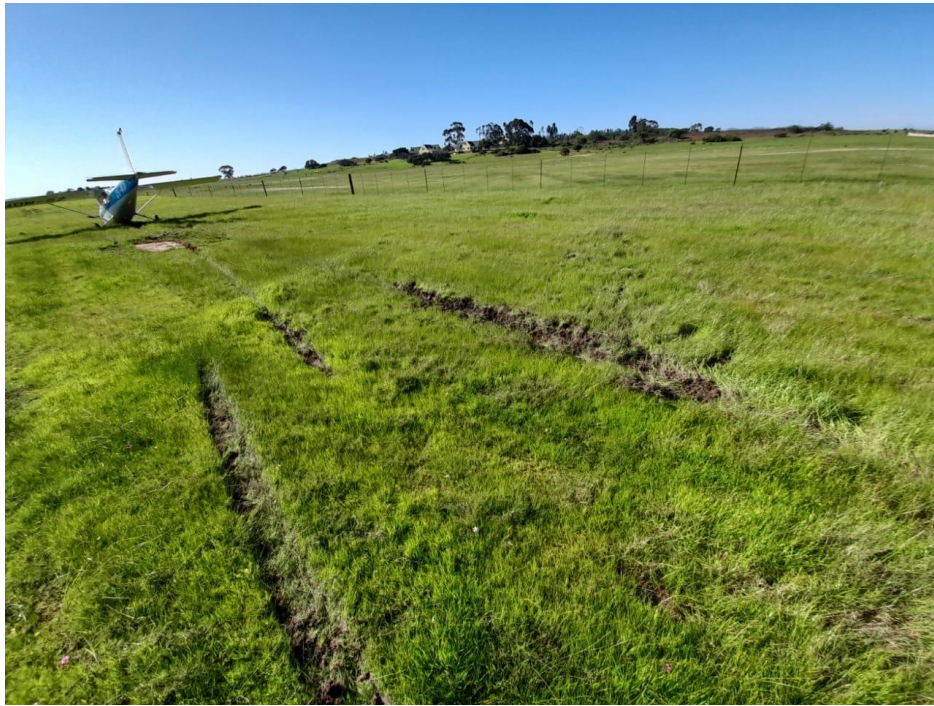
Figure 1: The aircraft's wheel tracks and final resting position post-accident. (Source: Pilot)

It is likely that the aircraft was unstable during approach for landing, resulting in a hard landing where after the pilot lost directional control of the aircraft as it veered off to the right-side of the runway during which the nose gear broke before the aircraft came to a stop.

Safety Action/s
None.
Safety Message/s and/or Safety Recommendation/s
Safety message: During initial pilot training, instructor pilots are advised to be cautious when giving instructions during high-risk phases of flight such as take-off and landings.
Purpose of the Investigation
<i>In terms of Regulation 12.03.1 of the Civil Aviation Regulations (CAR) 2011, this report was compiled in the interest of the promotion of aviation safety and the reduction of the risk of aviation accidents or incidents and not to apportion blame or liability.</i>
About this Report
<i>Decisions regarding whether to investigate, and the scope of an investigation are based on many factors, including the level of safety benefit likely to be obtained from an investigation. For this occurrence, no investigation has been conducted, and the Accident and Incident Investigations Division (AIID) has relied on the information submitted by the affected person/s and organisation/s to compile this brief report. The report has been compiled using information supplied in the initial notification, as well as follow-up information to bring awareness of potential safety issues to the industry in respect of this occurrence, as well as possible safety action/s that the industry might want to consider in preventing a recurrence of a similar accident.</i>

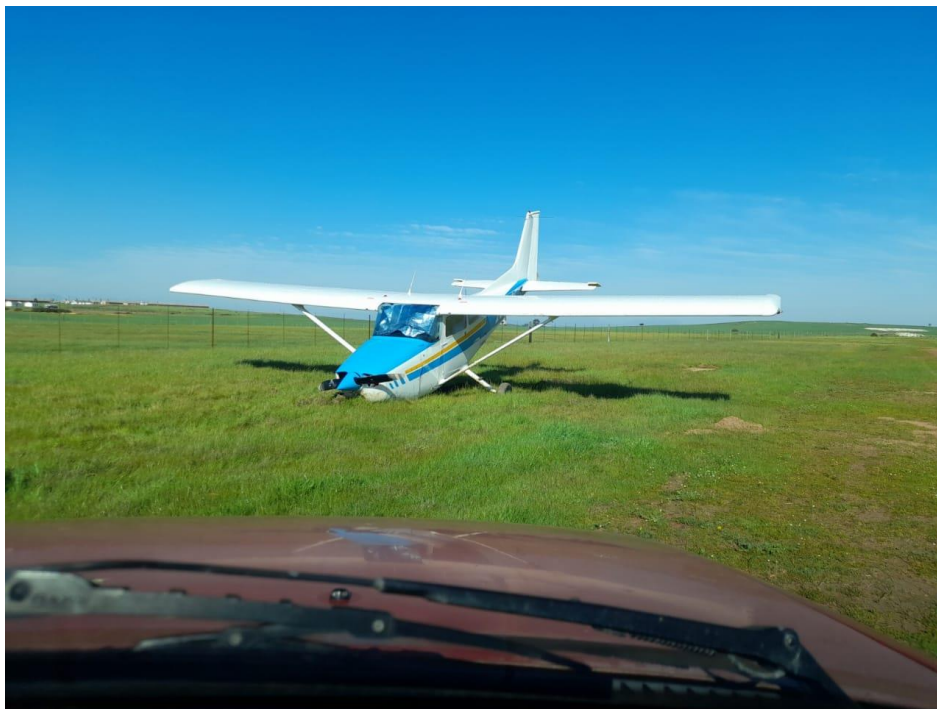
Figure 2: The aircraft as it came to rest. (Source: pilot)

The aircraft was unstable during approach for landing, resulting in a hard landing where after the pilot lost directional control of the aircraft as it veered off to the right-side of the runway during which the nose gear broke before the aircraft came to a stop.
