LIMITED ACCIDENT INVESTIGATION REPORT
--

Reference Number	CA18/2/3/10029						
Classification	Accident	Date	20 August 2021	Time	0805Z		
Type of Operation	Training Flight (Part 141)						
Location							
Place of Departure	Wonderboom Aerodrome (FAWB)		Place of Intended Landing	Wonderboom Aerodrome (FAWB)			
Place of Accident	Runway 29 at FAWB						
GPS Co-ordinates	Latitude	25°39'12.05"S	Longitude	28°13'20.76"E	Elevation	4078ft	
Aircraft Information							
Registration	ZS-STP						
Model/Make	Cessna 172M						
Damage to Aircraft	Substantial		Total Aircraft Hours	10290.6			
Pilot-in-command							
Licence Type	Student Pilot Licence (SPL)	Gender	Female		Age	20	
Licence Valid	Yes						
Total Hours on Type	8.7 hours		Total Flying Hours	46.7			
People On-board	1+0	Injuries	0	Fatalities	0	Other (on ground)	0
What Happened							
<p>On 20 August 2021 at about 0740Z, a student pilot on-board a Cessna 172M aircraft with registration ZS-STP took off from Wonderboom Aerodrome (FAWB) with the intention to conduct solo circuit training. Two circuits were conducted on Runway 29 without incident. According to the student pilot, wind direction was 090° at 5 knots (kts). The student pilot was clear

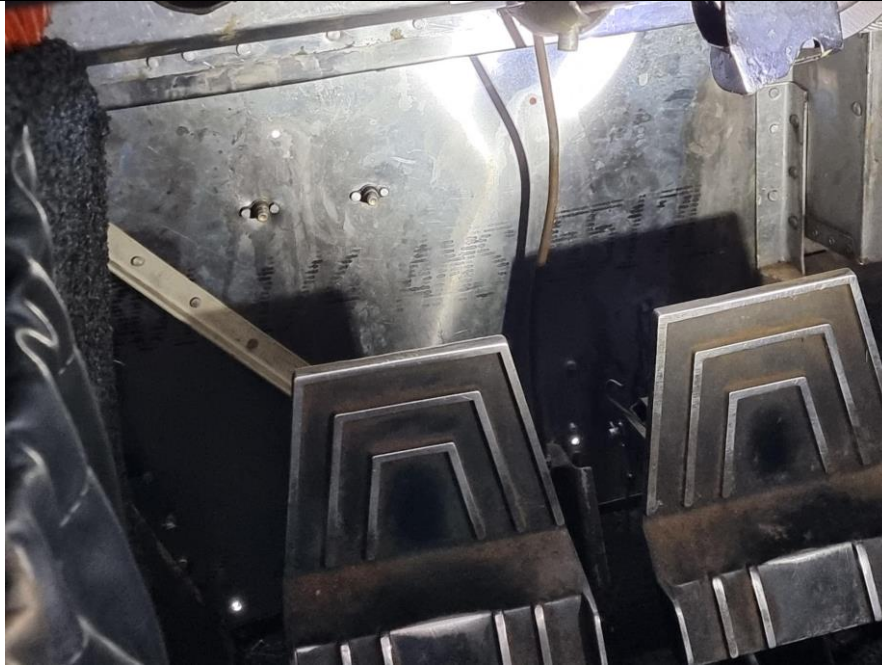
Figure 1: Aircraft damage to the fire wall. (Source: AMO)

It is possible that the aircraft was too high on final approach and landed hard before it bounced; thereafter, the pilot lost directional control as a result of a damaged nose gear.

Safety message: Pilots are advised to be alert when landing and taking off, as well as follow manufacturer's stipulated procedures.
