AIRCRAFT ACCIDENT REPORT AND EXECUTIVE SUMMARY

Reference:		CA18/2/3/10030	
Aircraft Registration	ZS-CKP	Date of Accident	23 August 2021		Time of Accident	1035Z	
Type of Aircraft	Piper PA-18A-150 Super Cub		Type of Operation	Part 43			
Pilot-in-command Licence Type	Commercial Pilot Licence (CPL)		Age	68	Licence Valid	Yes	
Pilot-in-command Flying Experience	Total Flying Hours		4174.6		Hours on Type	26.9	
Last Point of Departure	Port Alfred Aerodrome (FAPA), Eastern Cape Province						
Next Point of Intended Landing	Port Alfred Aerodrome (FAPA), Eastern Cape Province						
Damage to Aircraft	Substantial						
Location of the accident site with reference to easily defined geographical points (GPS readings if possible)							
Port Alfred Aerodrome (FAPA) on the left-side of RWY10L (GPS 33°33'14.72" S 026°52'24.60 E) at an elevation of 324 feet							
Meteorological Information	Wind: 030° at 4kt; Temperature: 20°C; Dew Point: 10°C; Visibility: ≥10000m; Cloud: CAVOK; QNH: 1016 hPa

Reference Number : CA18/2/3/10030
Name of Owner/Operator : Simon Bennett
Manufacturer : Piper Aircraft Company
Model : PA-18A-150 (Super Cub)
Nationality : South African
Registration Marks : ZS-CKP
Place : Por

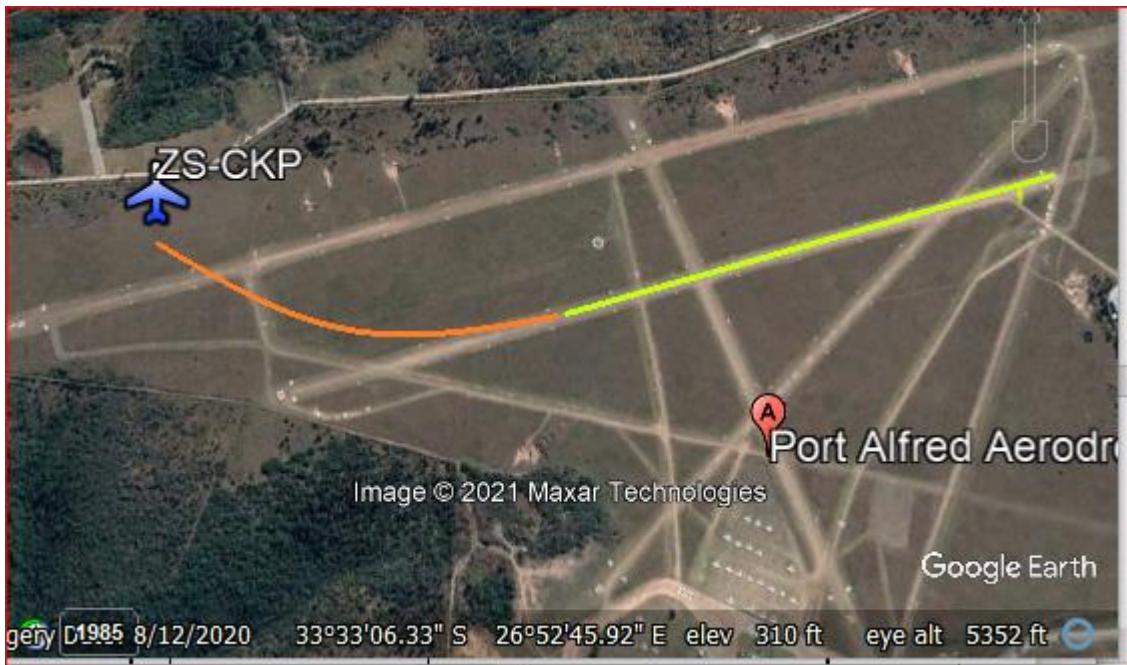
Figure 1: The aircraft path after take-off. (Source: Google Earth)

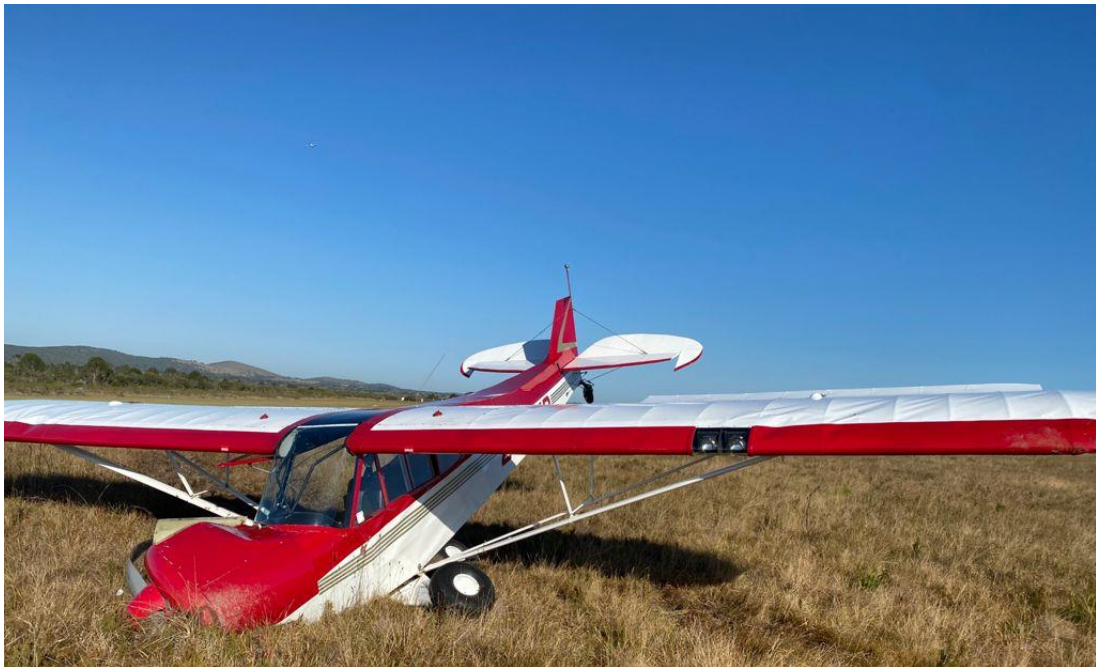
1.3.1 The aircraft sustained substantial damage during the accident sequence.

Figure 3: The aircraft at the accident site. (Source: Pilot)

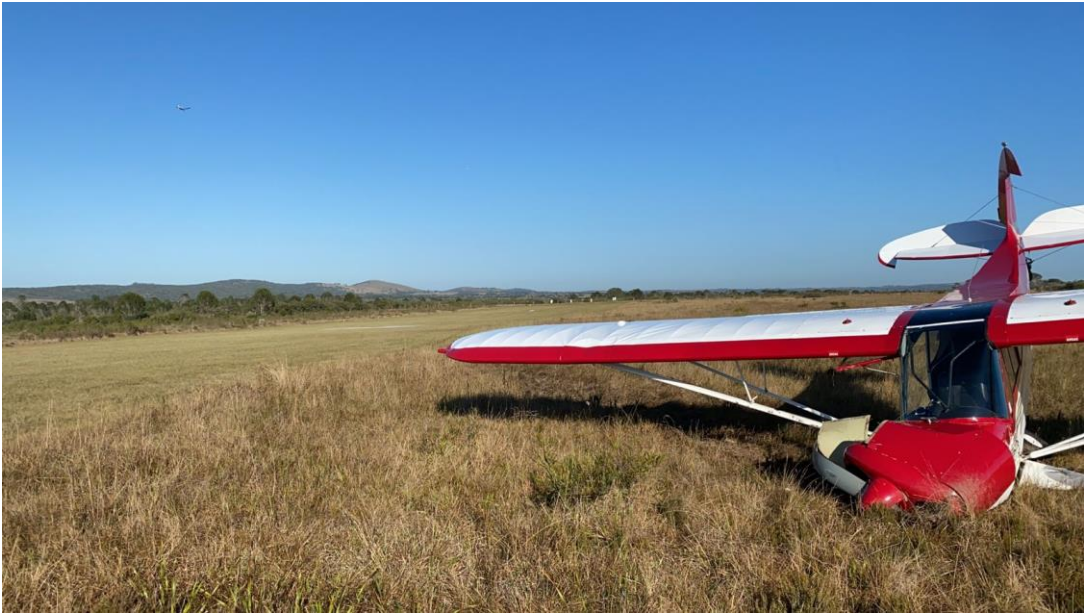
1.12.1 The aircraft took off from RWY 28L and, after rotating whilst climbing at 600ft AGL, the engine stopped. The pilot attempted to execute a teardrop turn to do a forced landing on Runway 10L. However, he could not complete the teardrop turn as the aircraft was rapidly losing height. The aircraft impacted the ground hard on the left-side of Runway 10L, damaging the engine cradle, propeller, fuselage and engine cowling.

Figure 4: The aircraft as it came to rest on the left-side of RWY10L.
