<b>LIMITED ACCIDENT INVESTIGATION REPORT</b>
--

<b>Reference Number</b>		CA18/2/3/10031					
<b>Classification</b>	Accident	<b>Date</b>	15 July 2021	<b>Time</b>	1430Z		
<b>Type of Operation</b>	Private (Part 94)						
<b>Location</b>							
Place of Departure	Wonderboom Aerodrome (FAWB), Gauteng Province		Place of Intended Landing	Wonderboom Aerodrome (FAWB), Gauteng Province			
Place of Incident	Runway 29, Wonderboom Aerodrome (FAWB), Gauteng Province						
GPS Co-ordinates	Latitude	S 25°39'13.20"	Longitude	E 28°13'36.73"	Elevation	4090ft	
<b>Aircraft Information</b>							
Registration	ZU-TRV						
Model/Make	Lancair IV-P (Serial number: 035)						
Damage to Aircraft	Substantial		Total Aircraft Hours	546.4			
<b>Pilot-in-command</b>							
Licence Valid	Yes	Gender	Male	Age	75		
Licence Type	Private Pilot Licence (Aeroplane)						
Total Hours on Type	5.5		Total Flying Hours	1557			
People On-board	1+1	Injuries	0	Fatalities	0	Other (On Ground)	0
<b>What Happened</b>

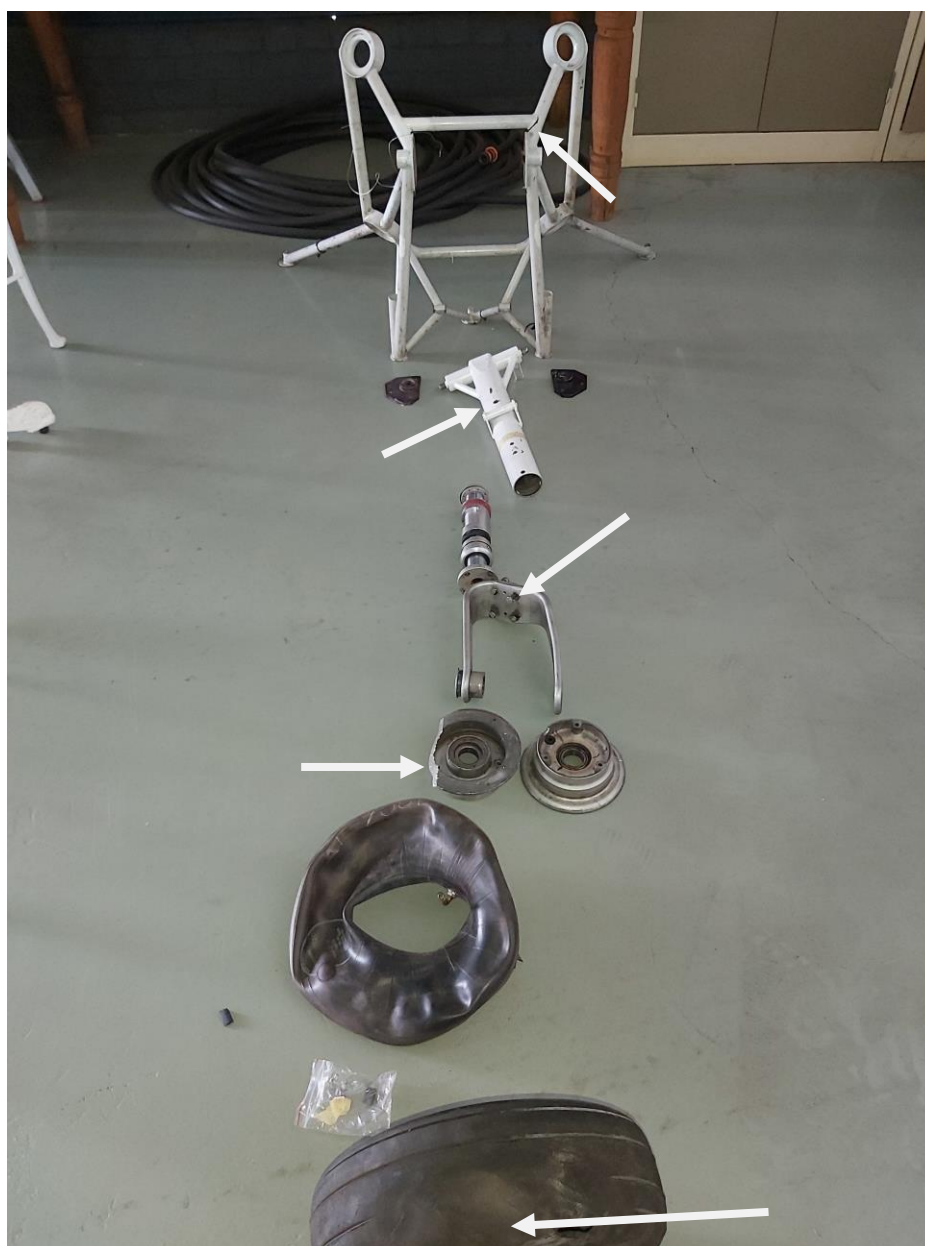
Post-accident, the aircraft was inspected by the aircraft maintenance organisation (AMO) and it was found that upon landing at FAWB, the nose wheel extended normally but, without the pilot's knowledge, the nose wheel tyre had deflated and had folded sideways. This prevented the free castor ring nose wheel from turning left or right, causing the wheel to grind down the runway and the fork to fold sideways.

The nose wheel trunnion was slightly bent during the incident; the trunnion is not repairable, it can only be replaced. The upper attachment point on the left-side of the trunnion attachment had also bent; the engine cradle had cracked open on the trunnion attachment point. No other damage was noted on the aircraft.

**Figure 1:** Damaged nose gear assembly parts.

The engine cradle was replaced with a new cradle, sourced from the aircraft manufacturer Lancair. A non-destructive testing (NDT) was carried out on the new cradle before installation. The nose wheel trunnion (with wheel fork and tyre) was replaced with a new unit from Lancair.

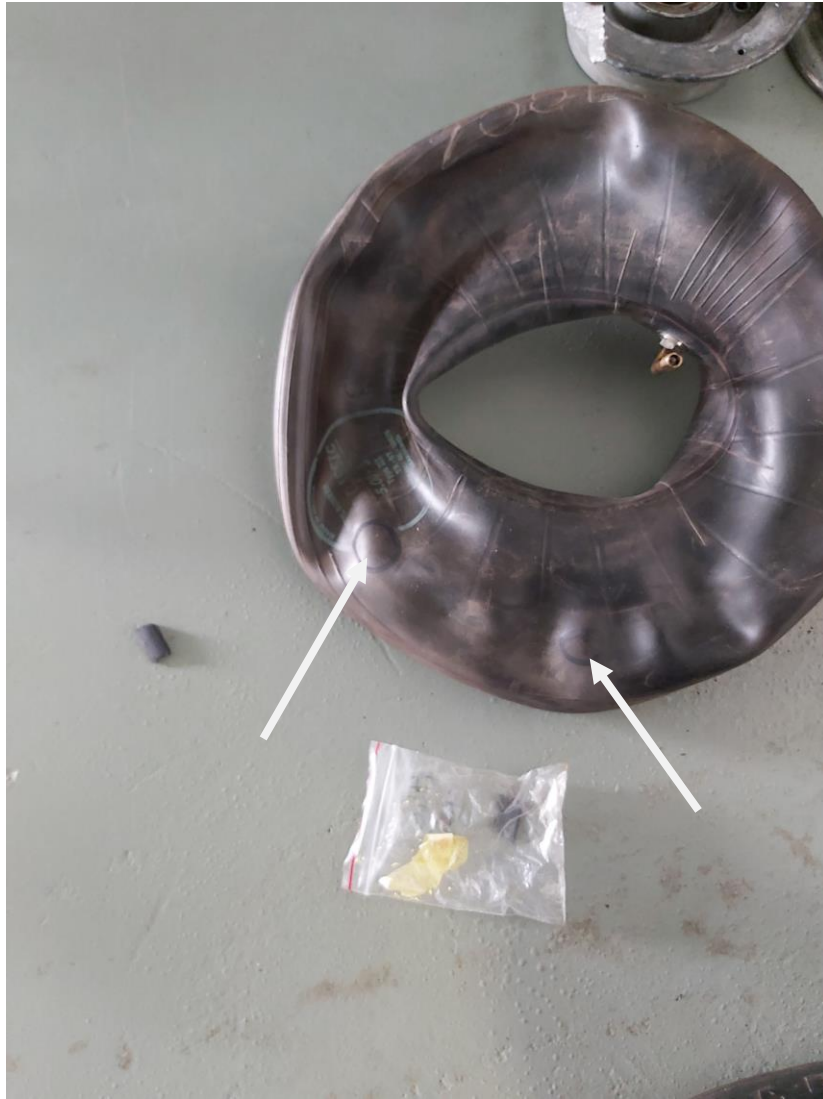
After inspection, the AMO also found two punctures in the inside tube of the tyre, which were in alignment with the defects on the surface of the tyre. During inspection, it could be seen that an object went in and then out of the tyre.

**Figure 2:** The tyre tube with white arrows showing the two punctures.

There were two punctures in the inside tube of the tyre which were in alignment with the defects on the surface of the tyre where an object went in and then pulled out of the tyre, causing the tyre to gradually deflate.

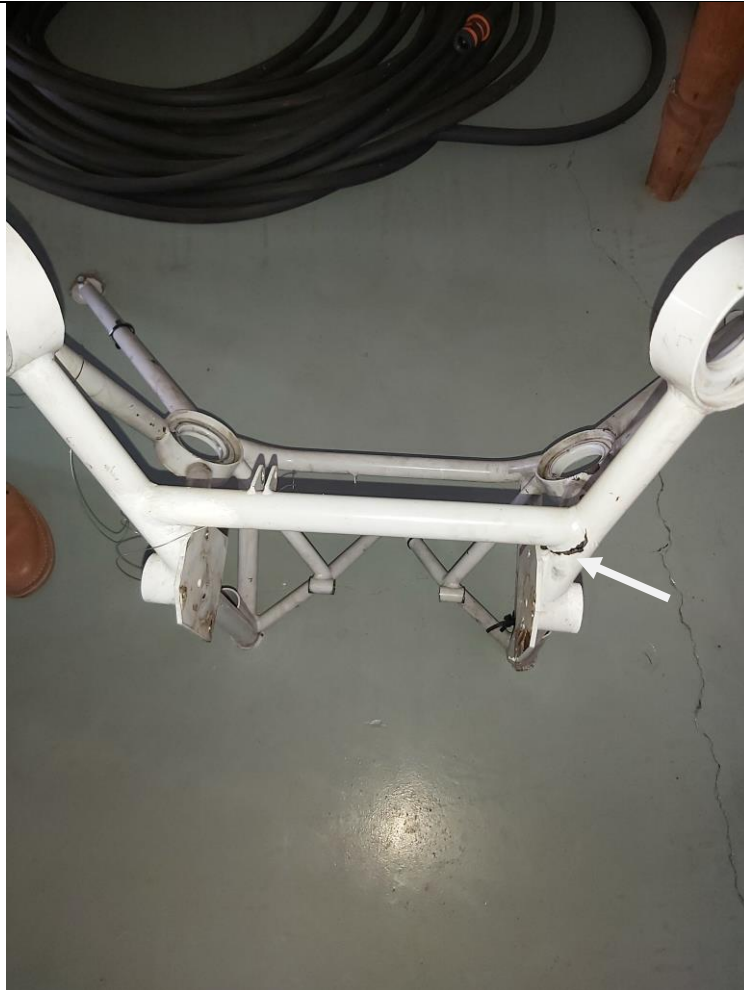
**Figure 3:** Damaged engine mount of the aircraft.

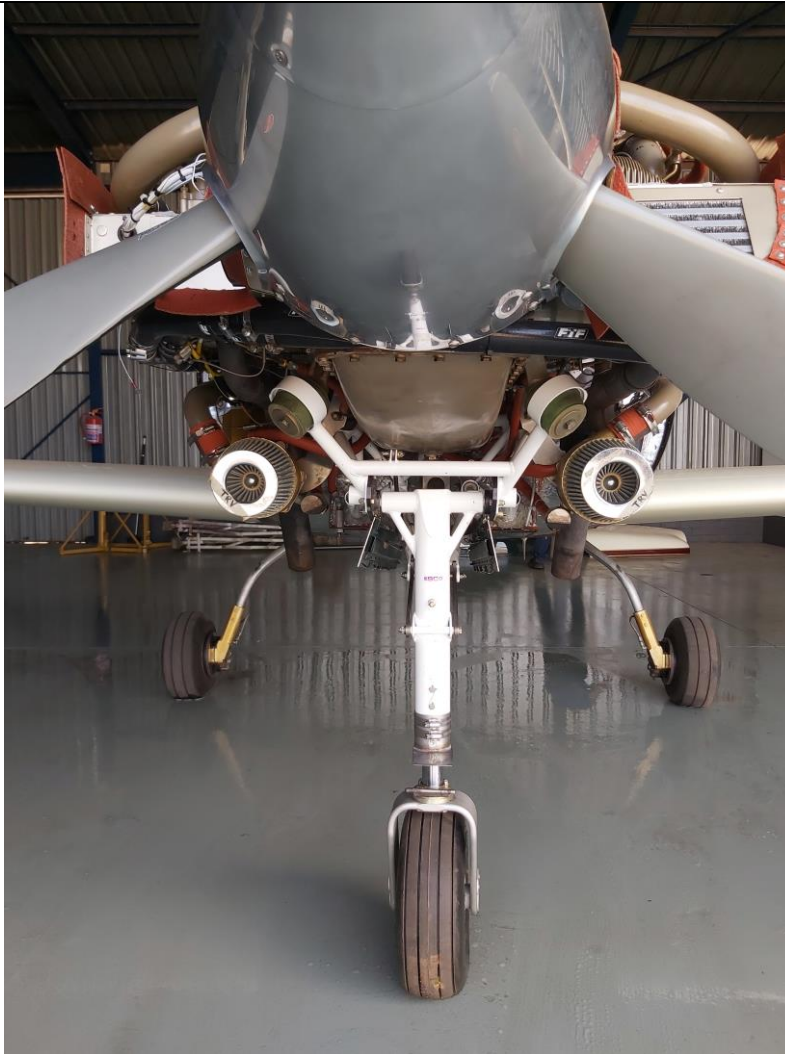
**Figure 4:** Repaired nose wheel assembly.
