**LIMITED ACCIDENT INVESTIGATION REPORT**

<b>Reference Number</b>	CA18/2/3/10035						
<b>Classification</b>	Accident	<b>Date</b>	4 September 2021		<b>Time</b>	0720Z	
<b>Type of Operation</b>	Private Flight (Part 91)						
<b>Location</b>							
Place of Departure	Orient Airfield (FAOI), Gauteng Province		Place of Intended Landing		Orient Airfield (FAOI), Gauteng Province		
Place of Accident	Runway 36L at Orient Airfield (FAOI)						
GPS Co-ordinates	Latitude	S 26°02'24.81"	Longitude	E 027°35'36.95"	Elevation	5115 feet	
<b>Aircraft Information</b>							
Registration	ZS-GYH						
Model/Make	Motor Falke SF25C (Serial Number: 4424)						
Damage to Aircraft	Substantial		Total Aircraft Hours		4255.3		
<b>Pilot-in-command</b>							
Licence Type	Private Pilot Licence (PPL)		Gender	Male	Age: 55		
Licence Valid	Yes						
Total Hours on Type	4.8		Total Flying Hours		434.8		
People On-board	1 + 1	Injuries	0	Fatalities	0	Other (on ground)	0
<b>What Happened</b>

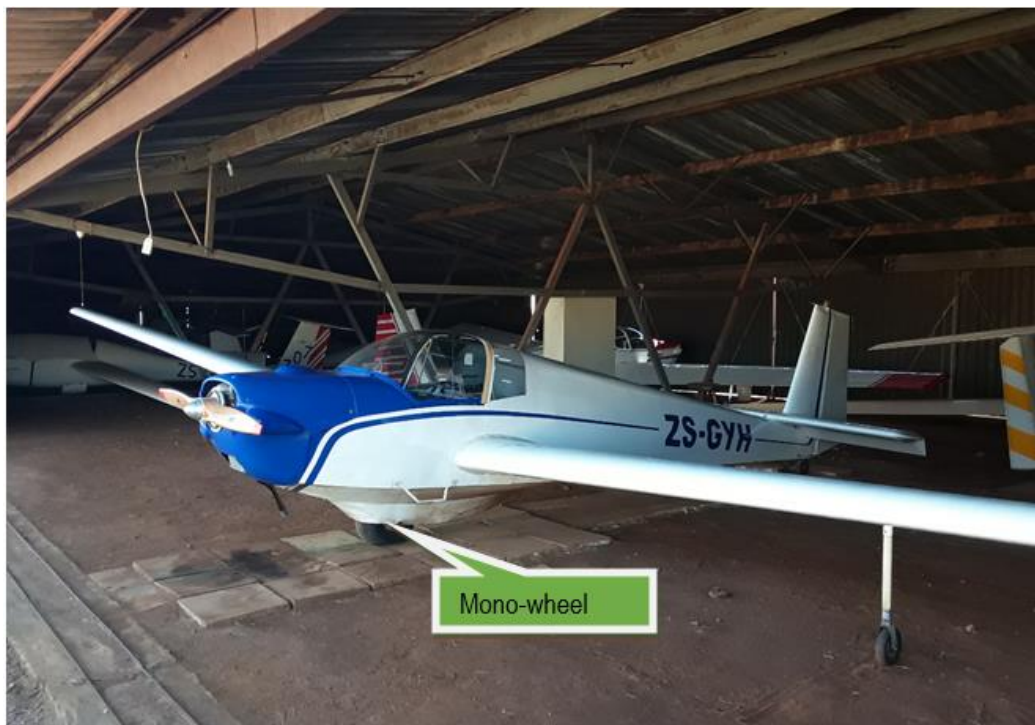
The aircraft sustained damage to the propeller, and the airframe tubing was bent behind the mono-wheel. Both occupants were not injured during the accident.

**Figure 2:** Aircraft after recovery. (Source: Pilot)

The aircraft was high on approach and the pilot flared too early, resulting in a hard landing and the propeller blades striking the ground.
