**LIMITED ACCIDENT INVESTIGATION REPORT**

<b>Reference Number</b>		CA18/2/3/10036					
<b>Classification</b>	Accident	<b>Date</b>	2 September 2021		<b>Time</b>	0615Z	
<b>Type of Operation</b>		Remotely Piloted Aircraft Systems (Part 101)					
<b>Location</b>							
Place of Departure		Ghaamsberg, Northern Cape Province		Place of Intended Landing		Ghaamsberg, Northern Cape Province	
Place of accident		Ghaamsberg, Northern Cape Province					
GPS Co-ordinates	Latitude	S29°26'25"	Longitude	E18°59'44"	Elevation	4740ft	
<b>Aircraft Information</b>							
Registration		ZT-WIV (Serial Number: M80DFK13030148)					
Model/Make		DJI M600 Pro					
Damage to Aircraft		Destroyed		Total Aircraft Hours		112.06	
<b>Pilot-in-command</b>							
Licence Valid		Yes		Gender		Male	
						Age 39	
<b>Licence Type</b>		Remote Pilot Licence (Drone)					
Total Hours on Type		754		Total Flying Hours		754	
People On-board	0	Injuries	0	Fatalities	0	Other (On Ground)	0
<b>What Happened</b>

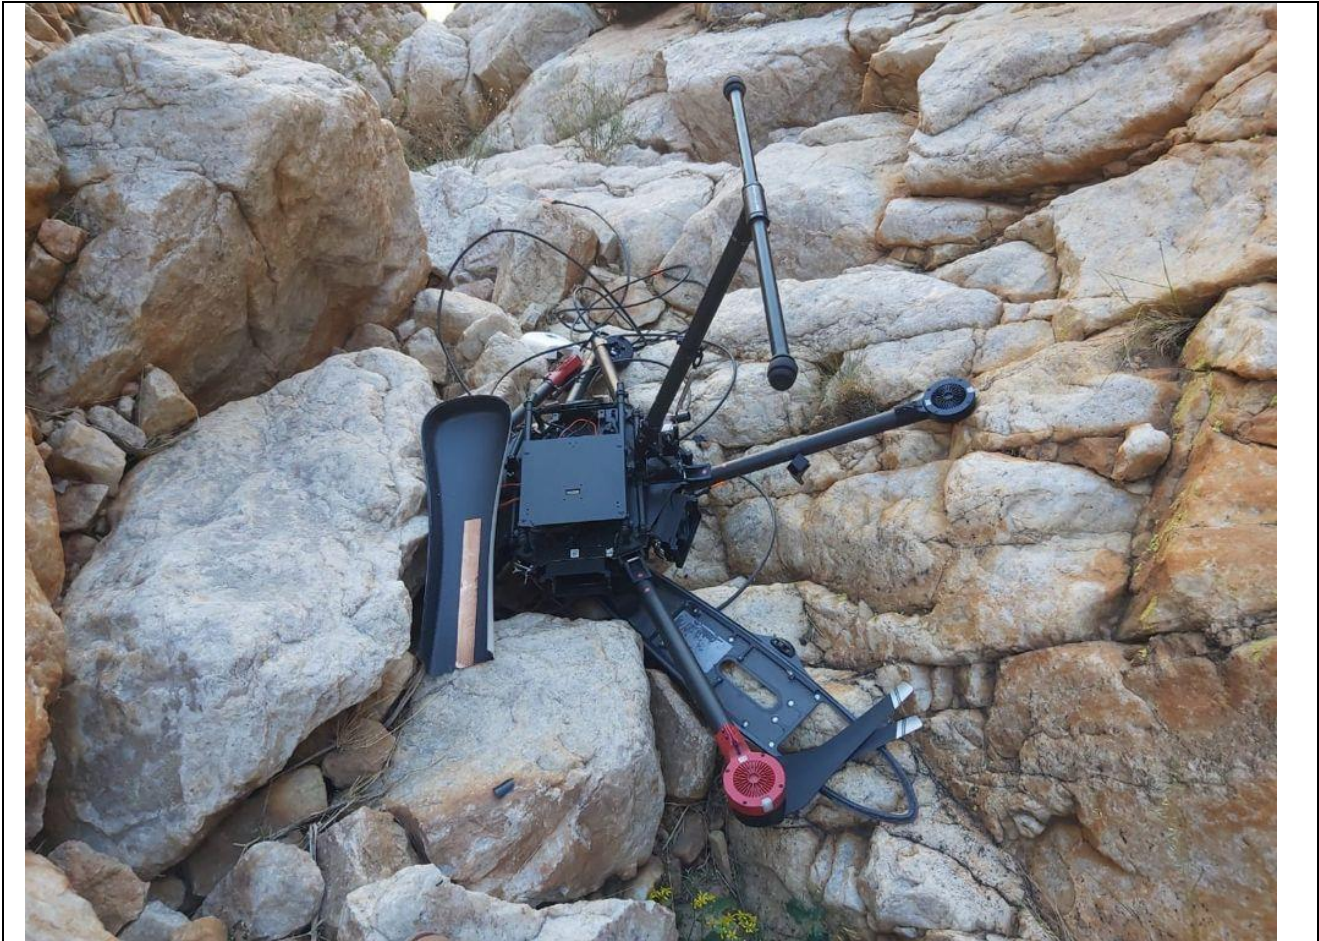
<p>On Thursday, 2 September 2021, a pilot was flying a drone registered ZT-WIV, which took off from Ghaamsberg in the Northern Cape province on a survey flight. The pilot stated that during the return flight, the drone transmitted error messages indicating that the motors were reaching maximum speed allowed; this was followed by compass and inertial measurement unit (IMU) errors. The drone then disconnected, and the pilot lost display of all telemetry. The pilot lost visual of the drone as it impacted rocks at the base of the terrain it was surveying. The drone and the under slung payload were destroyed.</p>

**Figure 1:** The drone at the base of the mountain. (Source: DC Geometrics)

Pilot lost sight of the drone, resulting in the drone colliding with the base of the mountain while returning to base (launch position).

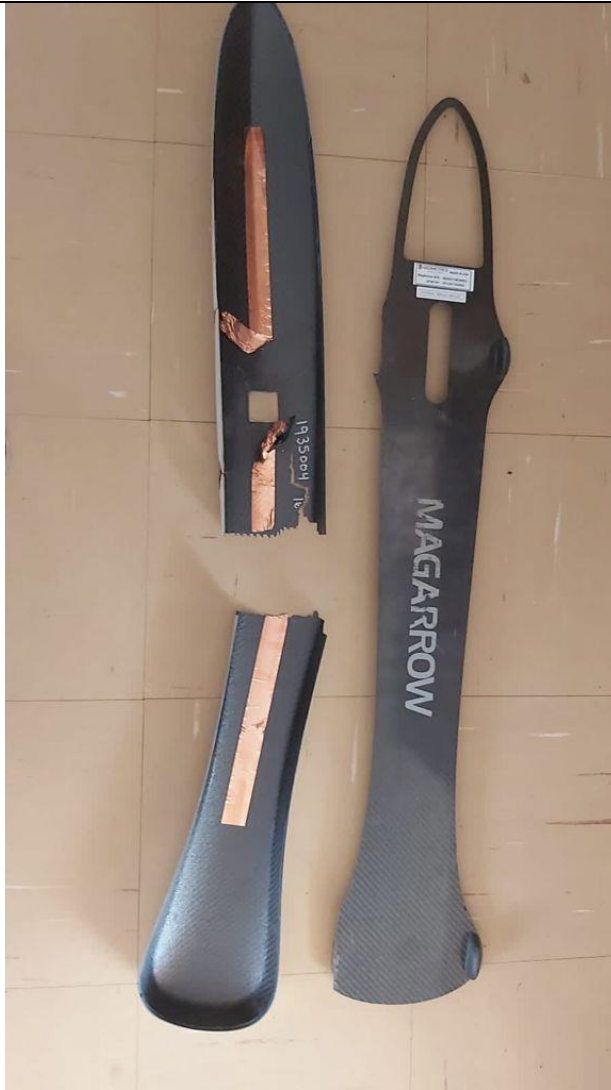
**Figure 2:** MagArrow which was the payload. (Source: DC Geometrics)

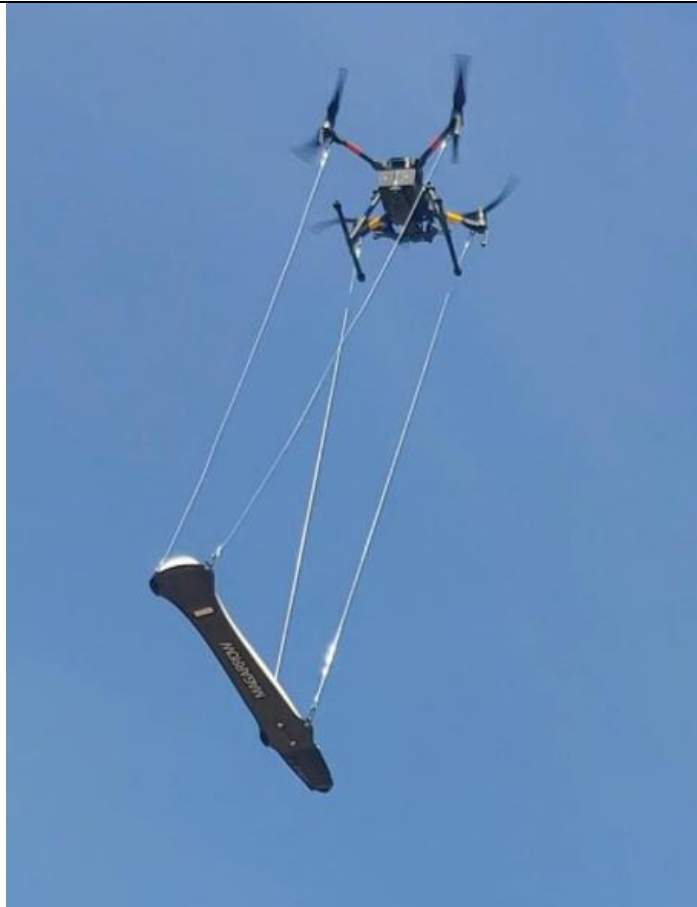
**Figure 3:** This is how the payload was suspended on the drone. (Source: geometrics.com)

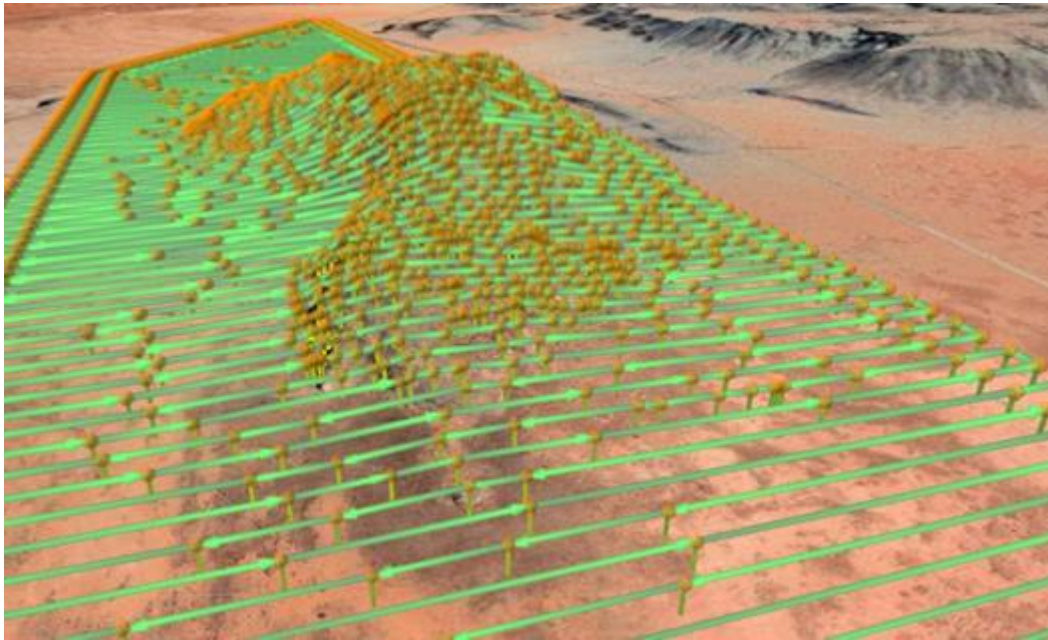
The operator reported that their client supplied them with a Lidar terrain model with an inaccuracy of 2.5m in x, y, and z. Generally, this high-quality dataset should be fine to fly safely. Within the survey area, there are a few areas of gorges and cliff faces which, in close analysis, seemed to fall within the shadow of the Lidar and were averaged out, therefore, supplying incorrect information in small critical spots within the survey block. The operator used this information to follow the terrain accurately using their drone navigation planning software. In this case, the terrain model was out by 10m in some areas, according to their calculations. These areas were of enough height and vertical angle to conflict with the flying height, which probably resulted in the impact with the ground. The operator's navigation is based on placing waypoints at appropriate places for the drone to follow, point-to-point. The waypoints only 'look down' directly and give the drone the

height information based on this. In Figure 4, it can be seen that the terrain starts to vary more; and more waypoints are placed to ensure that the terrain is followed accurately. *The key point to notice is that the waypoints only look down.*

**Figure 4:** The terrain showing waypoints. (Source: DC Geometrics)

The client provided the operator with inaccurate data which the operator did not verify, resulting in inability of the drone's navigational software to deal with the vertical cliff faces or drop offs.

<b>Safety Recommendation</b>	
It is encouraged that the operators must verify data and waypoints provided by their clients to have accurate Digital Terrain Model (DTM) to minimise risks and accidents.	
<b>Purpose of the Investigation</b>	
<i>In terms of Regulation 12.03.1 of the Civil Aviation Regulations (CAR) 2011, this report was compiled in the interest of the promotion of aviation safety and the reduction of the risk of aviation accidents or incidents and <b>not to apportion blame or liability</b>.</i>	
<b>About this Report</b>	
<i>Decisions regarding whether to investigate, and the scope of an investigation are based on many factors, including the level of safety benefit likely to be obtained from an investigation. For this occurrence, no investigation has been conducted, and the Accident and Incident Investigations Division (AIID) has relied on the information submitted by the affected person/s and organisation/s to compile this brief report. The report has been compiled using information supplied in the initial notification, as well as follow-up information to bring awareness of potential safety issues to the industry in respect of this occurrence, as well as possible safety action/s that the industry might want to consider in preventing a recurrence of a similar accident.</i>

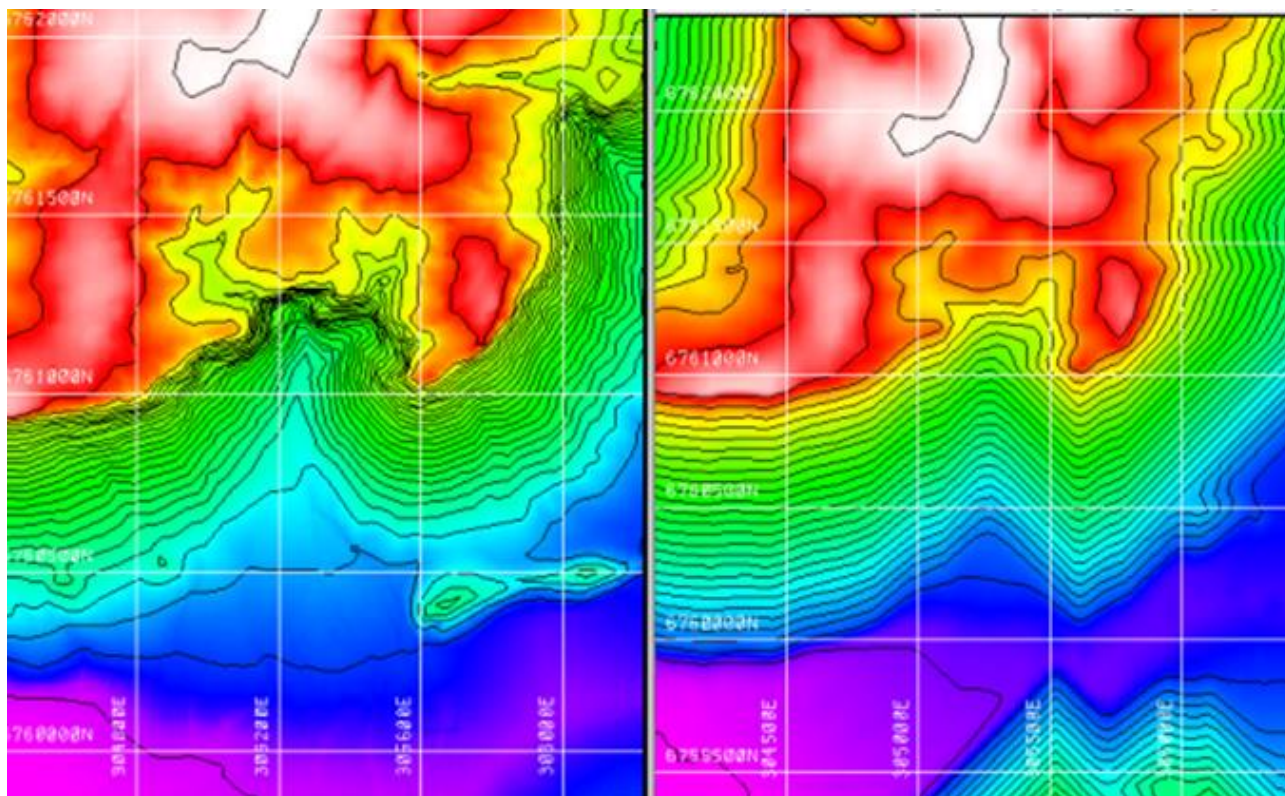
**Figure 5:** Contour map showing area layout. (Source: DC Geometrics)

Note the deep in the gorge in Figure 5 (left image); the terrain has very sudden vertical edges (contour interval 10m). In Figure 5 (right image), after correction of a predetermined maximum climb, speed and height control, the terrain model is smoothed out to allow the drone to fly very easily over this area. The client will need to accept that in these instances, the drone will be significantly higher above ground than the proposed flying height; safety will overrule the proposed height. The new waypoints will be generated based on this corrected surface. No attempt will be made to navigate the very steep terrain at all except when using the operator's version that has been generated.

New software has been developed that allows the operator to put tight parameters on the terrain and generate new surface of the earth within these parameters and, by so doing, avoid severe terrain where the Lidar might have incorrect data. The software will allow the drone to fly smoothly

over such areas while still allowing precise height control over flatter terrain. Here are some examples (Figure 5 images) the operator had generated from rough terrain and the outcome after they applied corrections.

The ground surface was adjusted to allow easy flying for the drone with no possibilities of obstacles. The climb and descent rates never exceed 40 degrees at any time. The drone will be programmed to start its climb or descent some distance before or after a steep edge to allow for this to occur. The operator believes that this software is a world first in the marketplace and will offer a real sense of satisfaction, not only to them (operator), but to their clients and insurers.
