LIMITED ACCIDENT INVESTIGATION REPORT

Reference Number	CA18/2/3/10037					
Classification	Accident	Date	9 September 2021	Time	1224Z	
Type of Operation	Private (Part 91)					
Location						
Place of Departure	Rand Aerodrome (FAGM), Gauteng Province	Place of Intended Landing	Rand Aerodrome (FAGM), Gauteng Province			
Place of Occurrence	Runway 11 at FAGM, Gauteng Province.					
GPS Co-ordinates	Latitude	S25° 56.' 19"	Longitude	E027°55.'34	Elevation	4520 feet
Aircraft Information						
Registration	ZS-EFF					
Model/Make	Piper PA-24-260 Comanche (Serial No: 24-4045)					
Damage to Aircraft	Substantial	Total Aircraft Hours	2336.9			
Pilot-in-command						
Licence Valid	Yes	Gender	Male	Age	43	
Licence Type	Airline Transport Pilot Licence (ATPL)					
Total Hours on Type	65.9		Total Flying Hours	13022.5		
People On-board	1 + 1	Injuries	0	Fatalities	0	Other (On Ground) 0
What Happened						
<p>On 9 September 2021, a pilot accompanied by an aircraft maintenance engineer (AME) on-board a Piper PA-24-260 Comanche tricycle retractable landing gear aircraft with registration ZS-EFF took-off on a private flight from Rand Aerodrome (FAGM) Runway 11, situated in Germiston, Gauteng Province, with

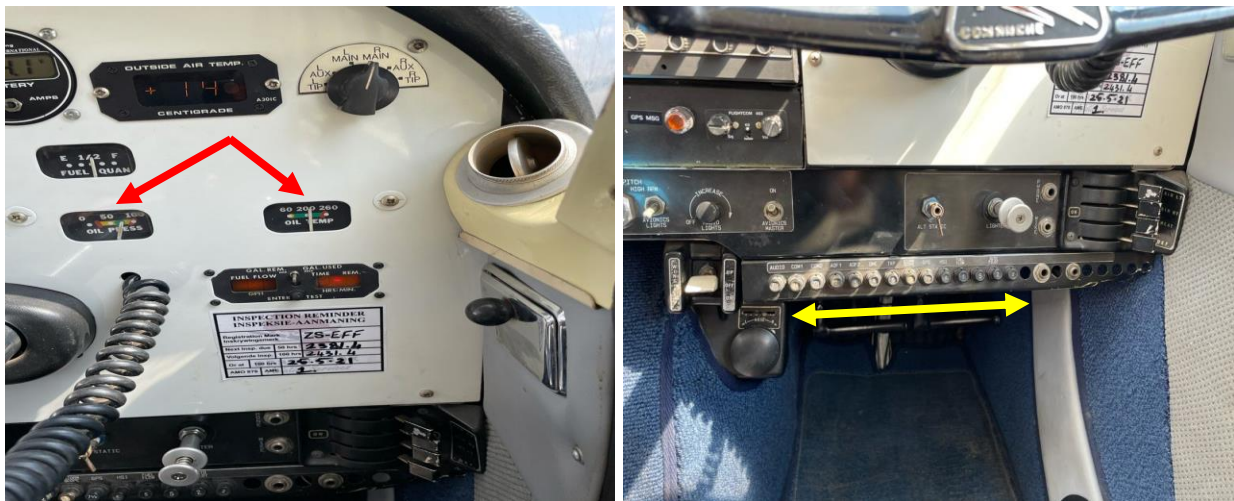
Figures 1/2: The indication of the oil pressure and the oil temperature within limits (green arch), (left picture). A picture of the instruments panel showing all the CBs in pressed-in position (right picture). (Source: AME)

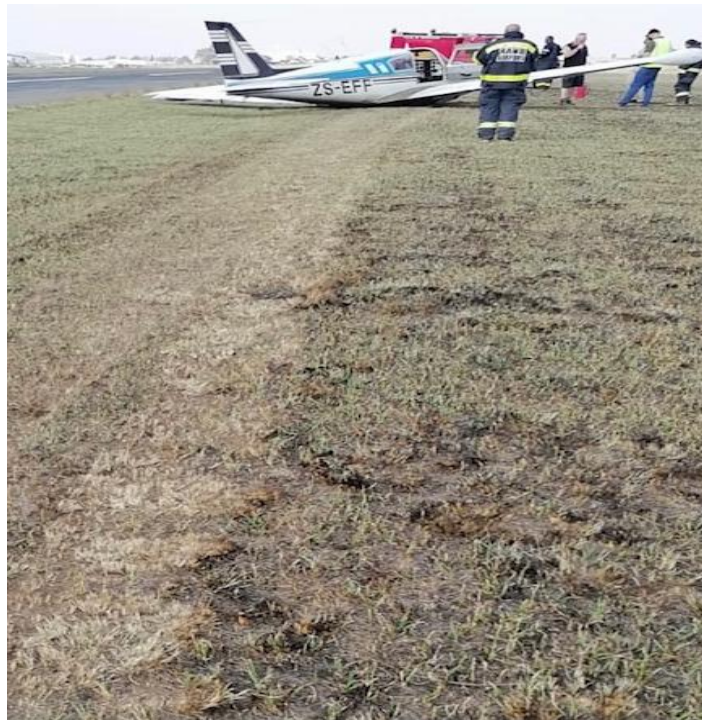
beyond Runway 11 threshold markings. During the landing roll and after approximately 60m, the landing gear collapsed and the propeller blades struck the runway surface. The aircraft slid on its belly to the right-side, exited the runway and came to a stop approximately 5m from the runway edge on the grass area just before the second taxiway. The aircraft sustained substantial damages. None of the occupants were injured during the accident sequence; they vacated the aircraft without assistance.

Figure 3: The aircraft at the accident site. (Source: Operator)

Post-accident examination of the propeller blades indicated that the engine was producing a substantial amount of power at the time of impact.

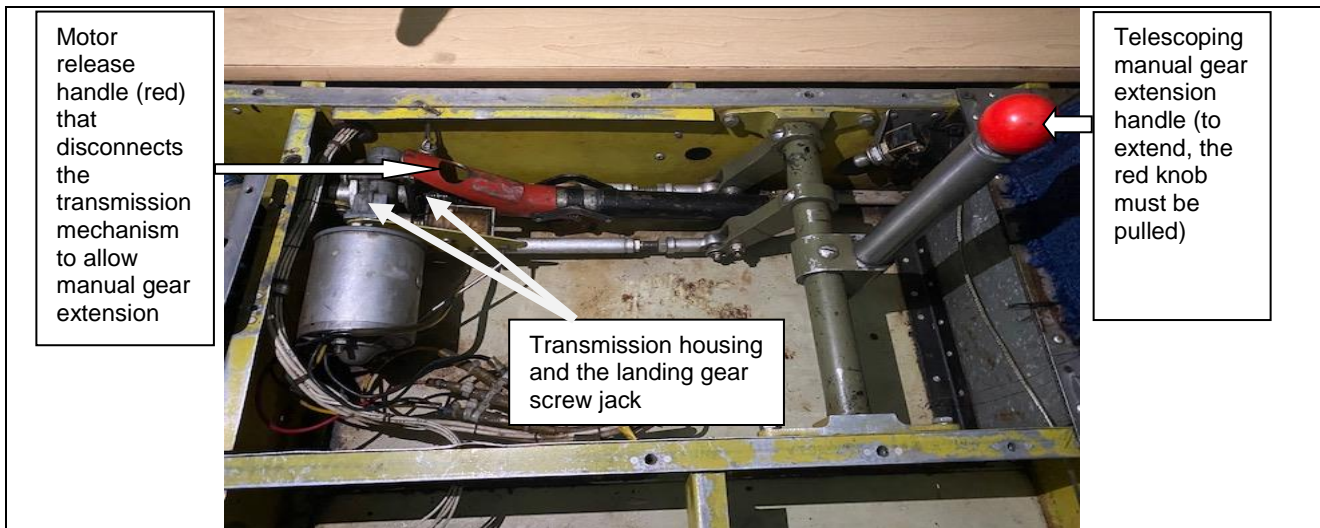
Figure 4: The landing gear manual extension lever in an extended position.

The aircraft's landing gears collapsed during the landing roll because they did not lock into position prior to landing, probably due to the landing gear manual extension being performed while the electrical motor was still operative. This appeared to have prevented the movement of the gear mechanism.

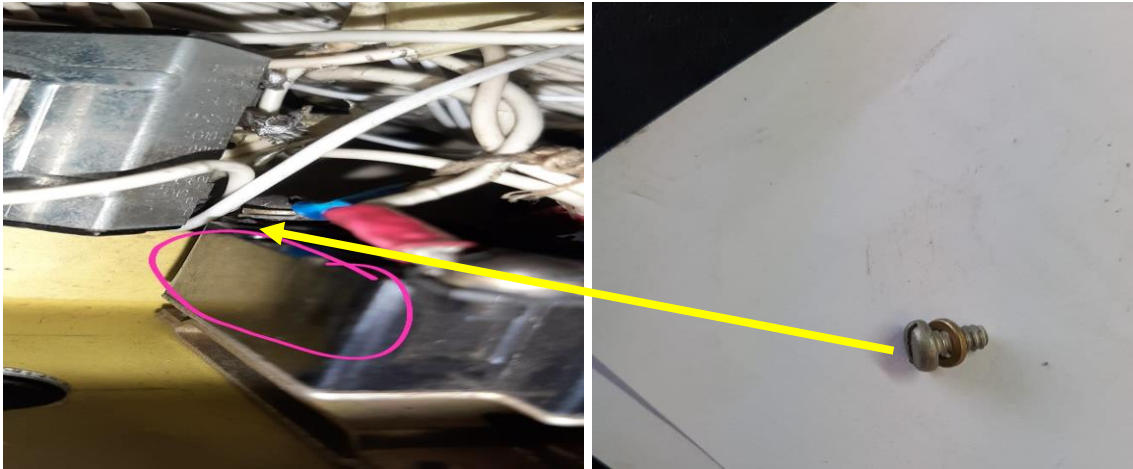
On 13 September 2021, the aircraft maintenance organisation (AMO) with a valid approval certificate was contracted by the operator to assist with the electrical system defect investigation. The engineer who assisted with the investigation had both Category W and X ratings. Inspection was carried out on the battery and connection to the master solenoid, making sure that the fasteners were properly secured; nothing abnormal was noted. The wiring under the floor panels was inspected and found undisturbed. After the AMO's engineer had opened a panel situated on the left of the pilot's side, he noticed that the screw securing the cable ring lug to the master switch was loose. The cable was found to have detached from the master switch body. The cable in question controls the aircraft's charging system and the defect was directly linked to electronic failure as the charging system was not sufficiently keeping buss and battery voltage at operating levels. The buss voltage dropped too low that the master solenoid switched off.

Figures 5/6: The area where a loose screw was found (left picture). The screw in question (right picture).

The electrical failure on the aircraft was caused by a disconnected master switch cable which controls the charging system, and the defect was directly linked to the electrical failure as the charging system was not sufficiently keeping buss and battery voltage at operating levels.
