LIMITED ACCIDENT INVESTIGATION REPORT
--

Reference Number		CA18/2/3/10039					
Classification	Accident	Date	17 September 2021	Time	1350Z		
Type of Operation	Training (Part 141)						
Location							
Place of Departure	Lanseria International Aerodrome (FALA)	Place of Intended Landing	Lanseria International Aerodrome (FALA)				
Place of Accident	Runway 07, Lanseria International Aerodrome (FALA), Gauteng Province						
GPS Co-ordinates	Latitude	25° 56' 45.37" S	Longitude	027° 55' 03.33" E	Elevation	4 521ft	
Aircraft Information							
Registration	ZS-FTS						
Model/Make	Piper PA-28-140 Cherokee						
Damage to Aircraft	Substantial	Total Aircraft Hours	6658.7				
Pilot-in-command							
Licence Valid	Yes	Gender	Female	Age	20		
Licence Type	Student Pilot Licence (SPL)						
Total Hours on Type	32.4		Total Flying Hours	32.4			
People On-board	1 + 0	Injuries	1	Fatalities	0	Other (on ground)	0
What Happened							
<p>On Friday afternoon, 17 September 2021, a flight instructor and a student pilot on-board a Piper PA-28-140 Cherokee aircraft with registration ZS-FTS were cleared by air traffic control (ATC) for take-off on Runway (RWY) 07 to conduct circuit training at Lanseria Internatio

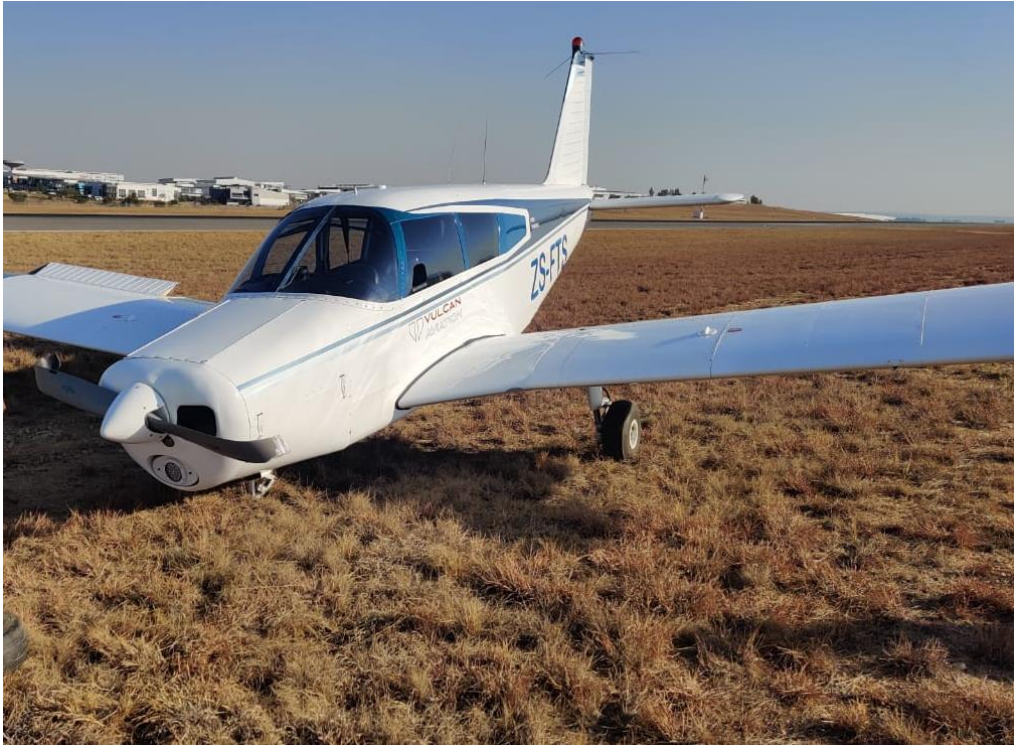
Figure 1: The aircraft post-accident showing the damaged propeller and broken nose gear. The photo was taken after the aircraft was moved from the runway. (Source: Pilot)

There were no mechanical defects or anomalies with the aircraft that could have contributed to or have caused the accident. The weather was not a factor in this accident.

The student pilot flared the aircraft too high, resulting in a hard landing and two bounces before impacting the ground hard with the nose gear first. This resulted in the nose gear breaking off and the propeller striking the ground.

Following the accident, the aviation training organisation (ATO) implemented remedial training for the student pilot with a senior Grade II instructor. The student pilot has undergone multiple simulator sessions where all possible emergency scenarios were completed; in addition, the student pilot has attended simulator sessions as an observer for increased exposure to flying. The student pilot is also undergoing decision making as well as effecting corrective actions during both normal and abnormal

- (1) Completion of simulator sessions where all possible emergency scenarios are to be completed successfully.
- (2) Undergoing decision-making and effecting corrective actions training.
- (3) Attending simulator sessions as an observer for increased exposure to flying.
