<b>LIMITED ACCIDENT INVESTIGATION REPORT</b>
--

<b>Reference Number</b>	CA18/2/3/10040						
<b>Classification</b>	Accident	<b>Date</b>	17 September 2021	<b>Time</b>	1730Z		
<b>Type of Operation</b>	Training (Part 91)						
<b>Location</b>							
Place of Departure	Grand Central Aerodrome (FAGC)			Place of Intended Landing	Grand Central Aerodrome (FAGC)		
Place of Accident	FAGC Runway 35, Gauteng Province						
GPS Co-ordinates	Latitude	25° 59' 6.74S	Longitude	028° 8' 24.5E	Elevation	5161 ft	
<b>Aircraft Information</b>							
Registration	ZS-ELH						
Model/Make	Piper PA-28-140						
Damage to Aircraft	Substantial			Total Aircraft Hours	7393.8		
<b>Pilot-in-command</b>							
Licence Type	Private Pilot Licence (PPL)	Gender	Male		Age	21	
Licence Valid	Yes						
Total Hours on Type	26.6			Total Flying Hours	150.7		
People On-board	1+0	Injuries	0	Fatalities	0	Other (on ground)	0
<b>What Happened</b>							
<p>On 17 September 2021 at approximately 1615Z, a Piper PA-28-140 aircraft with registration ZS-ELH took off from Grand Central Aerodrome (FAGC), routed to Grasmere Golf Alfa Victor beacon (GAV) and back (to FAGC) for hour building exercise. The pilot was the sole occupant during

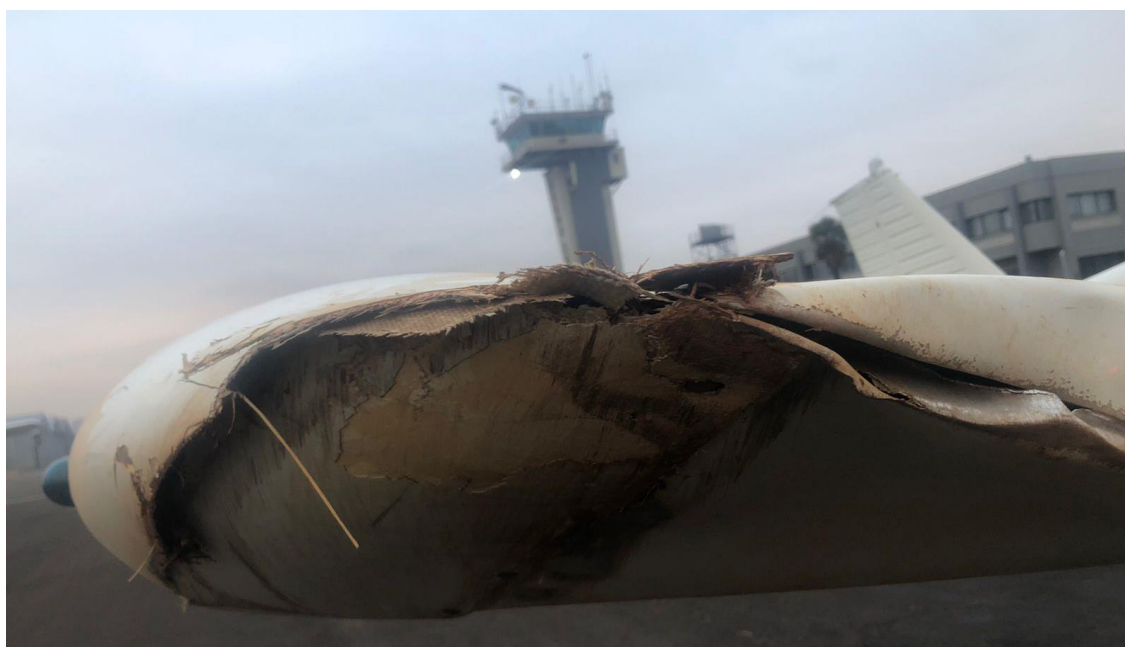
**Figure 3:** Damage to the right-side wing tip.

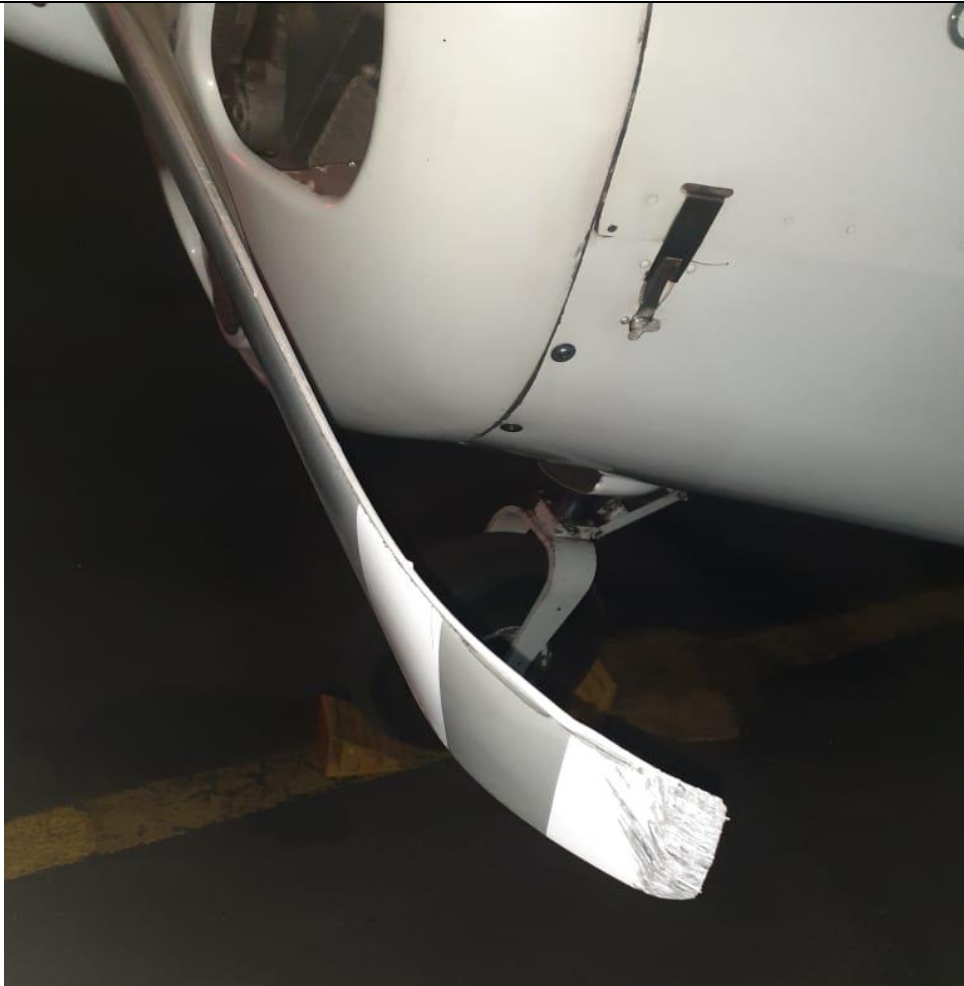
ground and the aircraft veered off to the left-side and exited the runway. The aircraft came to a stop 5 metres from the left of the runway's edge.

**Figure 4:** The damaged propeller.

The pilot lost control of the aircraft during landing due to excessive gusting wind that resulted in the aircraft landing hard, bouncing, and veering off to the left-side of the runway; lost directional control on landing and poor technique.

Post-accident, the pilot was advised by his ATO not to hesitate to initiate a go-around. Moreover, the ATO committed to intensify go-around training for pilots.
