**LIMITED ACCIDENT INVESTIGATION REPORT**

<b>Reference Number</b>	CA18/3/2/10043						
<b>Classification</b>	Accident	<b>Date</b>	21 September 2021	<b>Time</b>	1105Z		
<b>Type of Operation</b>	Training Flight (Part 141)						
<b>Location</b>							
Place of Departure	Lanseria International Airport (FALA)		Place of Intended Landing	Lanseria International Airport (FALA)			
Place of Accident	At FALA on Runway 07						
GPS Co-ordinates	Latitude	25°56'23.0" S	Longitude	027°55'28.8" E	Elevation	4517 ft	
<b>Aircraft Information</b>							
Registration	ZS-OHK						
Make/Model	Cessna 172N						
Damage to Aircraft	Substantial		Total Aircraft Hours	11306.7			
<b>Pilot-in-command</b>							
Licence Valid	Yes		Gender	Male		Age: 24	
Licence Type	Student Pilot Licence (SPL)						
Total Hours on Type	50.2		Total Flying Hours	50.2			
People On-board	1 + 0	Injuries	0	Fatalities	0	Other (On Ground)	0
<b>What Happened</b>							
<p>On Tuesday, 21 September 2021, a student pilot on-board a Cessna 172N aircraft with registration ZS-OHK took off on a training flight from Lanseria International Airport (FALA) Runway 07 to the general flying area with the intention to return to FALA. The total flight time

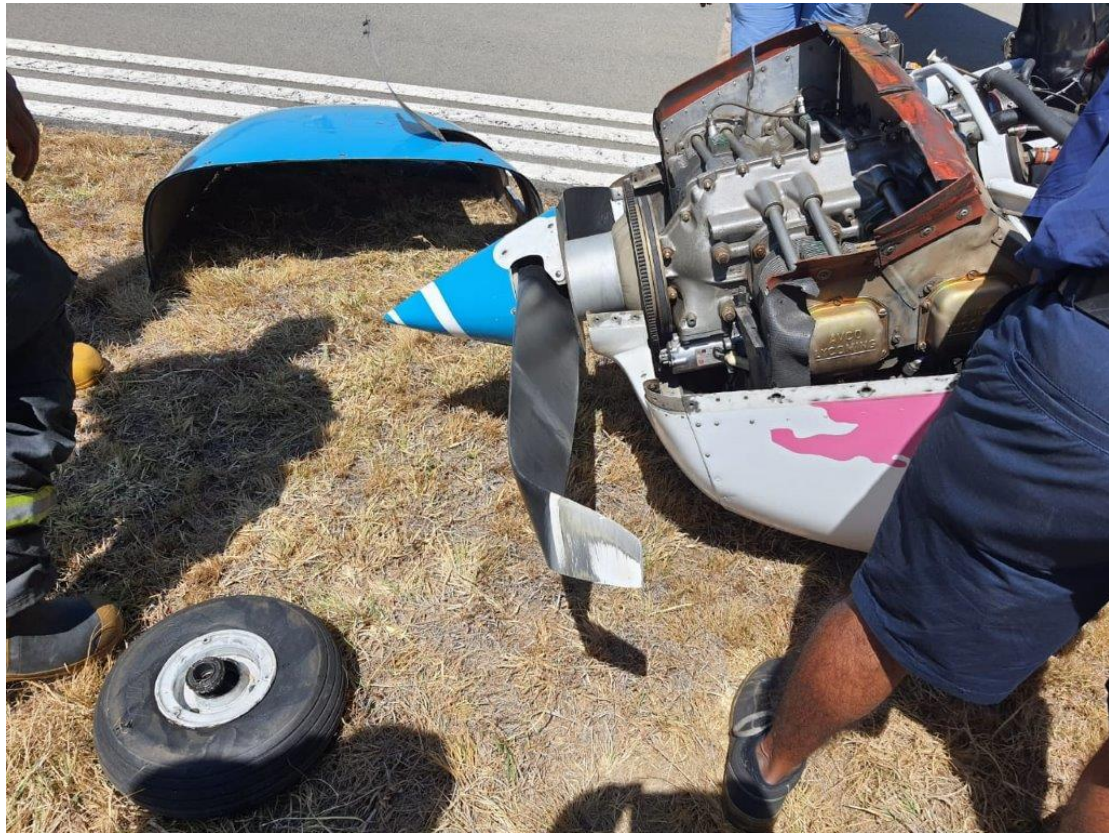
**Figure 1:** The aircraft's curled propeller blades. (Source: ATO)

The aircraft approached at a high speed and it ballooned before landing hard with its nose gear touching down first. This caused failure of the nose gear, and thus, the aircraft skidded and came to a halt on the left edge of the runway.

To avoid injury or damage to property, pilots are advised to ensure that they keep to the landing limits indicated in the Pilot's Operating Handbook.

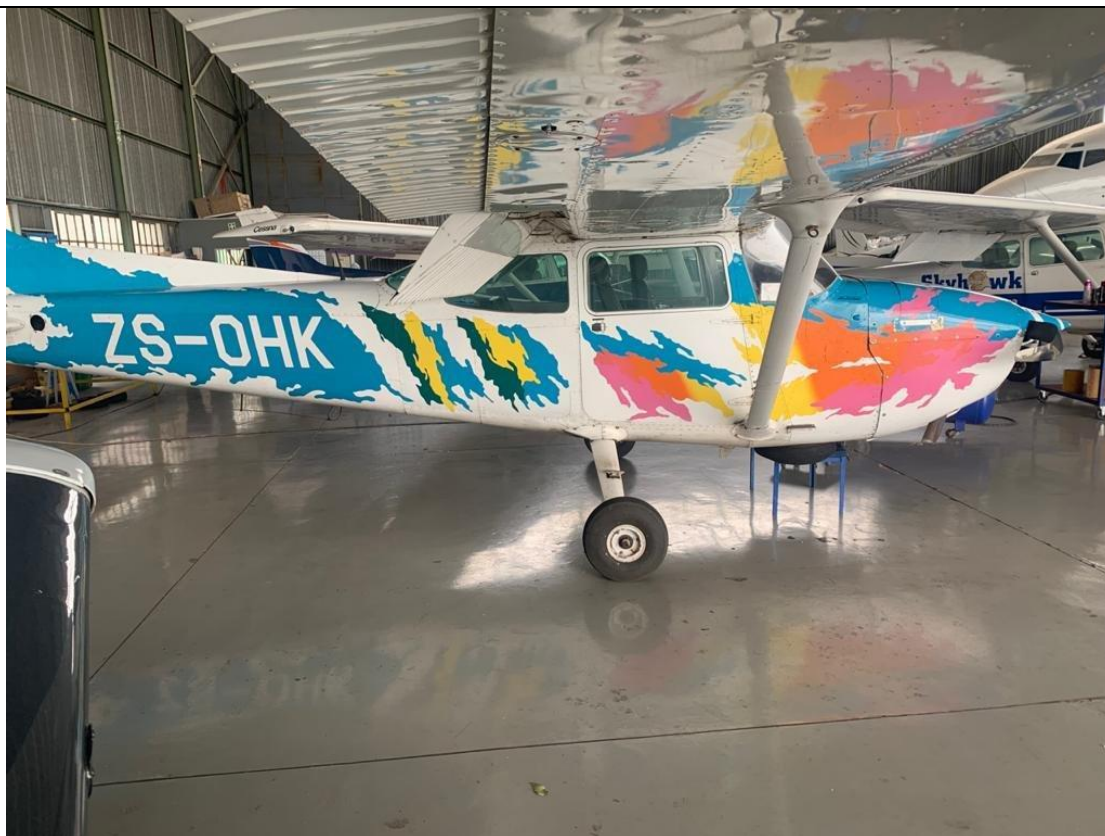
**Figure 2:** The Cessna 172N ZS-OHK in the hangar post-accident. (Source: ATO)
